## Facilities Condition Assessment Program (FCAP)

## FCAP Assessments of State Facilities

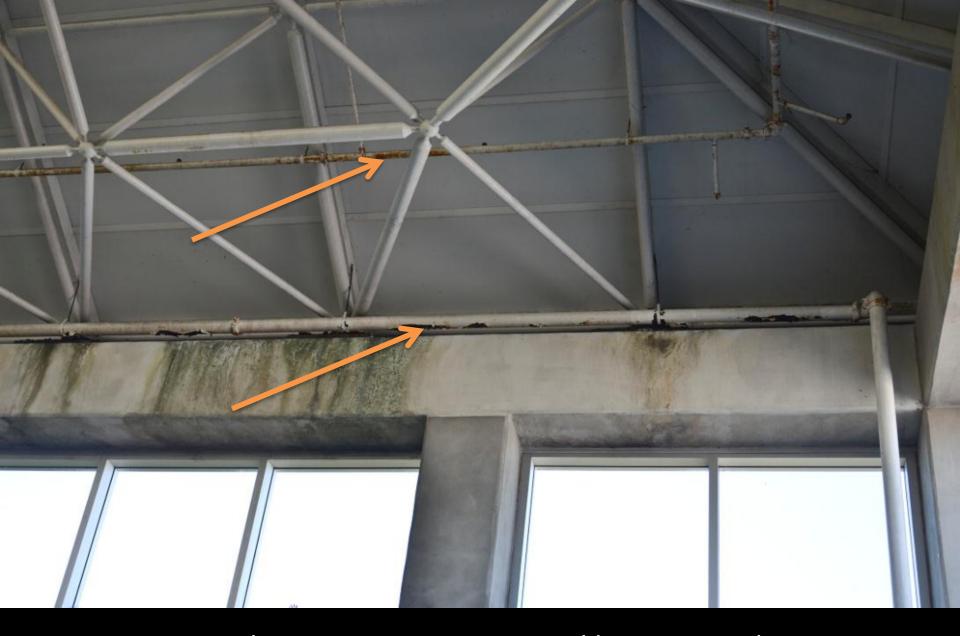
DENR - Fort Fisher Aquarium — Fire sprinkler pipes in the conservatory are corroding as a result of exposure to the salt air.

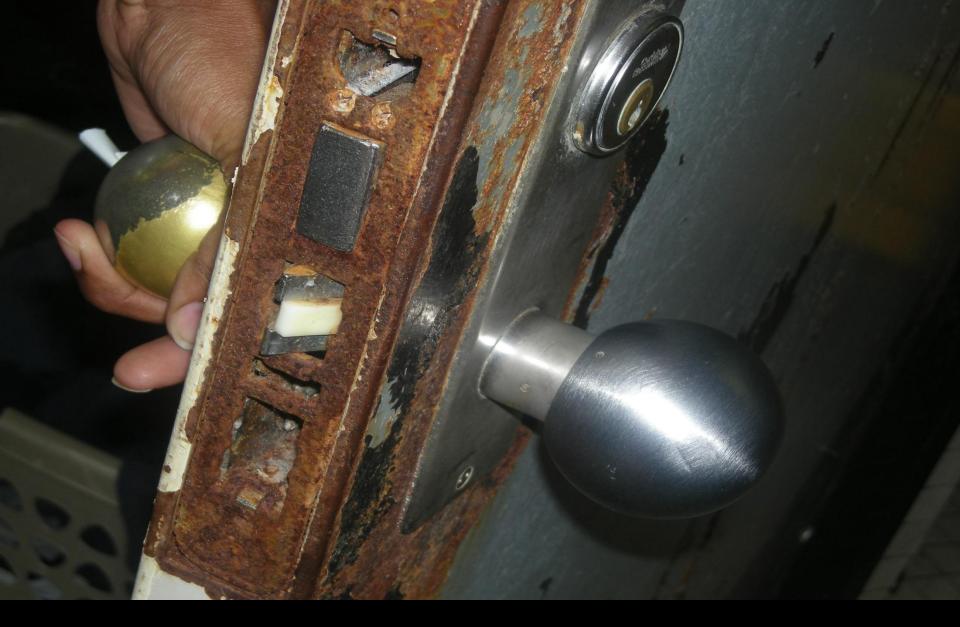
DPS – New Hanover Juvenile Detention Center - Security locks need to be replaced in multiple facilities.

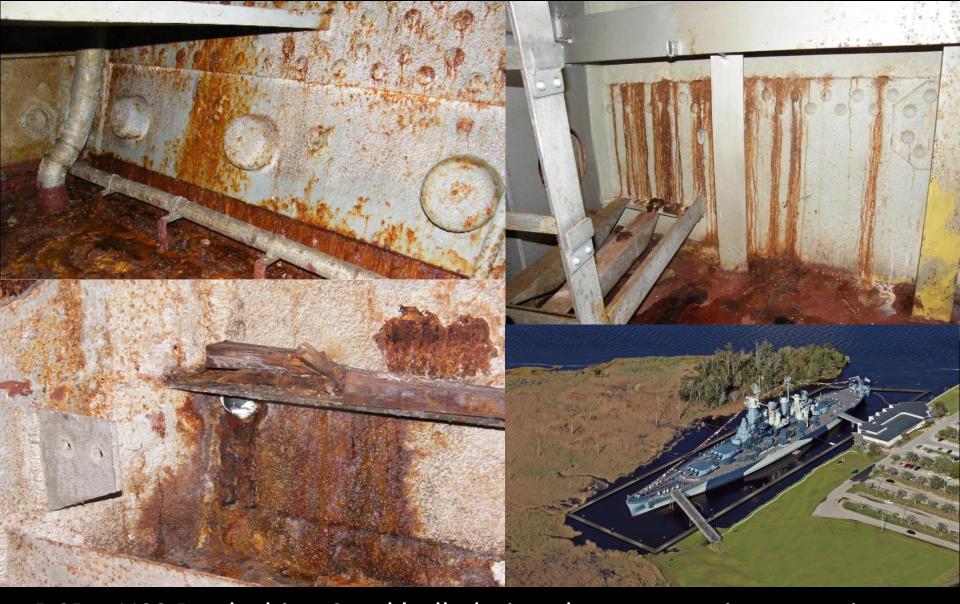
DCR – USS Battleship - Steel hull plating shows excessive corrosion. Battleship is now leaking around hull plating rivets and recent hull surveys indicate hull thicknesses of less than 0.1 inches.

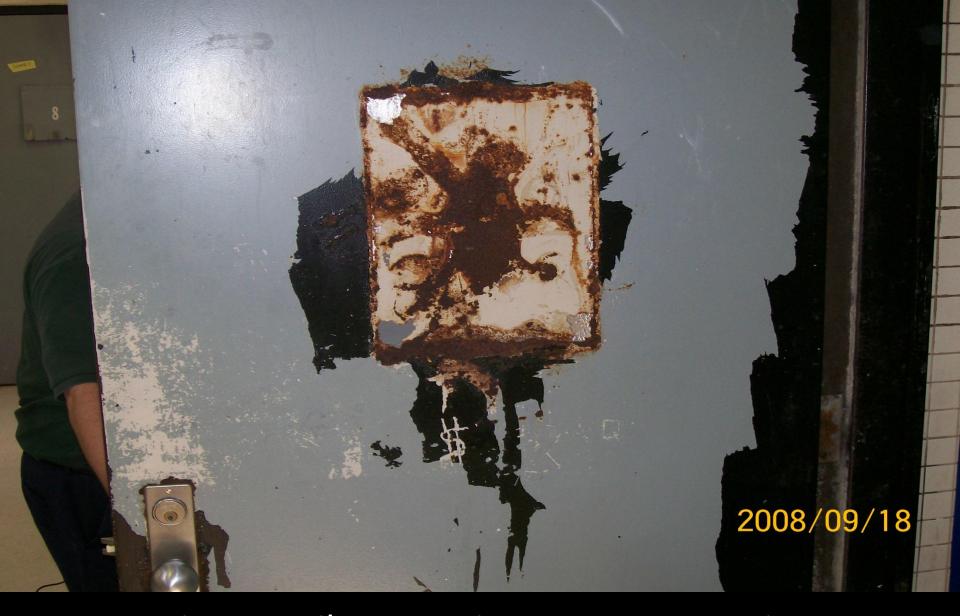
DPS – Pitt Juvenile Detention Center - Security doors need replacing at multiple facilities.

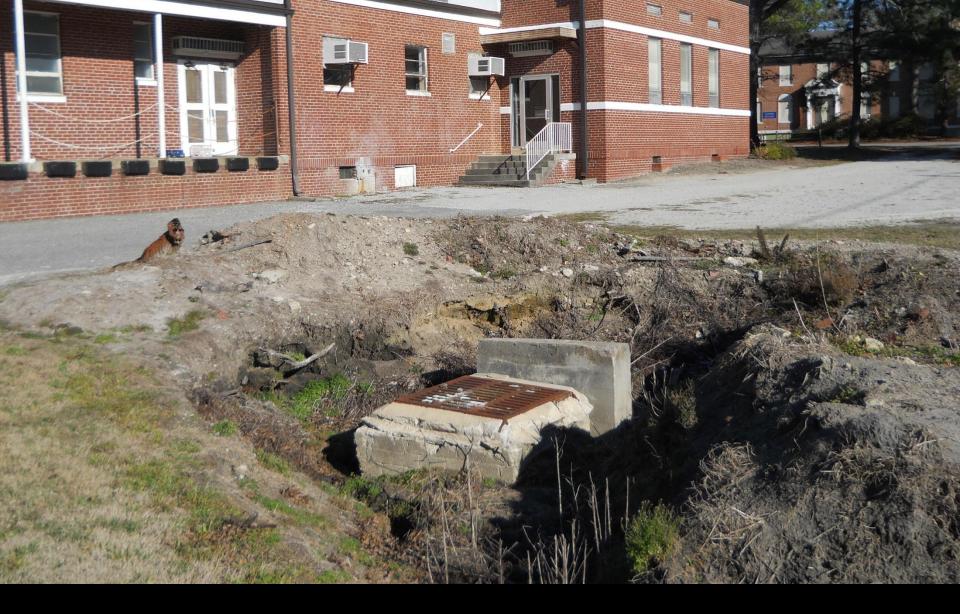
DPS – Dobbs Youth Development Center - The storm water drainage system needs replacement.

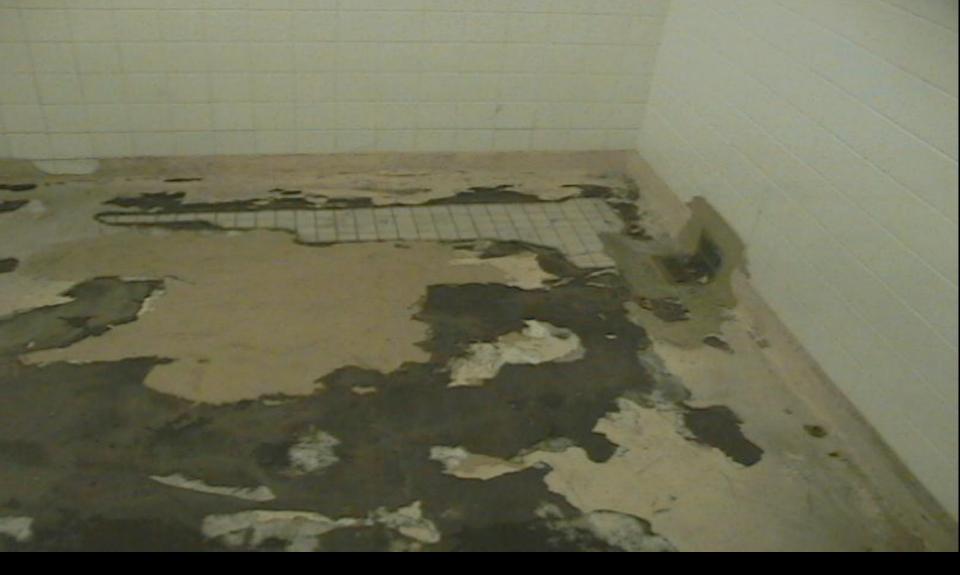
DPS – Hyde Correctional – Shower flooring needing replacement. Cracked or damaged shower flooring can cause damage to the finished spaces on the floor below (ie Dorms).

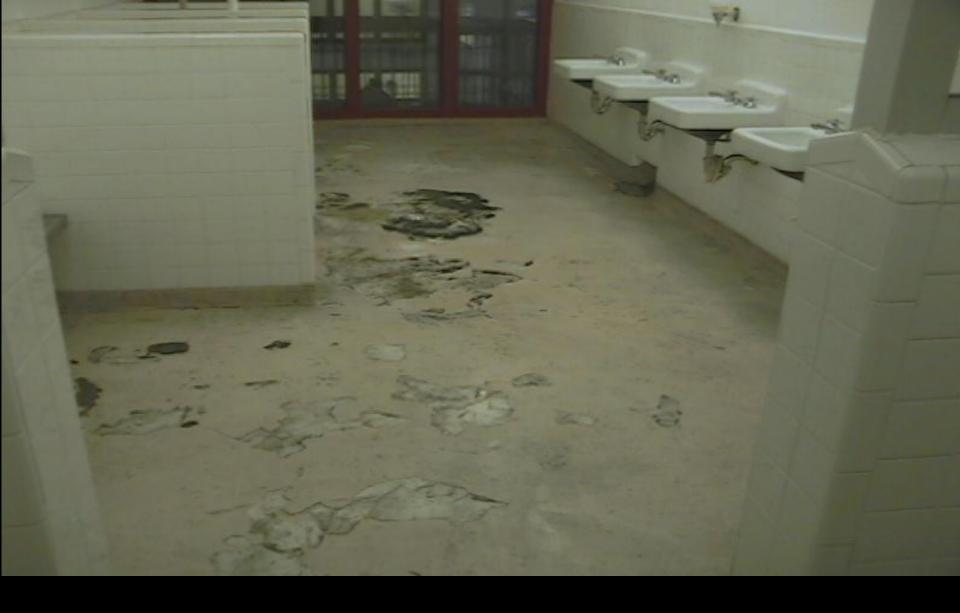
DPS – Hyde Correctional – Bathroom flooring worn and needs replacement.

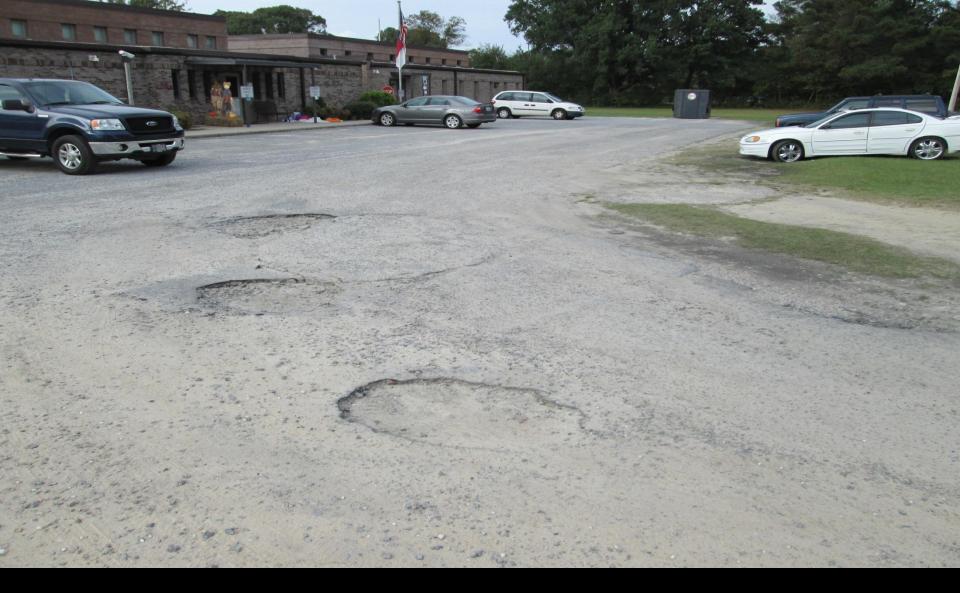
DPS – Pitt Juvenile Justice Center Asphalt deterioration - Without repair, the freeze/thaw cycle will create further and more rapid deterioration.

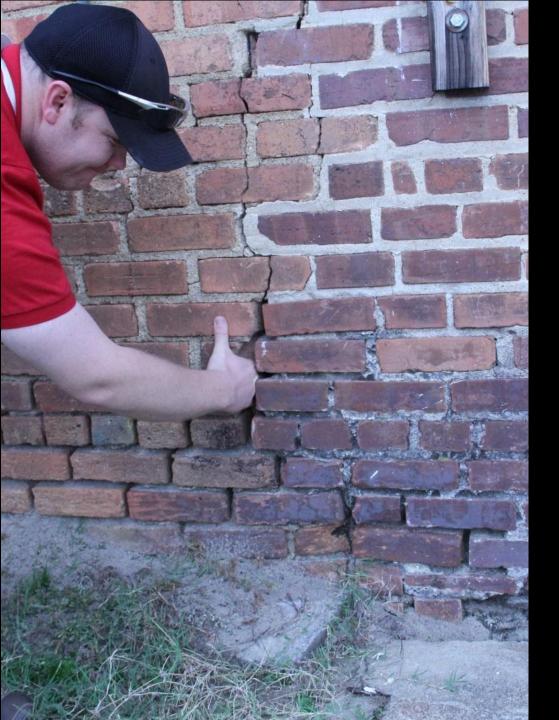
DHHS – Cherry Grounds
Building – Brick and
mortar deterioration

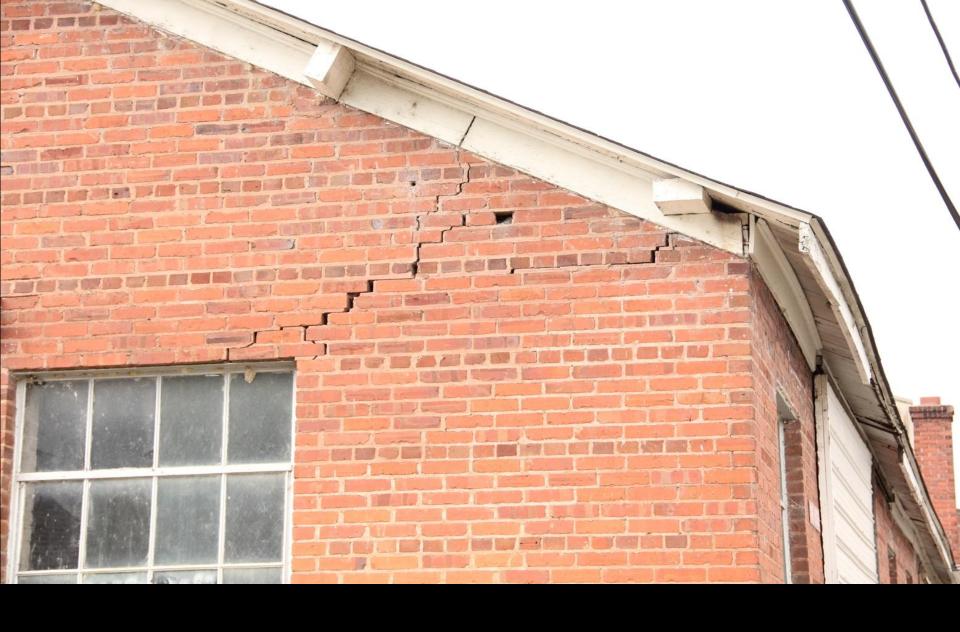
DHHS – Cherry Garage – Cracked walls and foundation settling.

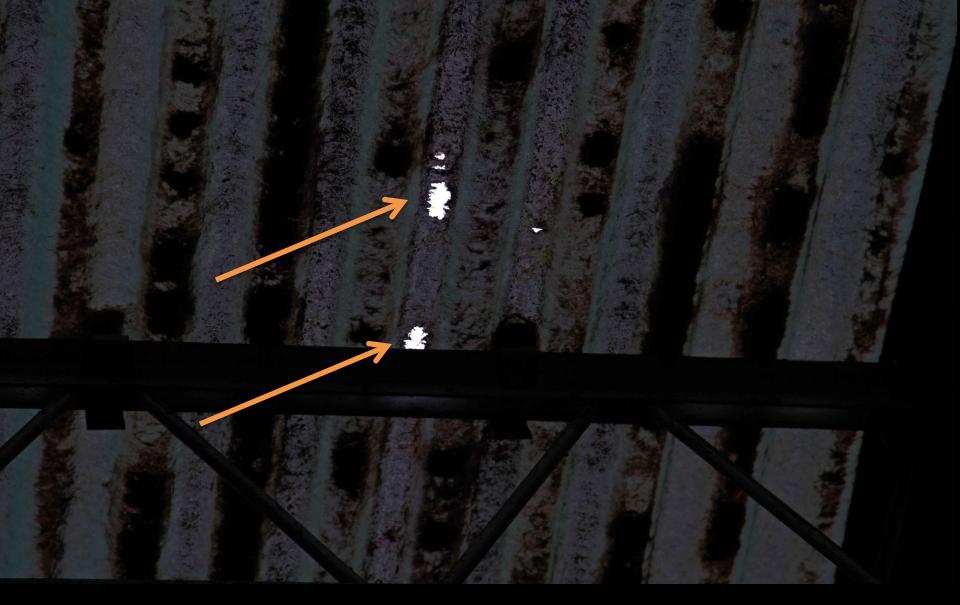
DHHS – Cherry Warehouse – Metal roof decking is totally rusting through. Metal is so thin, walking on it to repair causes additional penetrations.

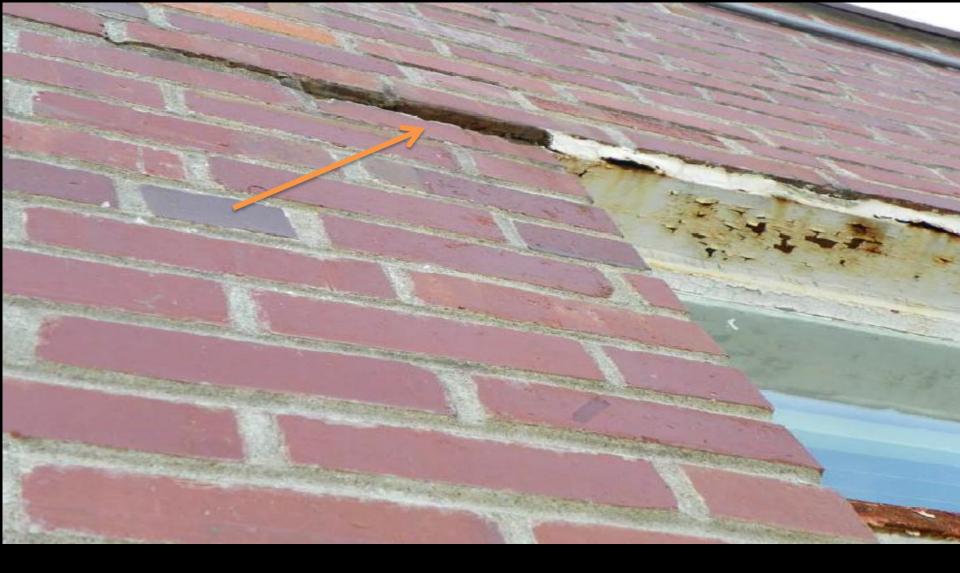
DPS – Dobbs Youth Development Center – Rusting lintels above windows causing structural problems. Typical across the state.

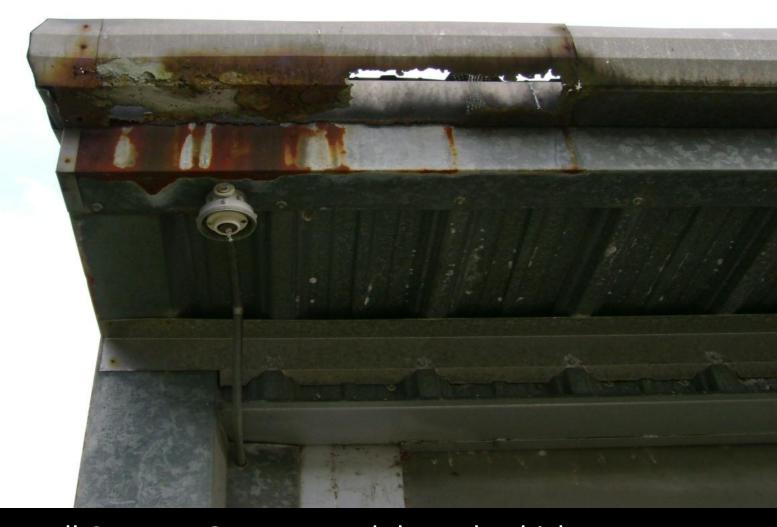
DHHS – Caswell Center – Gutter rusted through which causes roof water to pond against the building.

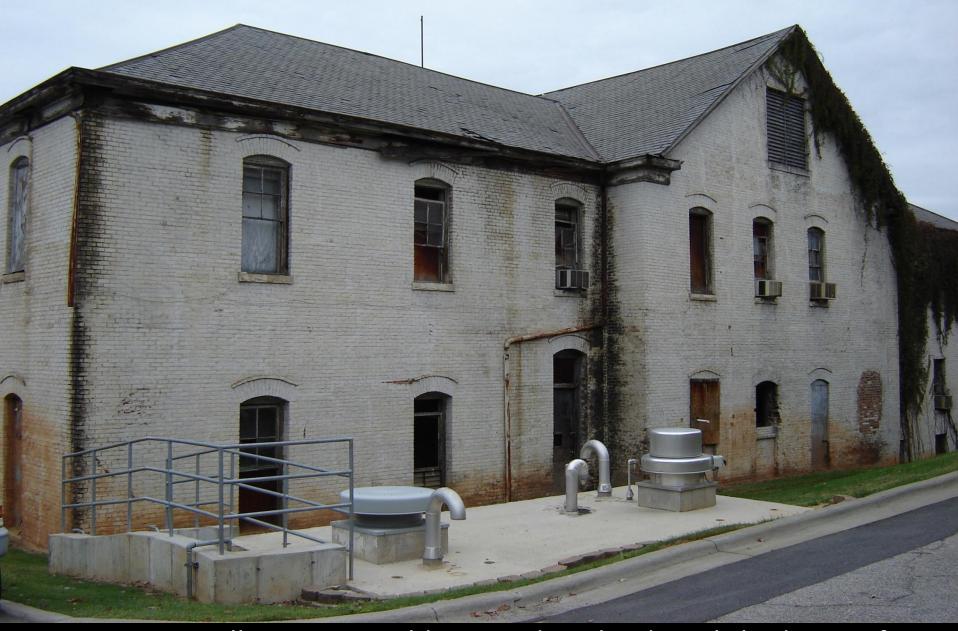
DOA – Caswell Square - Building needs to be demolished as roof is collapsing and it is a hazard.

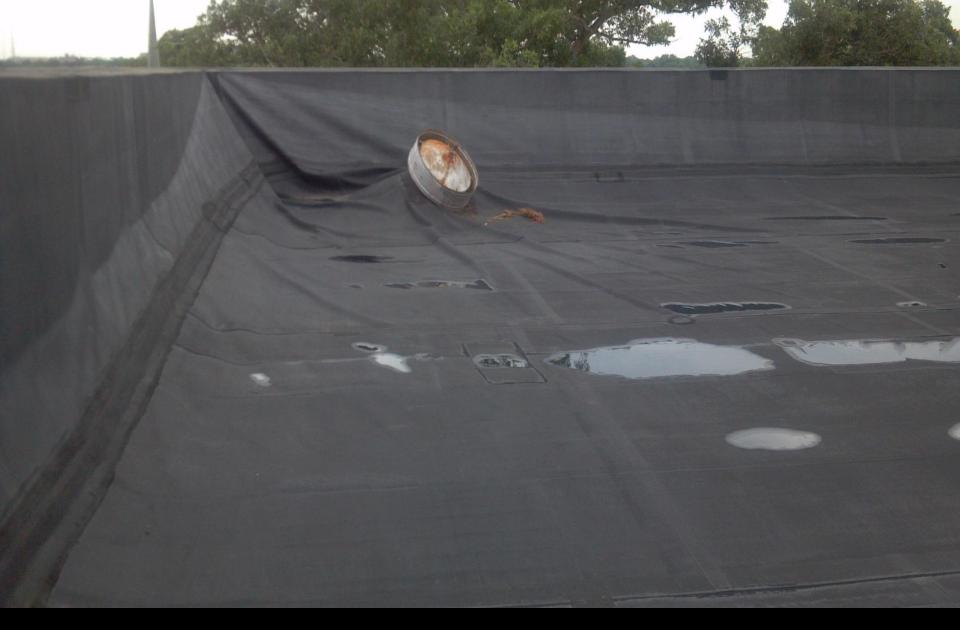
DHHS – Dix McBryde – EPDM roofing membrane failure.

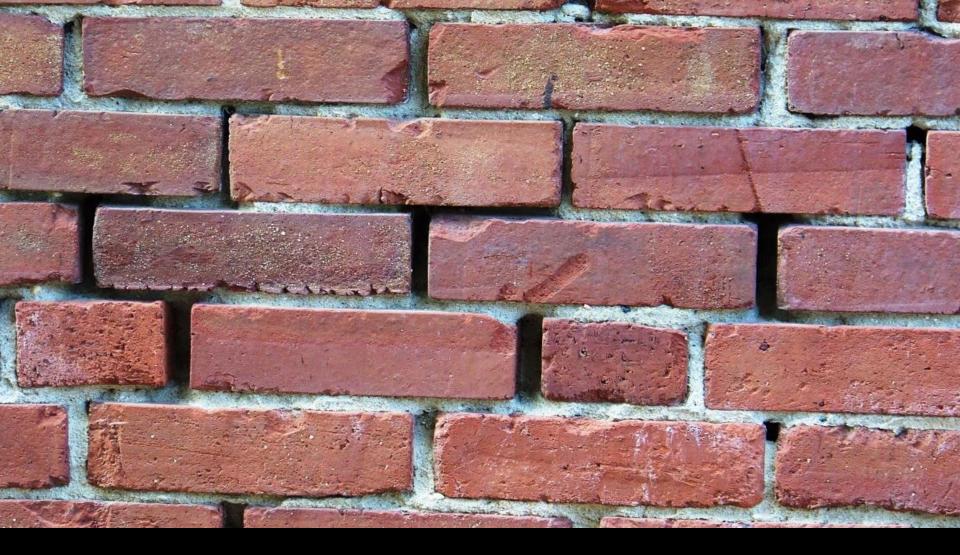
NCSU – Page Hall - Mortar loss in older masonry construction is a common route for rain water to enter a building. Moisture penetrating the building envelope will compromise structural integrity if left unchecked.

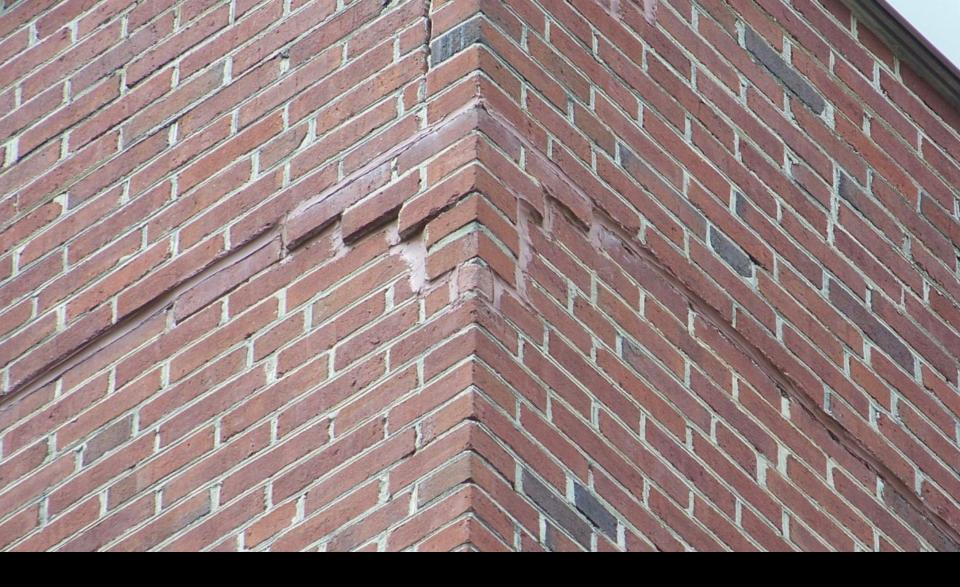
NCSU – Riddick Hall - Lateral movement of brick veneer. The weakened brick construction may cause moisture infiltration through the masonry.

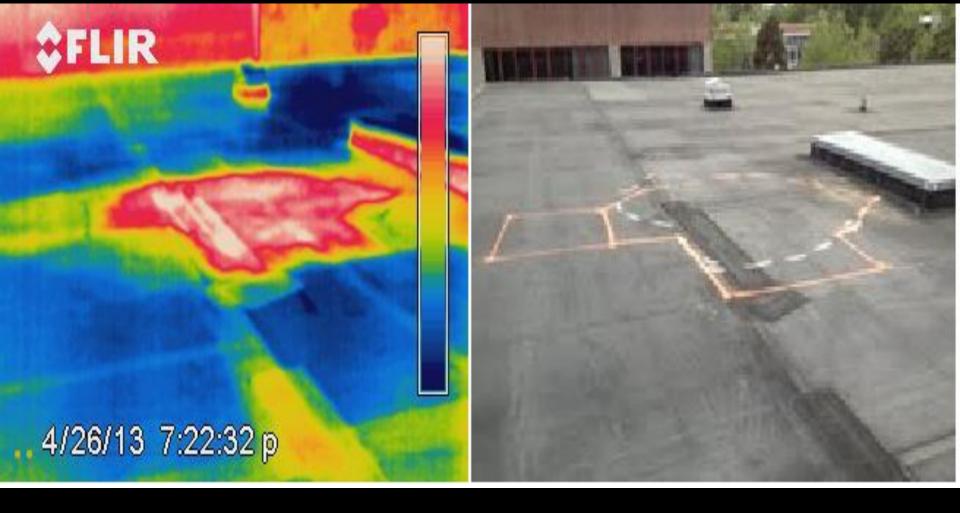
NCSU – Harris Hall - Water trapped beneath the roof membrane is visible in the infrared image at left and outlined in spray paint at the right. Moisture penetrating the building envelope can reduce the efficiency of the thermal insulation, and compromise structural integrity.

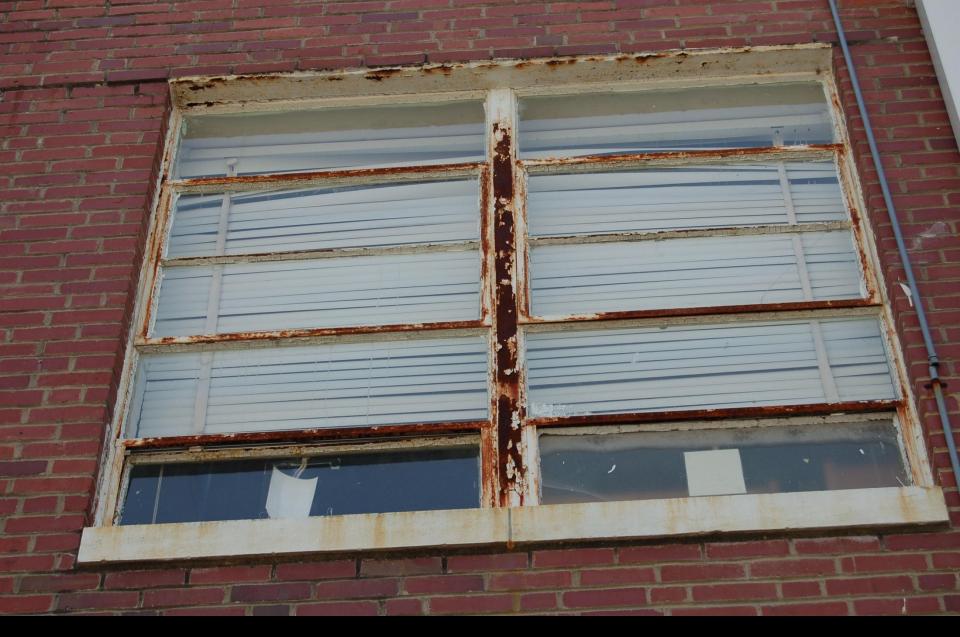
DPS – C.A. Dillion School - Numerous windows need replacement through-out the campus.

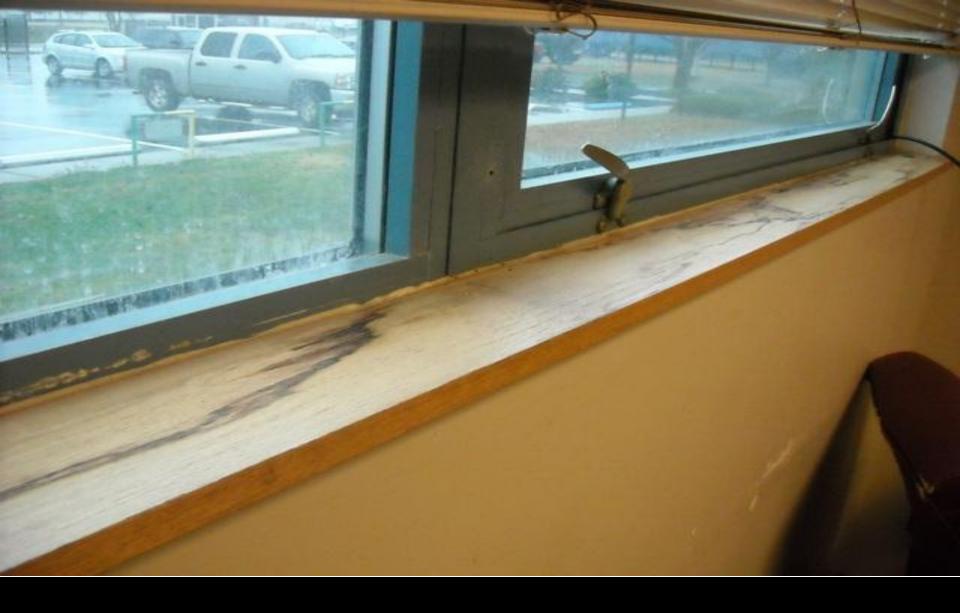
DPS – NCNG – Clinton Armory – Water infiltration through windows.

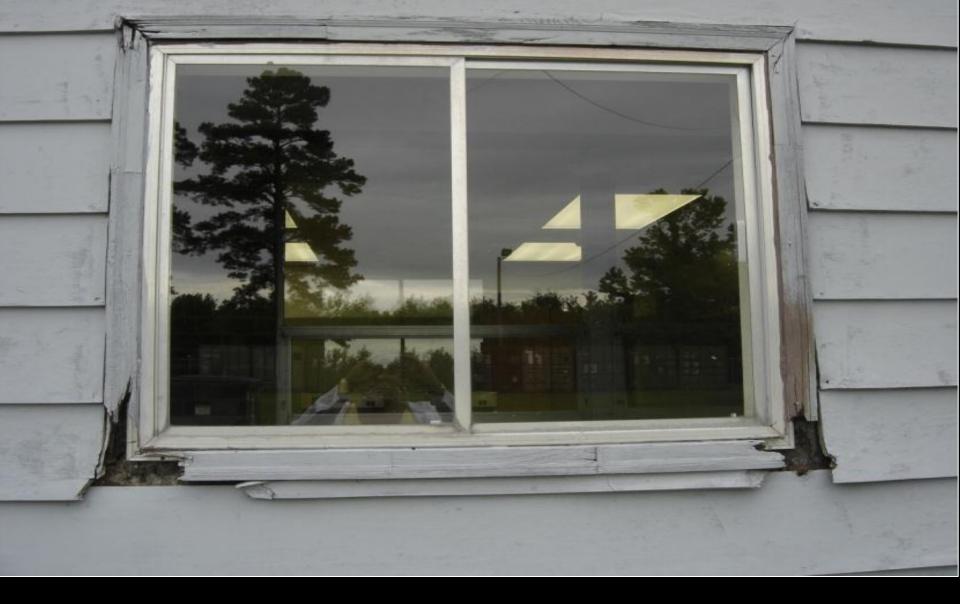
DPS – NCNG – Beulaville – Water infiltration due to rotting siding and window trim.

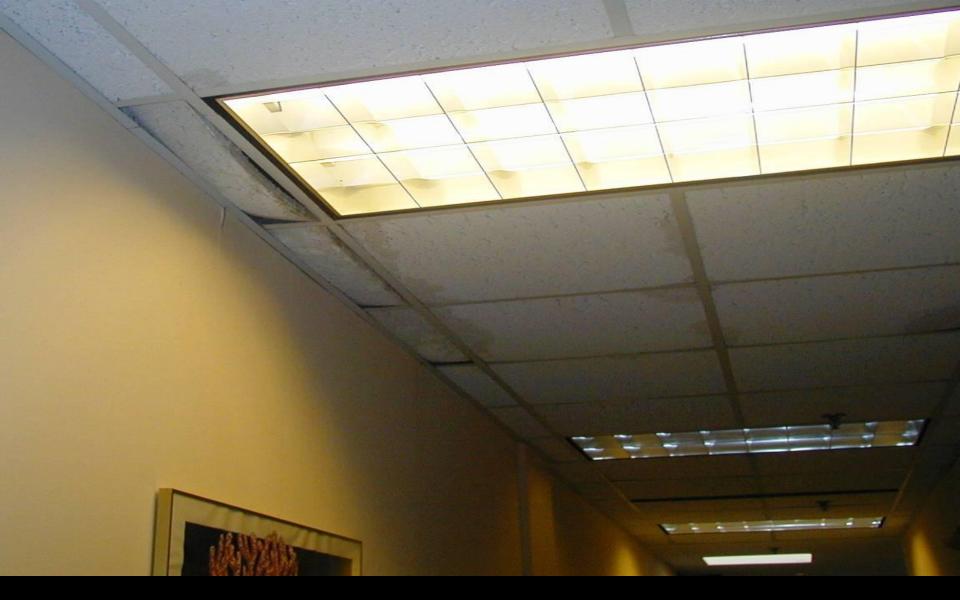
DENR – Zoo Education Center – Roof leaks causing damage to the interior.

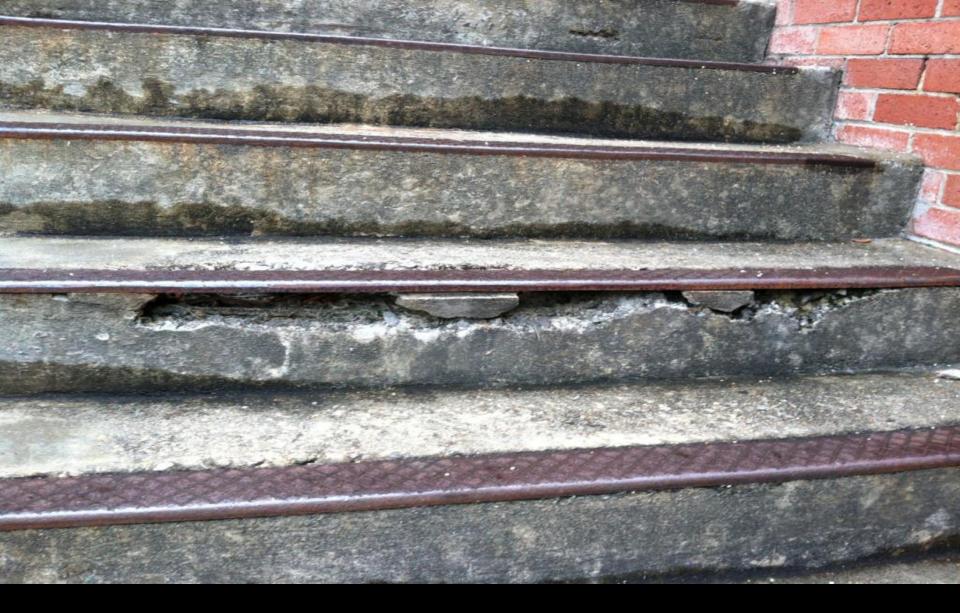
NCCU – Turner School of Law – Rusted stair nosing and deteriorated concrete steps. Safety hazard.

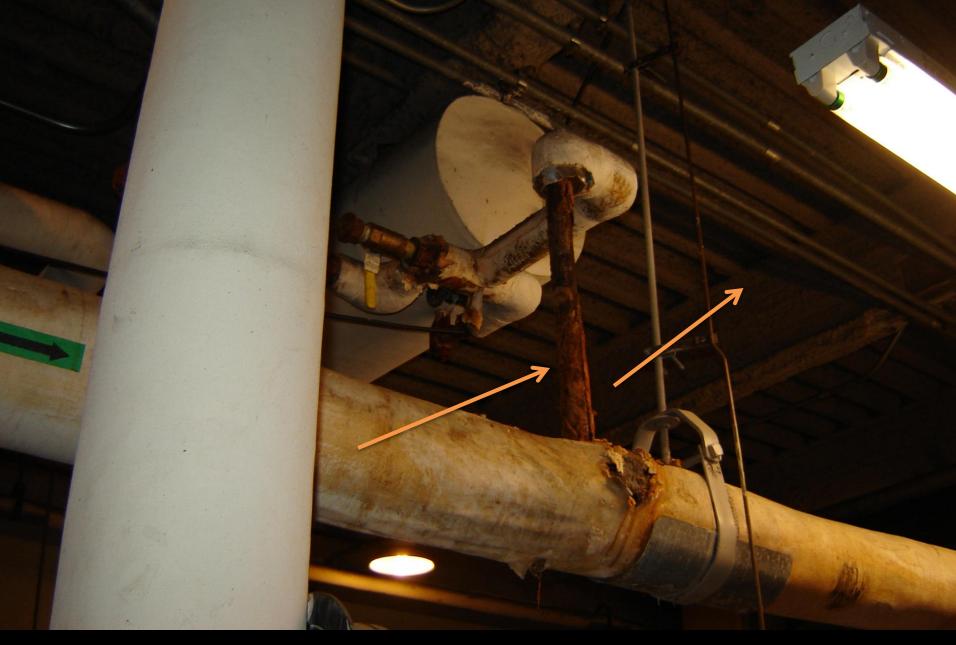
DOA – Administration – Sprayed on asbestos fireproofing releasing from structure and HVAC piping in poor condition.

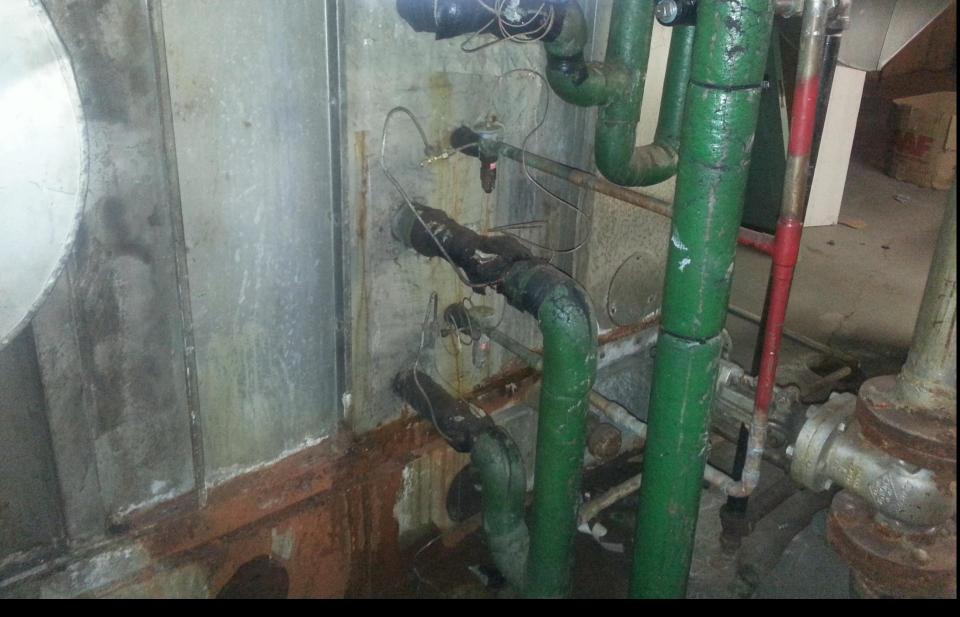
DOA – Shore – Corroded piping and equipment past useful life.

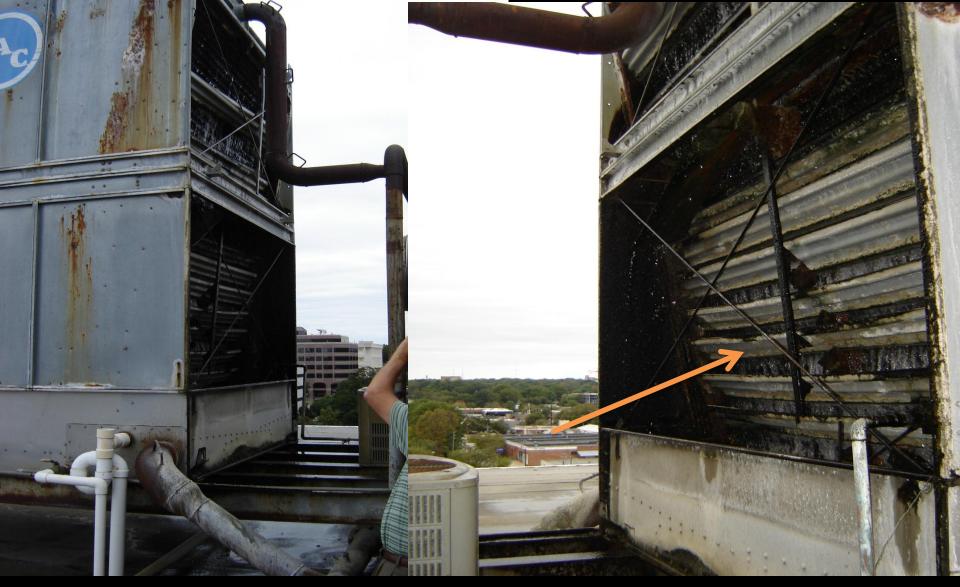
DOA – Shore Bldg – Cooling tower past is useful life. Rusted and broken supports.

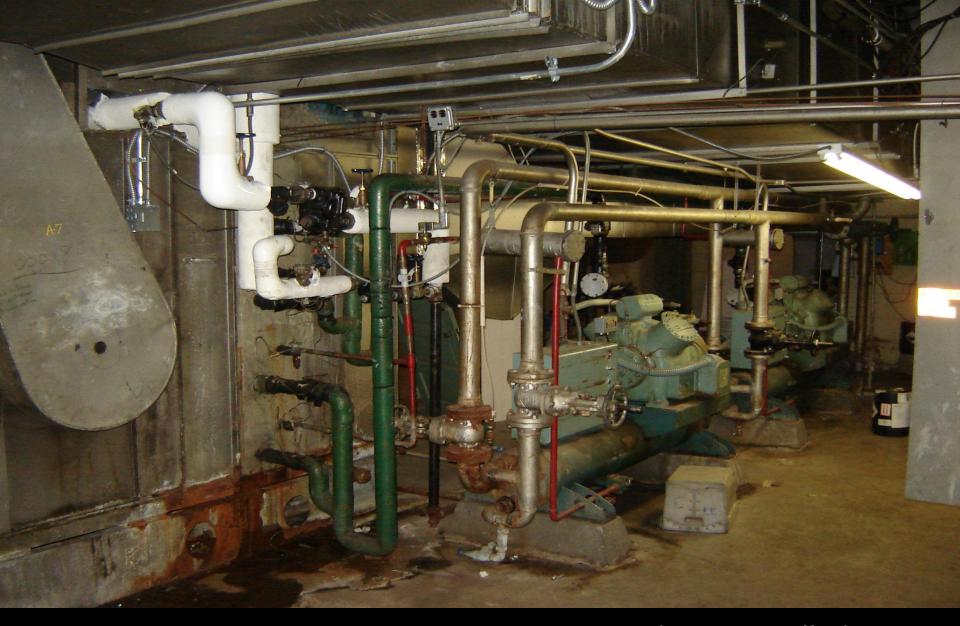
DOA – Cooper – HVAC equipment in poor condition. Installed in 1940's.

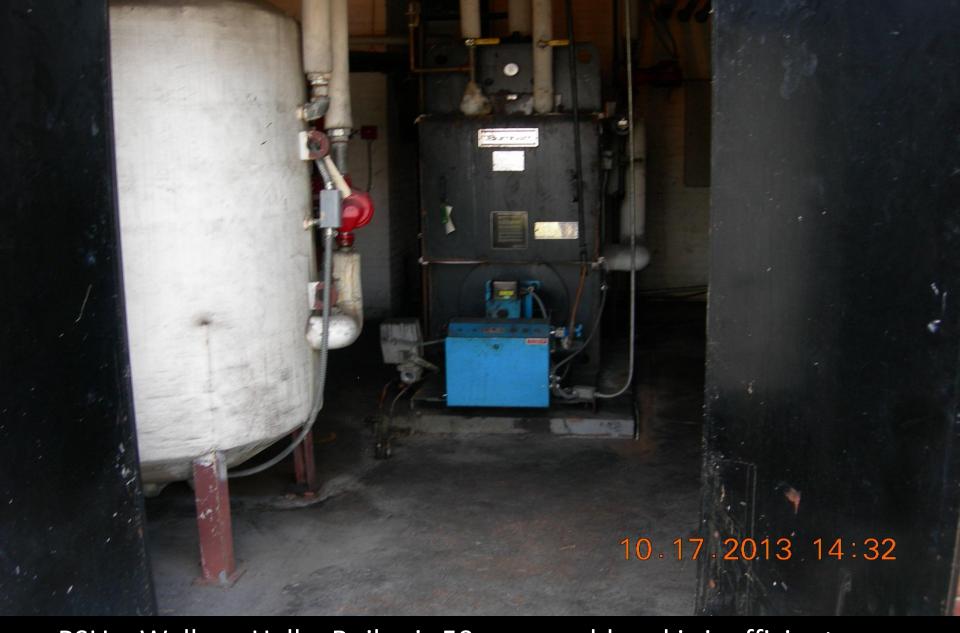
PSU – Wellons Hall – Boiler is 50+ years old and is inefficient.

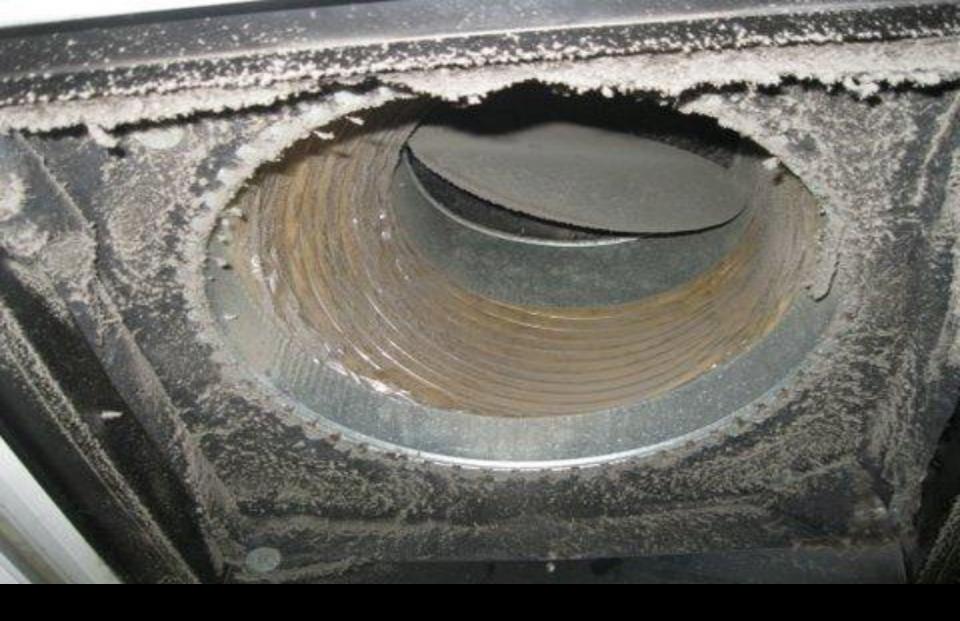
UNC-CH – Morehead Chemistry – Original ventilation system is filthy and deficient.

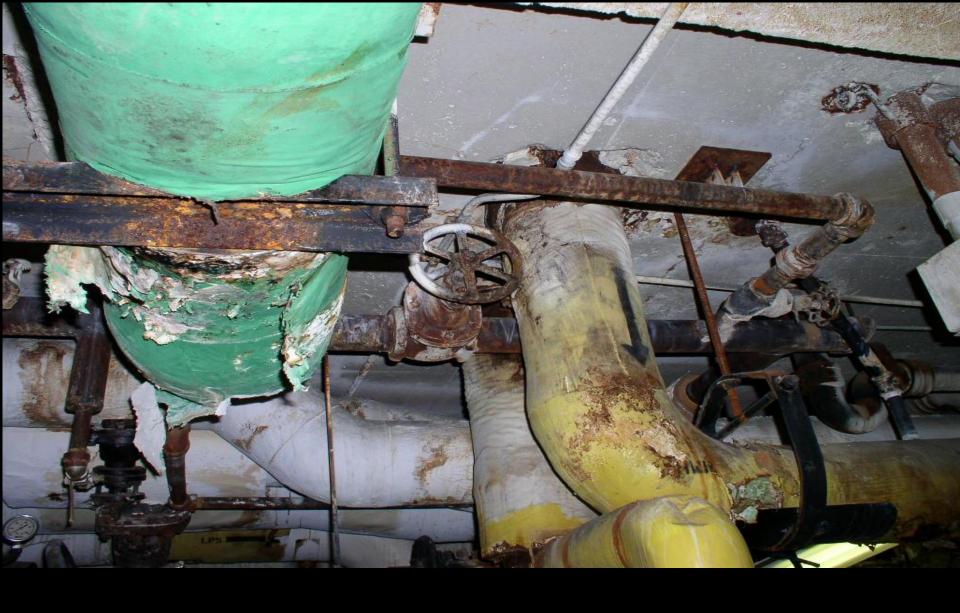
UNC-CH – MacNider Hall – HVAC system is deficient and poor shape.

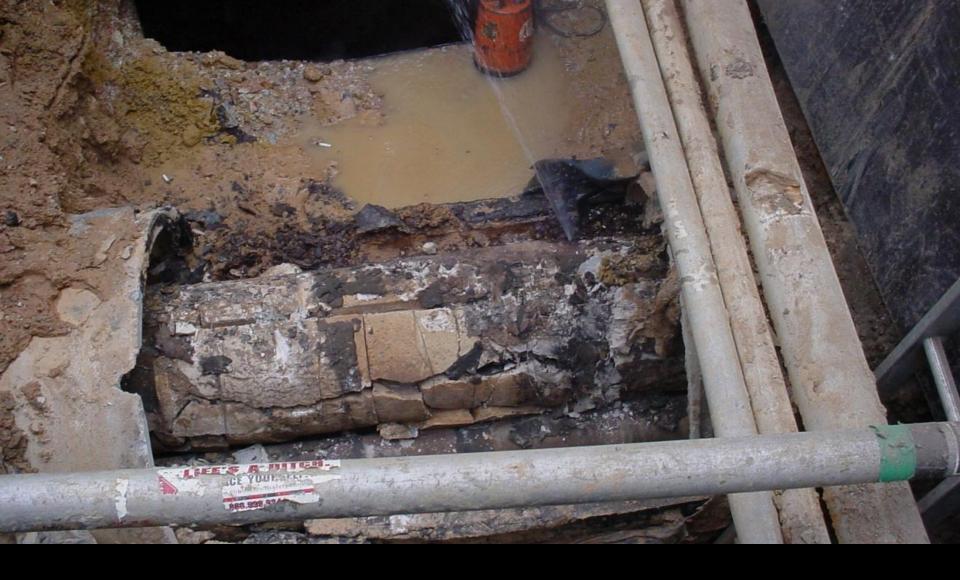
NCSU - Condensate leak between Carmichael Complex and Talley on Cates Avenue. Steam and condensate leaks cost thousands of dollars in lost energy.

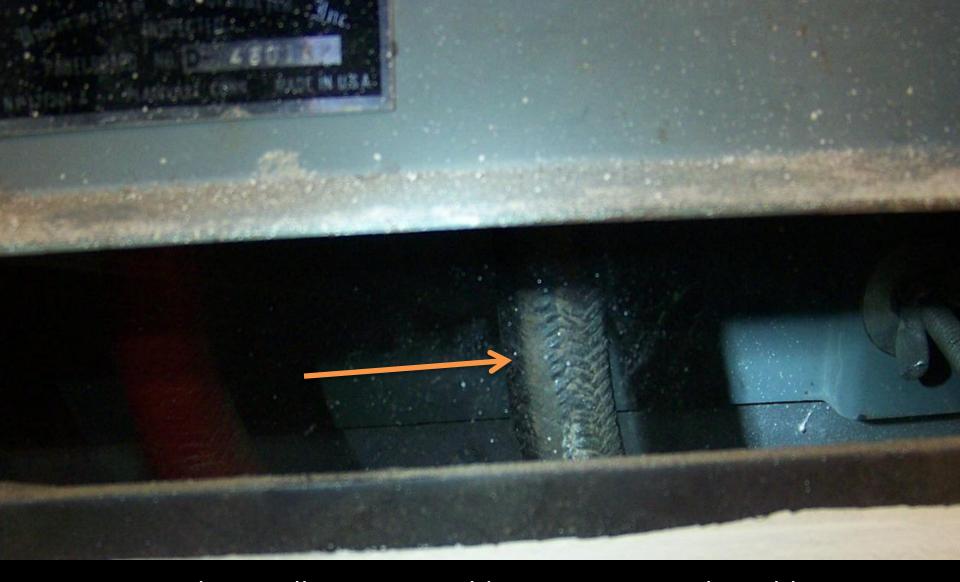
NCSU – Nelson Hall - 50+ year old Type RH wire - the rubber insulation is dry and brittle and could become a potential safety hazard.

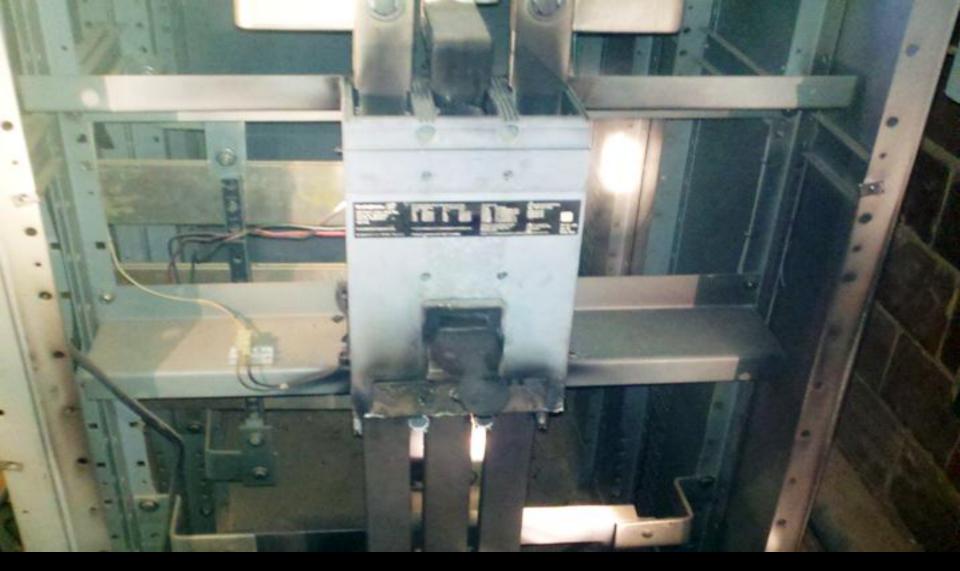
NCSU – Carmichael Gym - Arc fault damage from failed 42 year old 1200 amp breaker – led to  $2^{nd}$  and  $3^{rd}$  degree burns to shop supervisor.

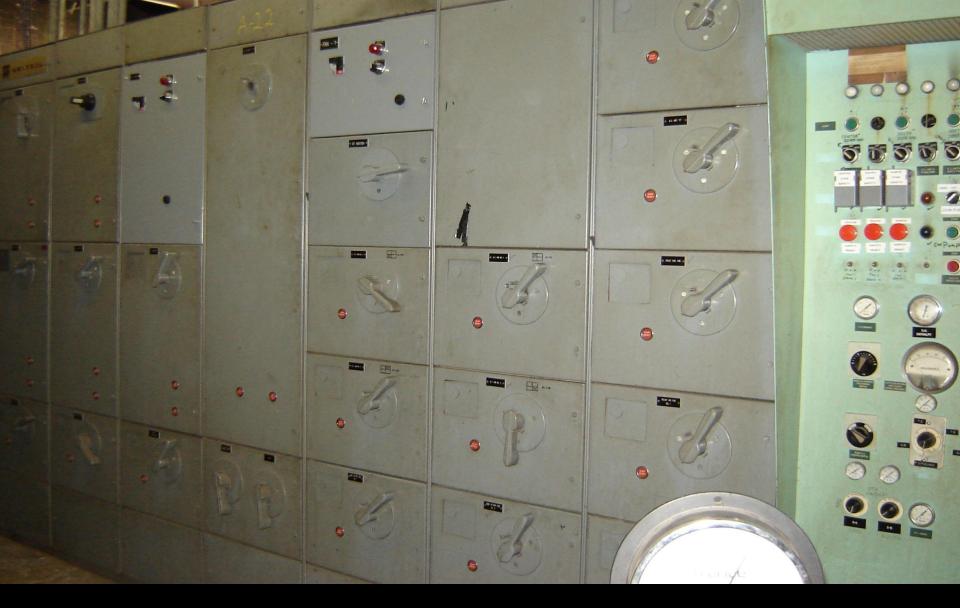
DOA – Administration – Main Control Center and Control Panel are obsolete and parts are no longer available. All controls are broken in set in manual position. Very inefficient.

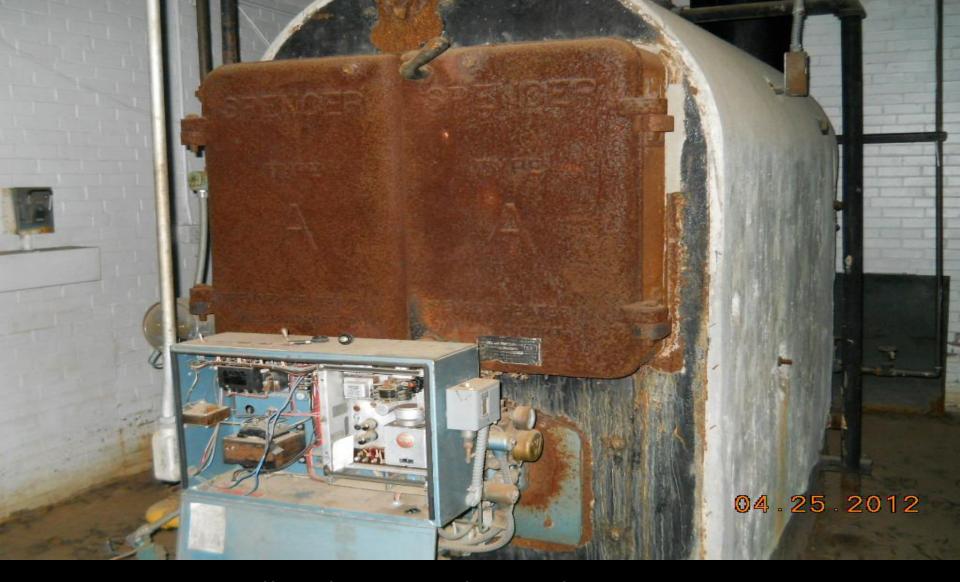
DPS - Stonewall Jackson Youth Development Center - Academic, Vocational, & the Gym Buildings boilers are in need of replacement.

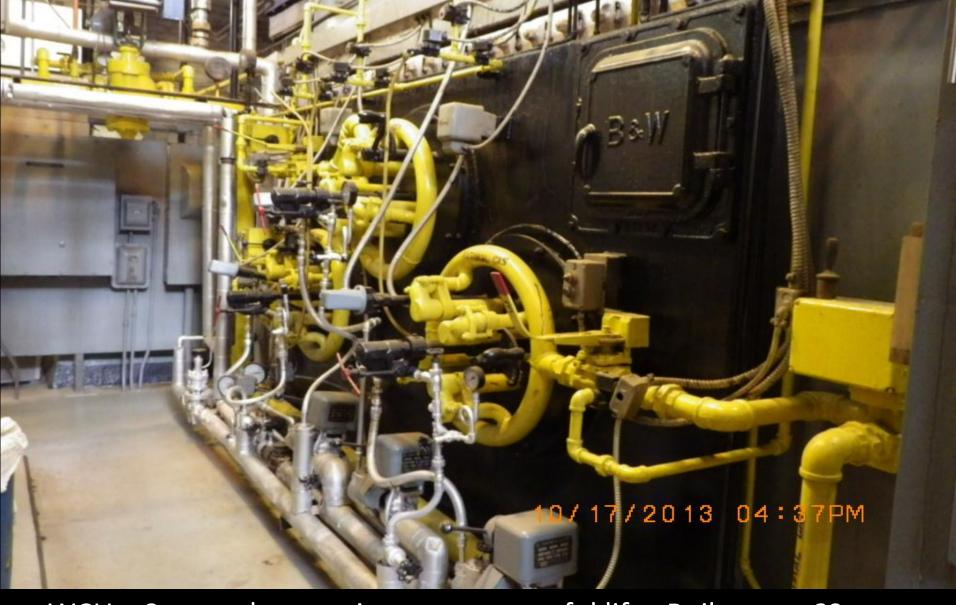
WCU – Steam plant equipment past useful life. Boilers are 60+ years old and can reliably operate at 75% of rated capacity. Recent winters have pushed steam plant to its maximum output.

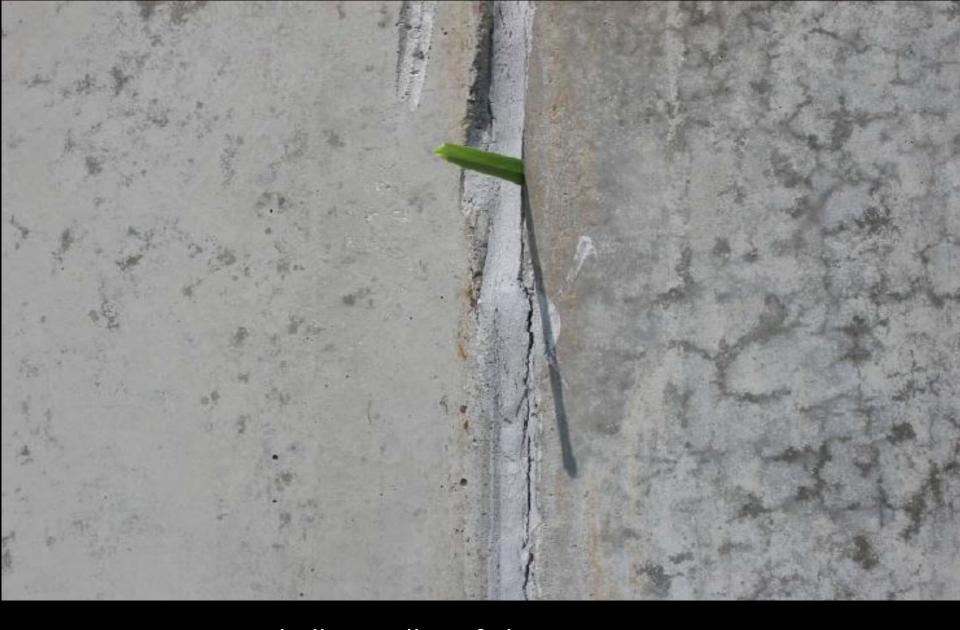
DPS – Avery Mitchell – Caulking failure. Common issue across the state in multiple buildings.

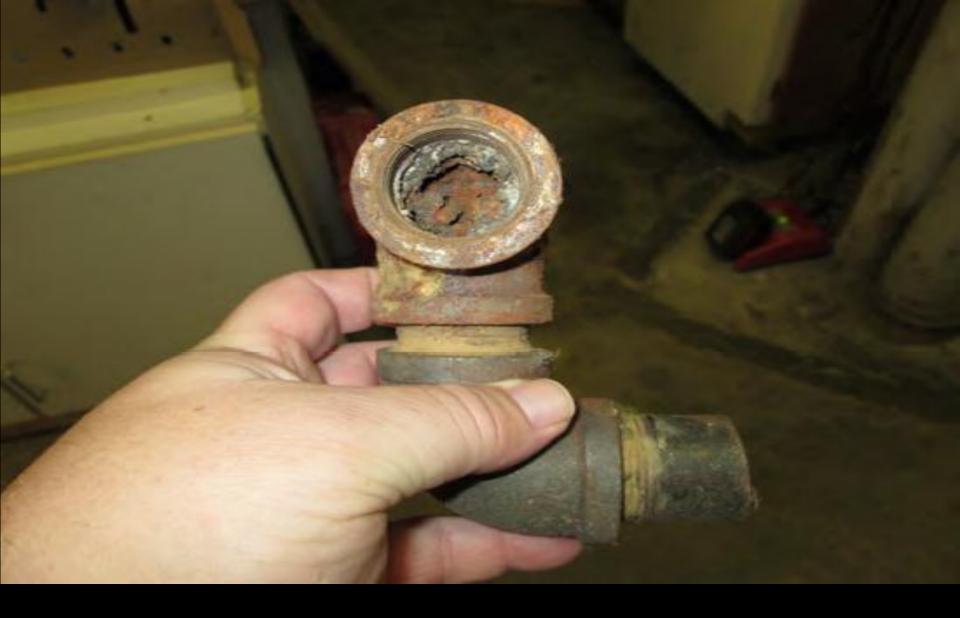
UNCC – Atkins - Hot water closed loop for heating showing signs of deterioration and massive scaling .
