## Facilities Condition Assessment Program (FCAP)

## FCAP Assessments of State Facilities

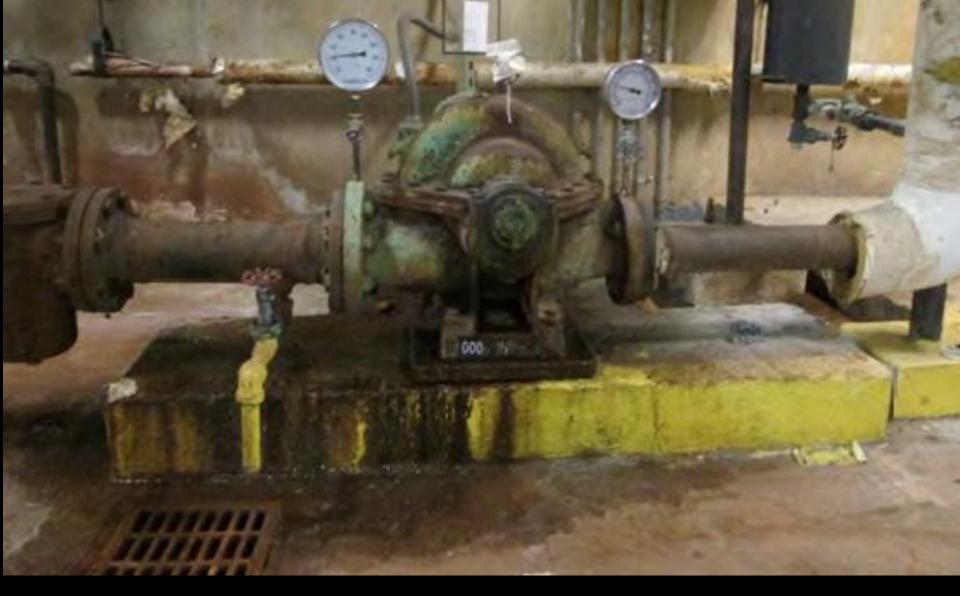
UNCC – Atkins – Hot water pumps and tank past life expectancy causing leaks and scaling .

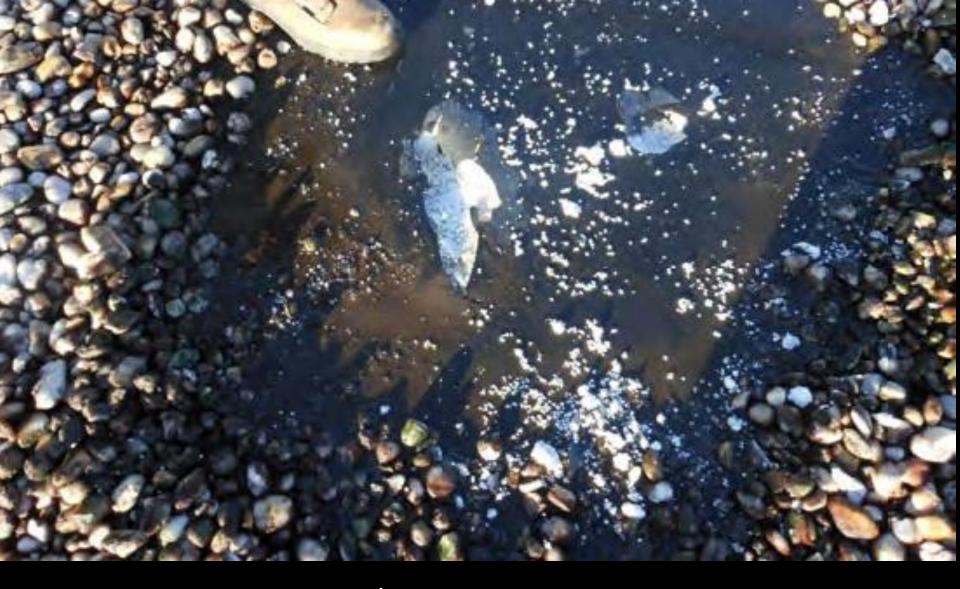
UNCC – Barnard - EPDM/Ballast has exceeded life expectancy. Frequent and random leaks. Gravel pulled back to show deterioration.

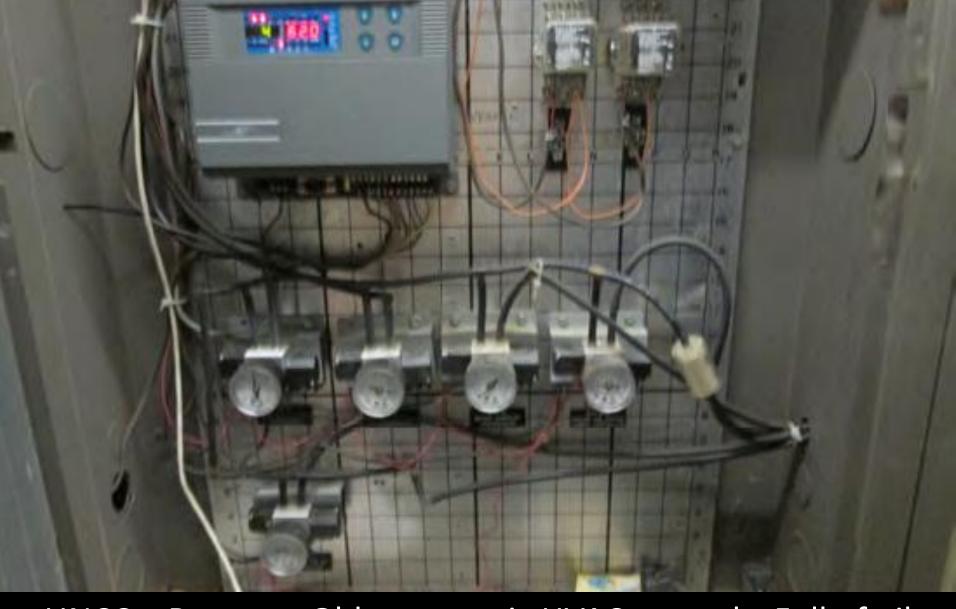
UNCC – Burson – Old pneumatic HVAC controls. Full of oil and water (typical across the state). Temperature cannot be regulated.

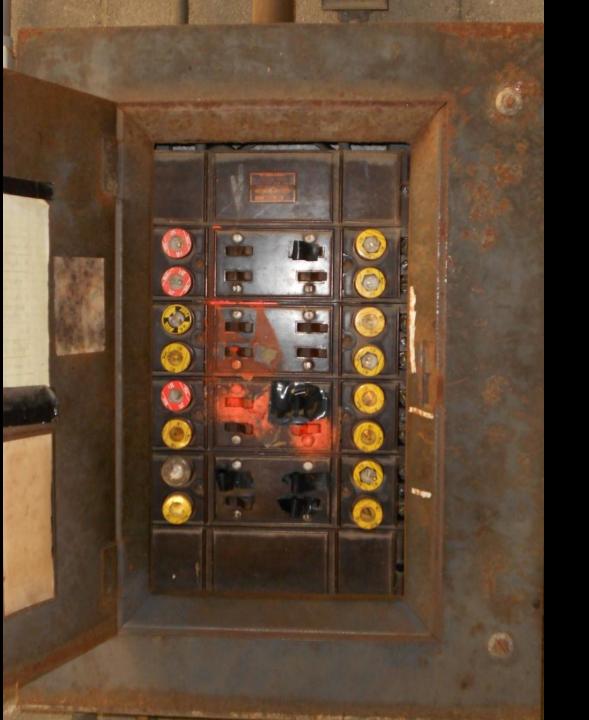
DOT Facility
Fused
Electrical
Panel

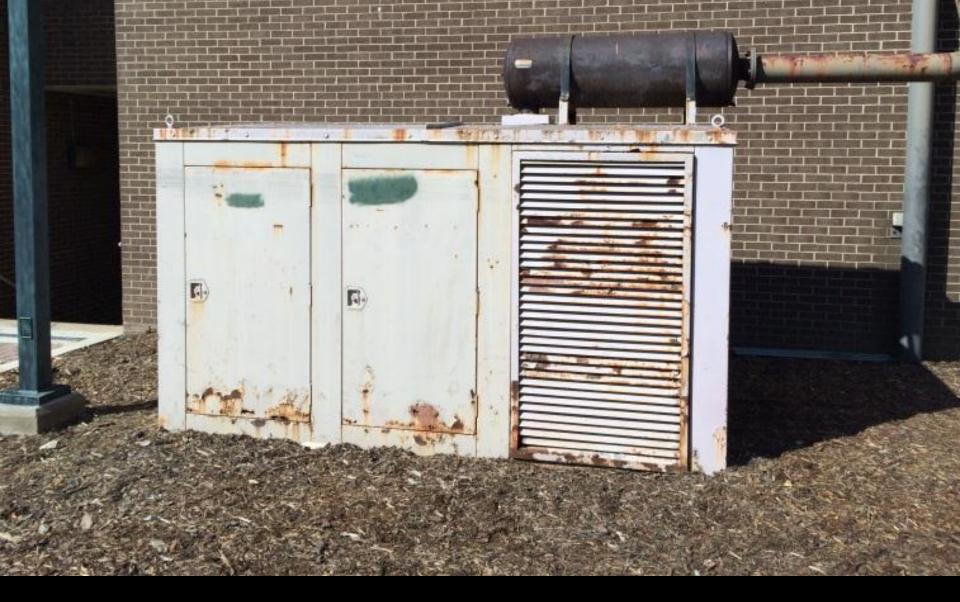
ASU – Health Services – Emergency generator out of service.

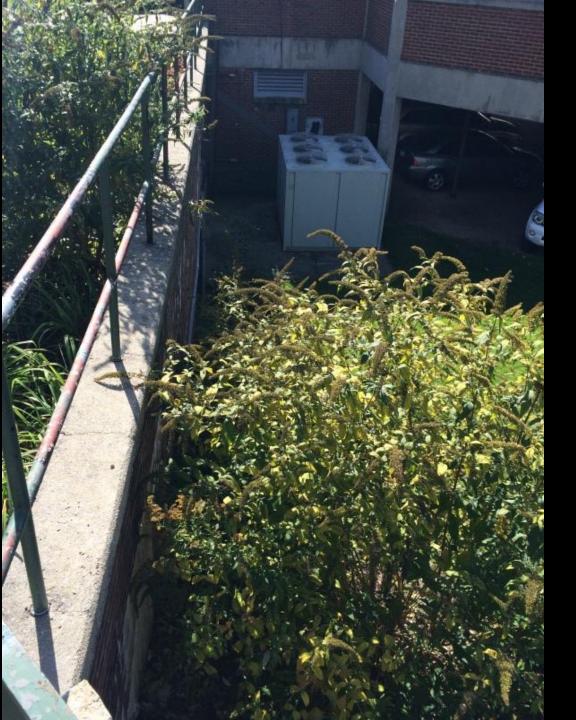
ASU – Octagon retaining wall bowing and leaning – structural stability concern.

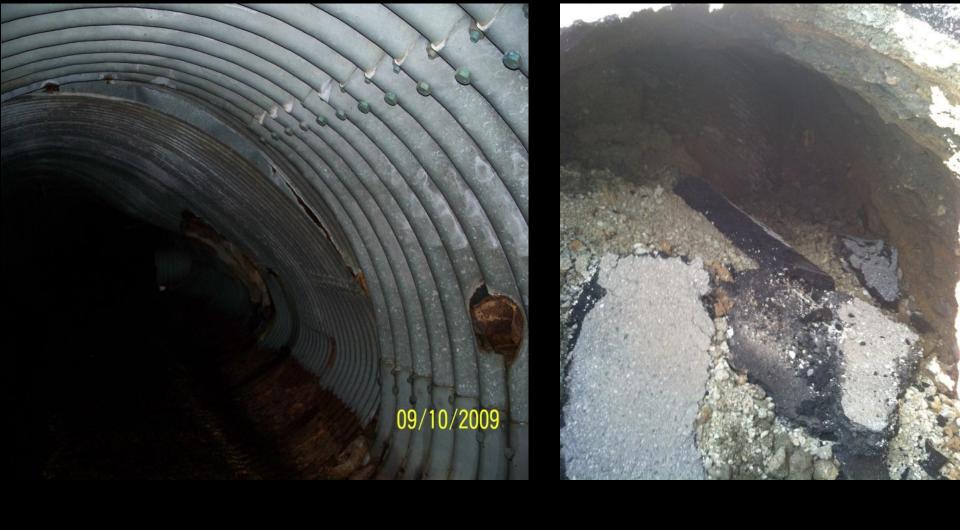
ASU – Raley parking lot – Being unable correct storm drainage piping causes total failure.

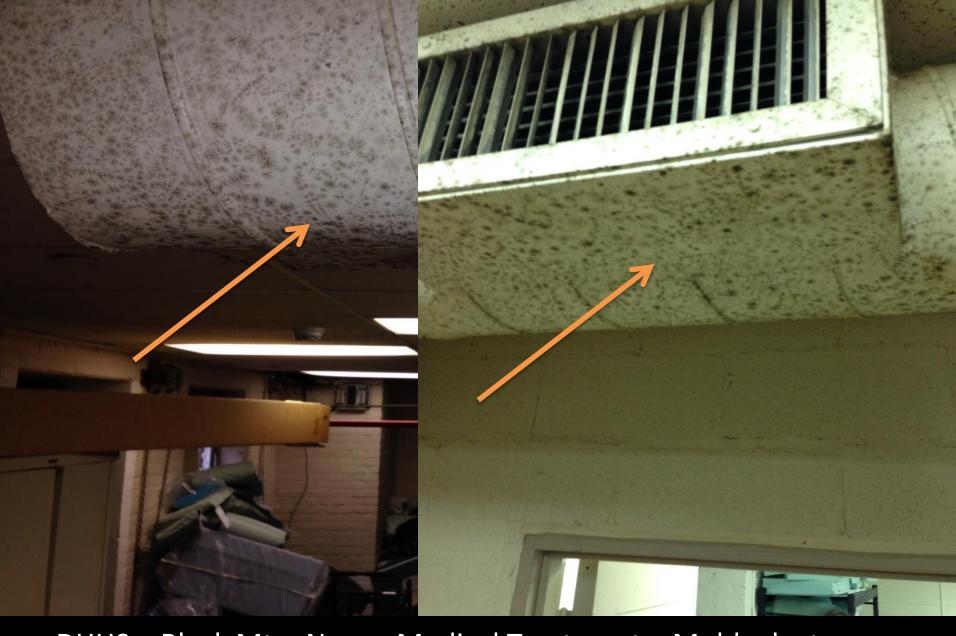
DHHS – Black Mtn. Neuro-Medical Treatment – Moldy ducts.
