1. Report No. ATRC-99-11		2. Government Accession No.		3. Recipient's Catalog No.	
4. Title and Subtitle Survey of Tire Debris on Metropolitan Phoenix Highways				5. Report Date November 1999

11. Contract or Grant No.	
12. Sponsoring Agency Name and Address ARIZONA DEPARTMENT OF TRANSPORTATION 206 S. 17TH AVENUE PHOENIX, ARIZONA 85007 Project Manager: John Semmens				13. Type of Report & Period Covered

14. Sponsoring Agency Code	
15. Supplementary Notes Prepared in cooperation with the Governor's Office of Highway Safety					
16. Abstract <p>This report was prepared in order to evaluate the impacts that tire debris on state highways produces in Arizona and the Phoenix metropolitan area. Estimates of debris collected in metro Phoenix were reported along with an analysis of the safety implications that roadway debris and tire defects have for Arizona motorists. In order to assess the causes of tire debris in metropolitan Phoenix, a sample of tires and tire fragments was taken at several ADOT maintenance yards in the metro area. These fragments were classified according to type of vehicle, retread or original tire, and probable cause of failure.</p> <p>The study revealed that, relat

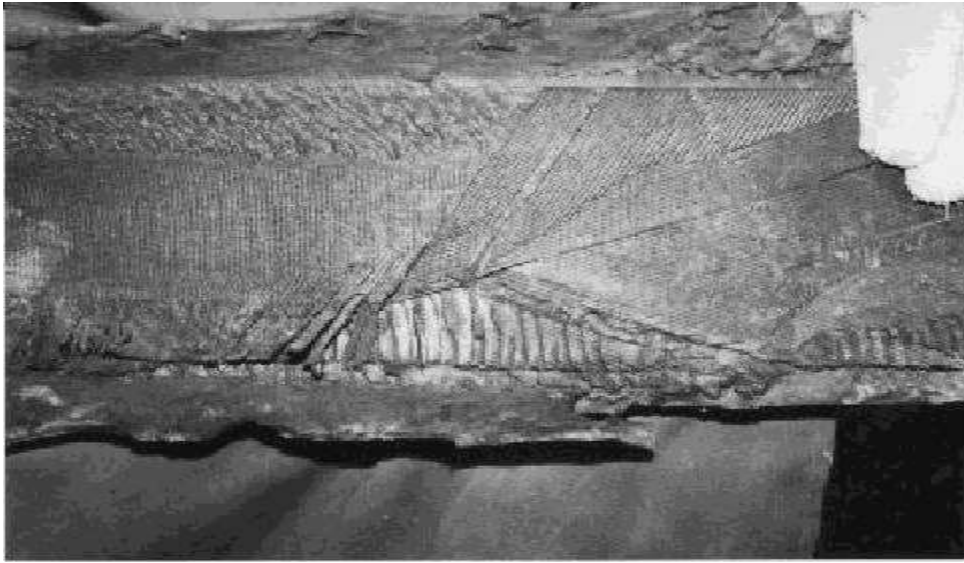
Figure 24: Improper / Missed Repair

A missed nail hole or improperly filled repair during the retreading process can lead to failure of the retread tire. Air or moisture in the hole interferes with the bonding process, and is evident from the rusted belt plies in this sample fragment (Figure 24). As the operating tire is subjected to heat and pressure, the new rubber separates from the casing along the damaged section. The strips of ply material in the highlighted area show the direction of this separation.

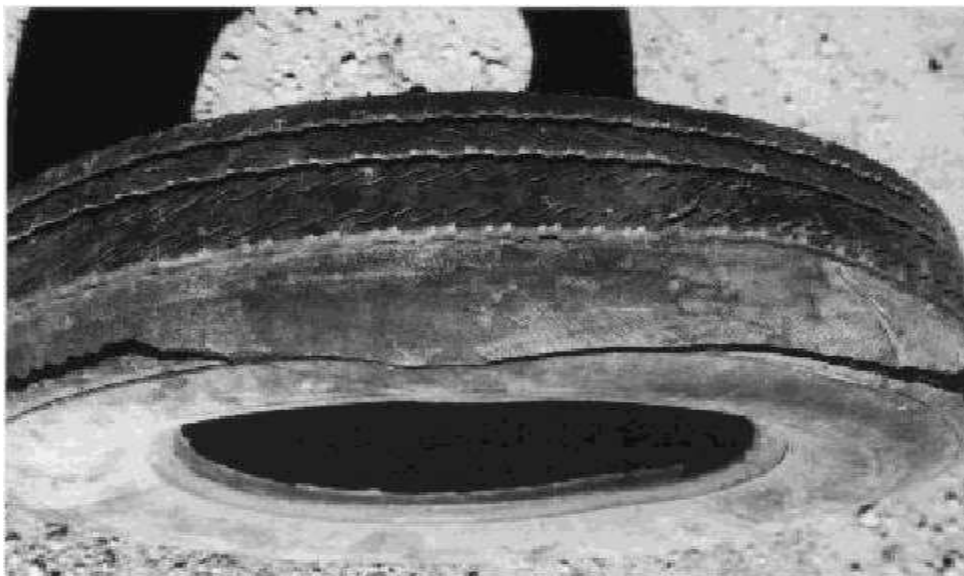
Figure 25: Bond Failure - Tread Leaving Casing

Bond failures do not occur solely in retreaded tires. In Figure 25, an original light truck tire tread has separated from the casing, most likely due to manufacturing error.

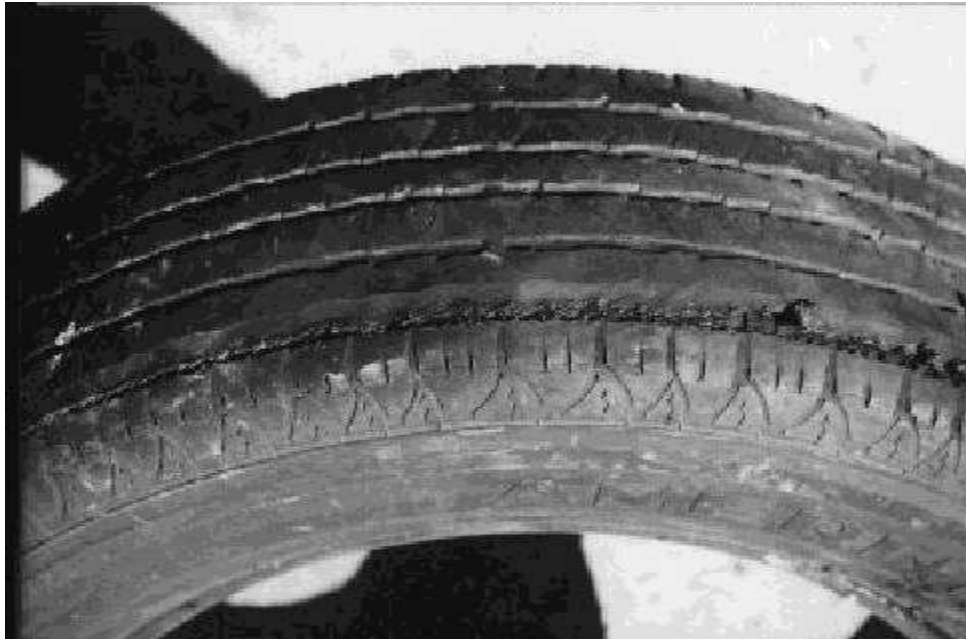
Figure 26: Excessive Shoulder Wear

Excessive wear, generally defined as tread depth of less than $\frac{2}{32}$ ", is a common maintenance problem on all types of tires. In the case of irregular excessive wear, such as that shown in Figure 26, improper alignment or tire mounting and mismatched tires can all cause rapid wear in a particular section of the tire.

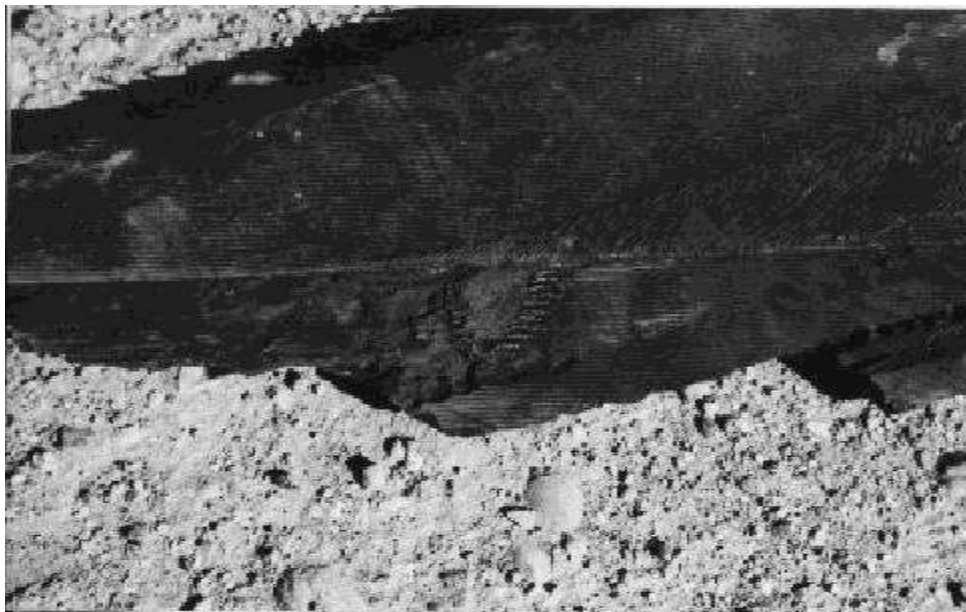
Figure 27: Improper Repair

Different types of tire damage require different repairs. Failure to perform a suitable repair can lead to repair failure under normal operating conditions, as shown in Figure 27.

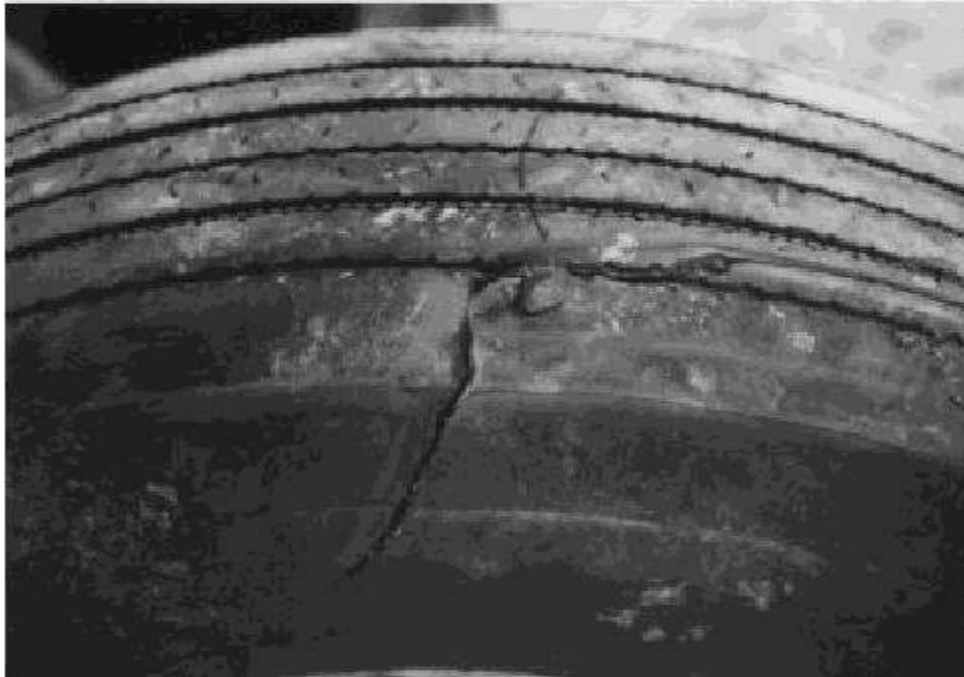
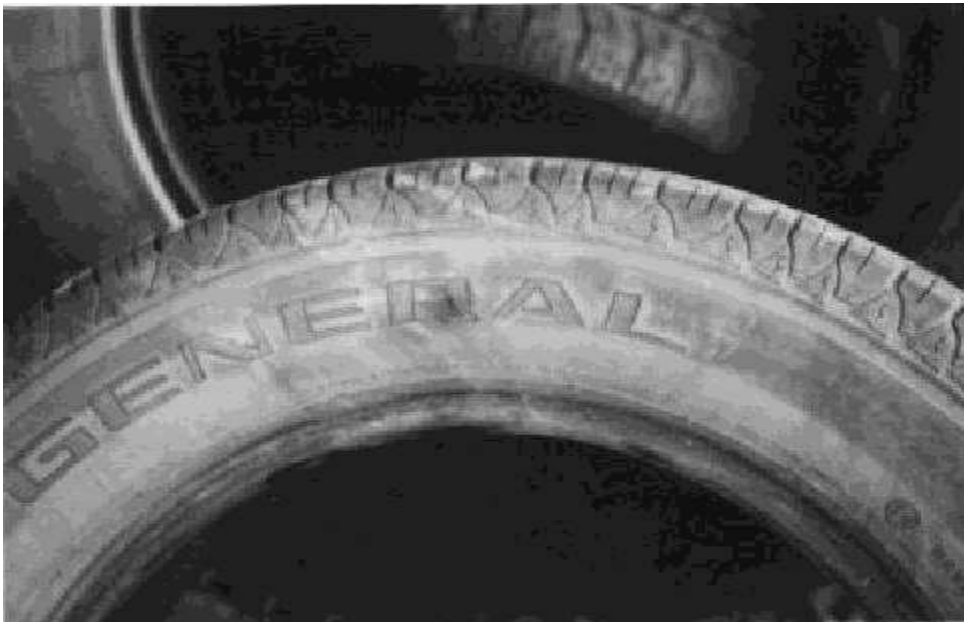
Figures 28 and 29: Sidewall Impact Breaks

Sidewall impacts as shown in Figures 28 and 29 are generally difficult to repair and result in rapid air loss. Both of these examples are larger truck tires, which may have been damaged by striking curbs in congested areas.

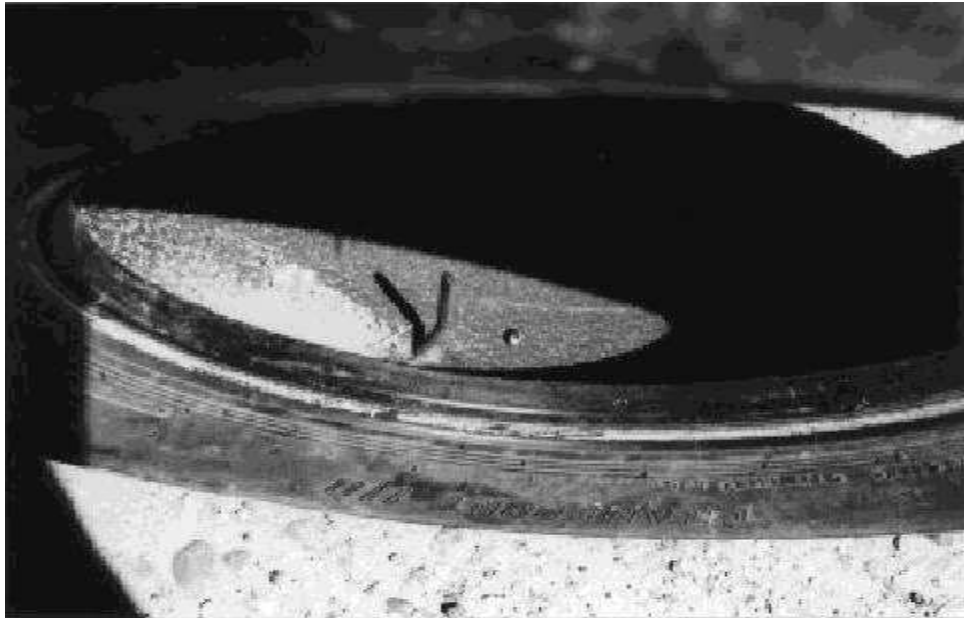
Figures 30 and 31: Road Hazard - Puncture(s)

Tires can often be run for extended periods with small punctures, as evident in the lower photo. In cases of small puncture(s), tire wear tends to occur gradually as a result of slow air loss and under-inflation. The punctures do not cause the tire to fail, but accelerate inflation problems that, if not addressed, will eventually lead to tire failure. In other cases, as seen in the top figure, punctures can be of sufficient size to induce tire failure directly.

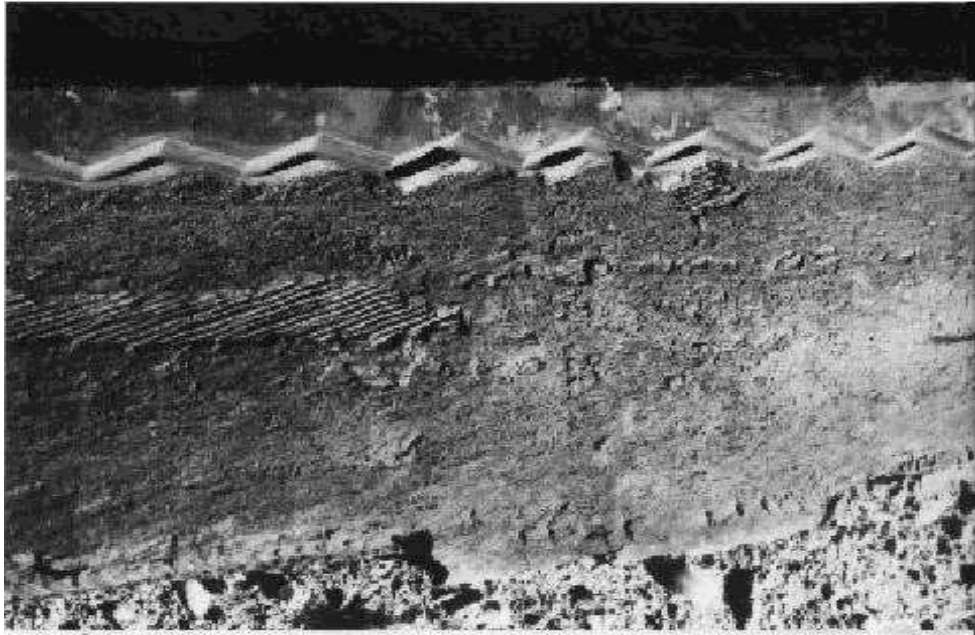
Figure 32 shows a retread bond failure. The tread rubber has separated cleanly from the casing, without wire ply belts. The rough surface patches indicate a rubber-to-rubber separation.

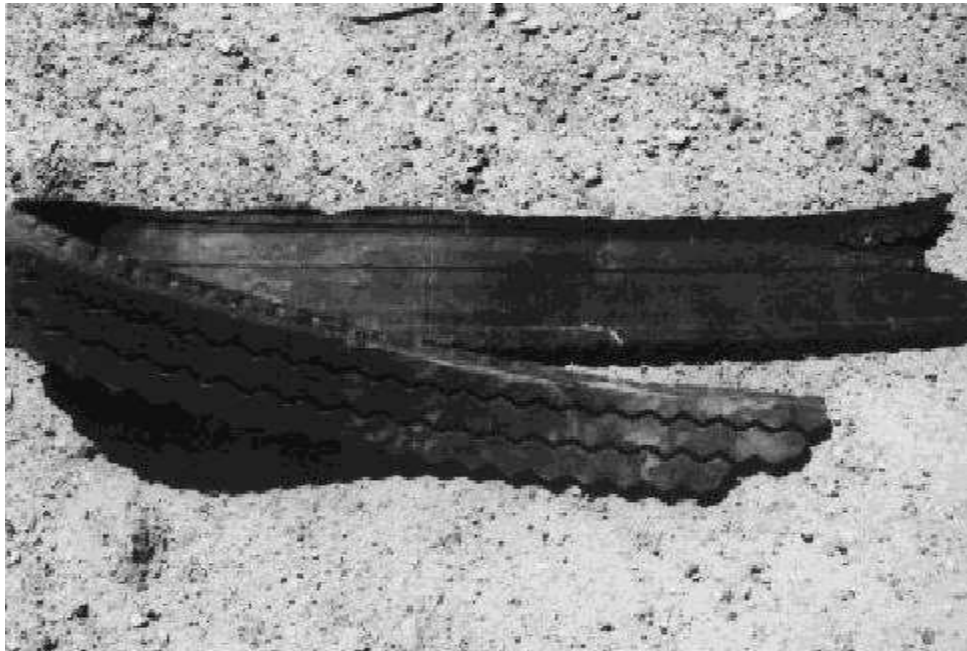
Figure 33 is a retread tire shred that contains no wire belting materials, consistent with a retread bond failure and a clean separation of tread rubber from casing materials. Darker patches exhibit bluing of rubber caused by excessive heat during tire failure.

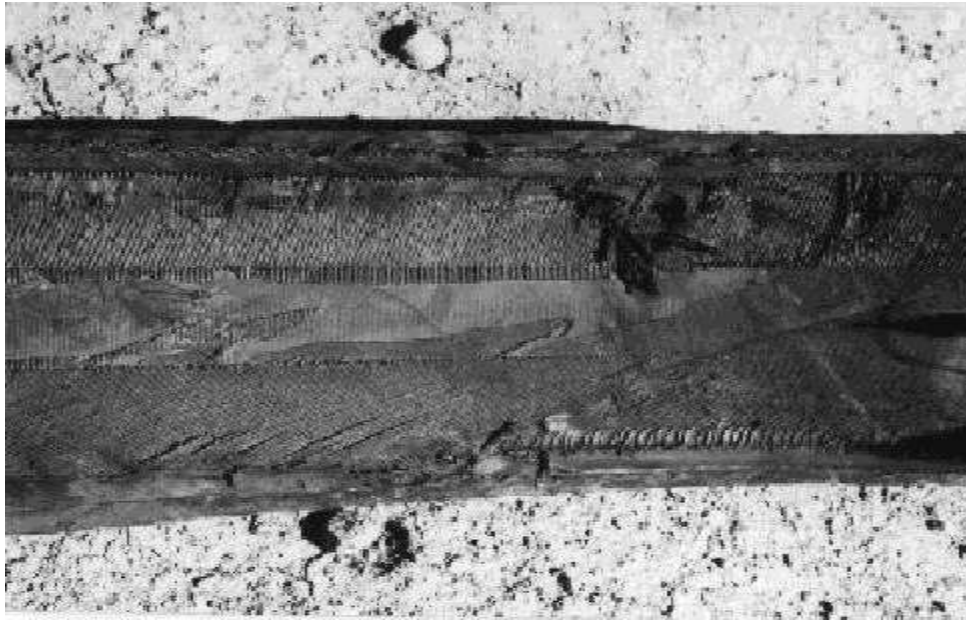
Figure 34: Under-inflation

The fragments in Figures 34 and 35 exhibit diagonal separation of belt plies, indicating separation between two belt layers. This condition is commonly associated with under-inflation, as heat and friction between the flexing belts leads to separation along the angle of the belting material. Another common symptom of under-inflation, "Belt Leaving Casing," is distinguished by belt separation at an angle perpendicular to the direction of travel, consistent with failure along radial plies that are configured in this fashion.
