Reference / Project: RAL1002.011 Fayetteville State Veterans Home Roof Repairs/Replacement
Amendment #03 Emergency Repair Design

Subject: Report of Existing Conditions for Owner's Immediate Response

RAL1002.011 Fayetteville State Veterans Homes - EMERGENCY LIFE SAFETY AND INFRASTRUCTURAL UPGRADES

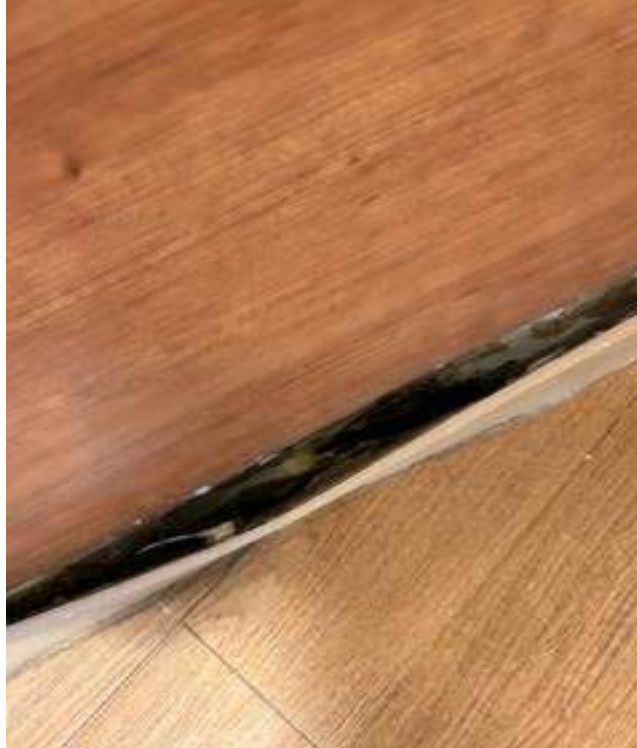
Visible mold growth behind cove base at kitchen hallway. Sample VET-S-01

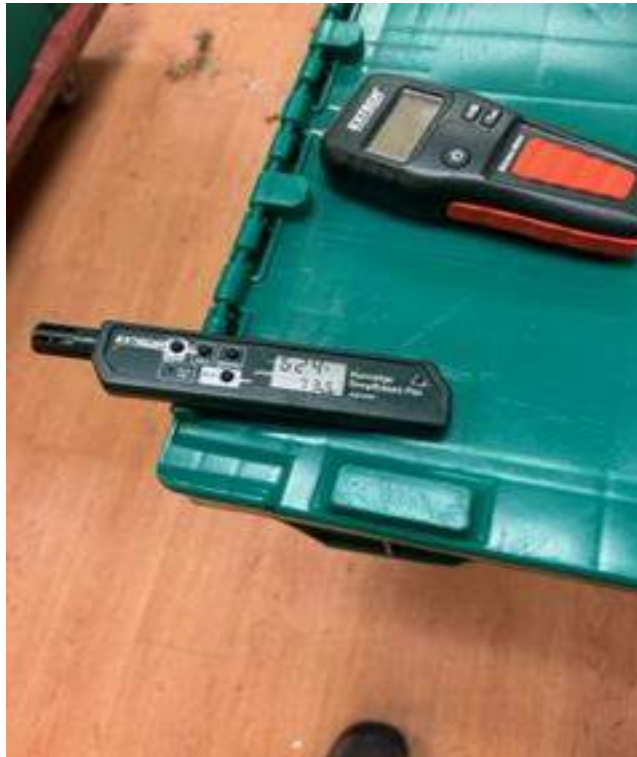
Elevated relative humidity levels measured in the conference room. Elevated relative humidity levels were measured throughout the facility.

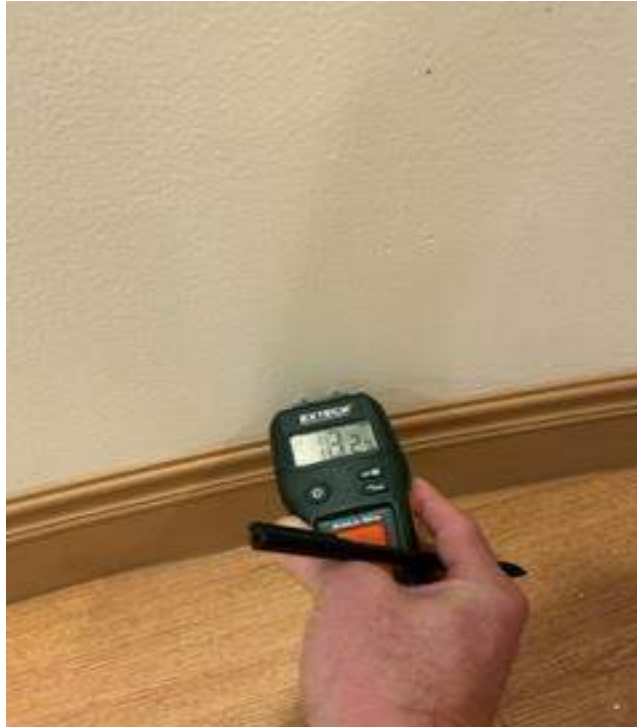
Elevated moisture levels (>16% moisture) measured in the hallway. Elevated moisture levels were observed throughout the facility.

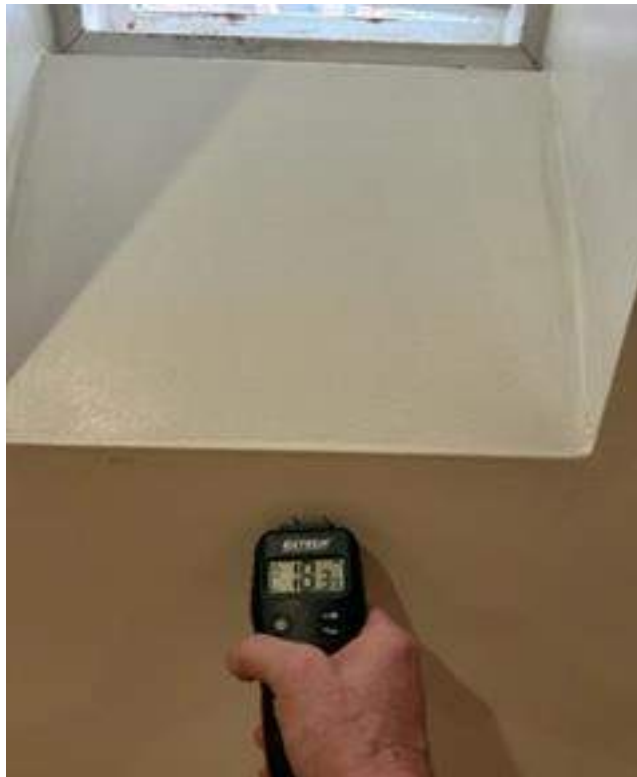
Elevated moisture levels (>16% moisture) measured in the hallway associated with windows throughout the facility.

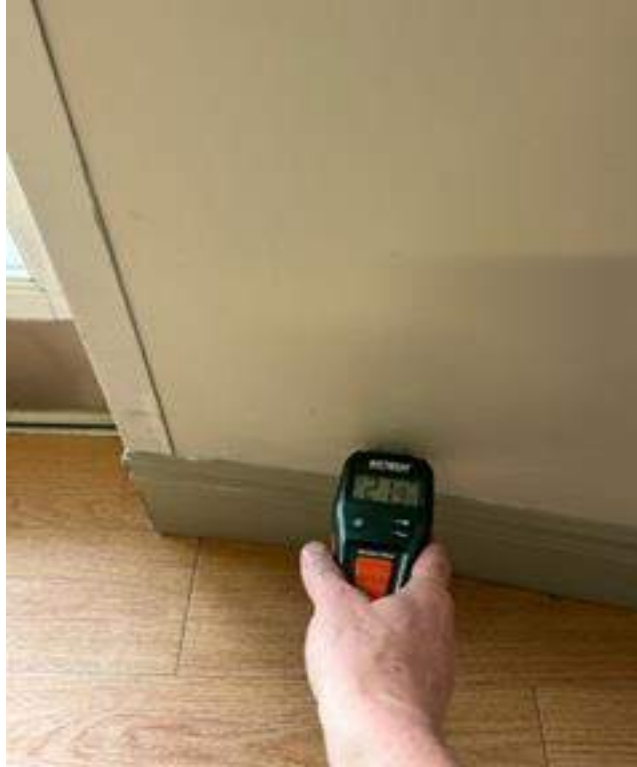
Typical of elevated moisture readings associated with entrance doors and lower walls throughout the facility.

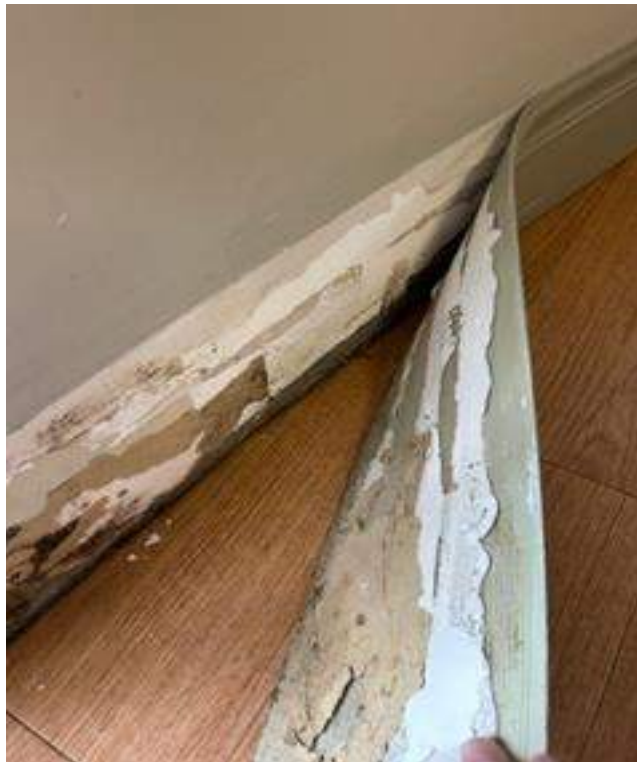
Typical of visible mold growth observed on drywall and cove base throughout the facility.

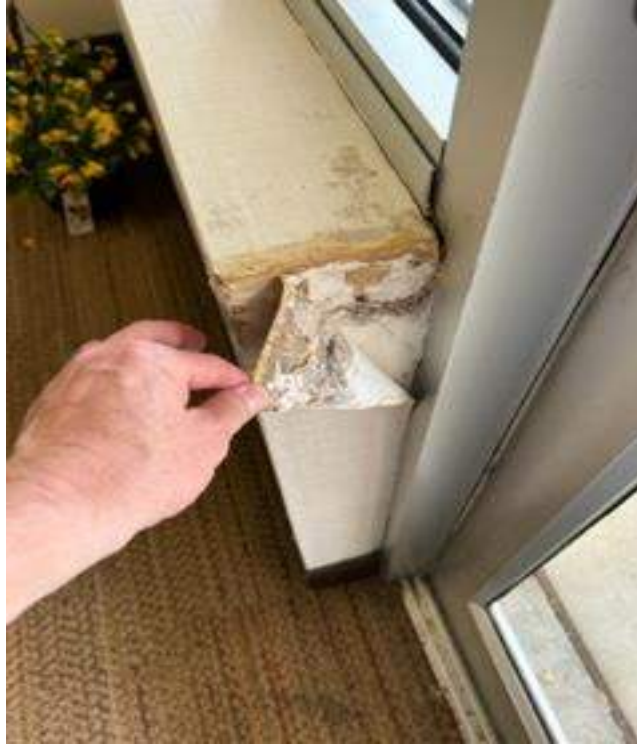
Visible mold growth behind wallcoverings at exterior windows and doors.

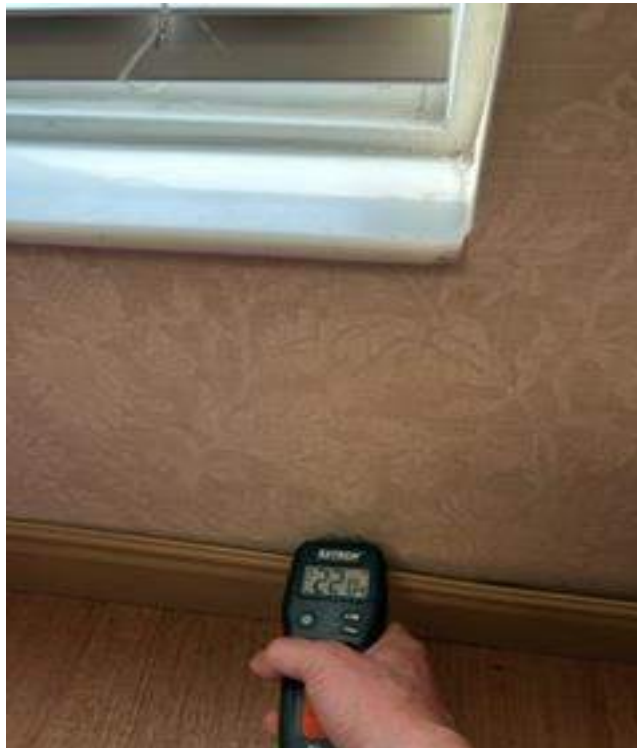
Elevated moisture levels measured in hallway associated with windows throughout the facility.

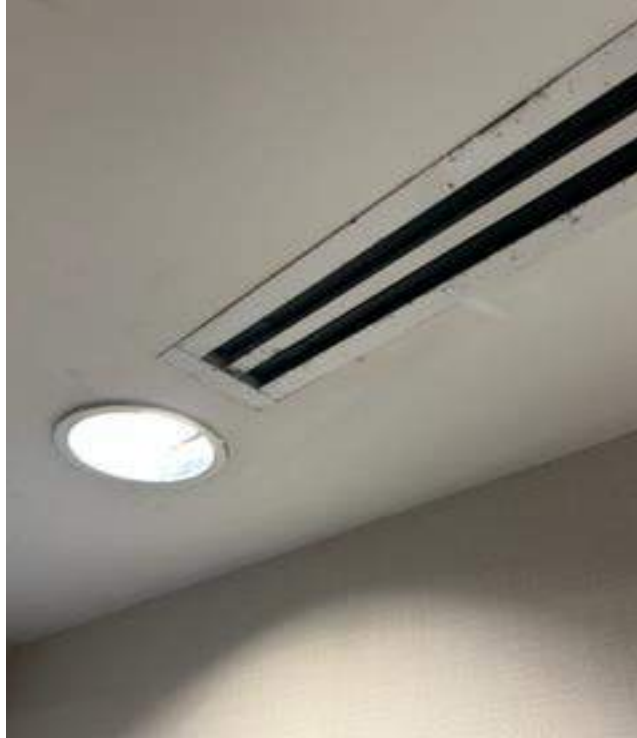
Typical of visible mold growth observed on supply diffusers throughout the facility.

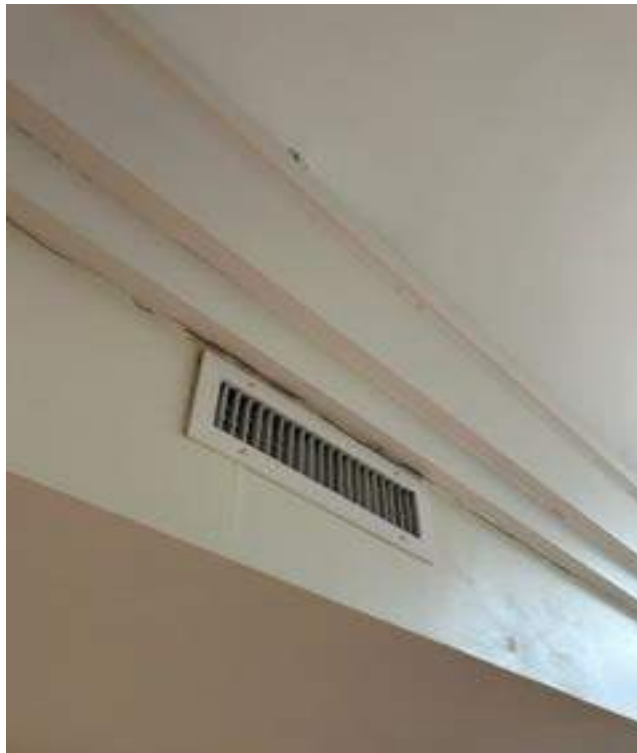
Typical of visible mold growth observed on supply diffusers throughout the facility.

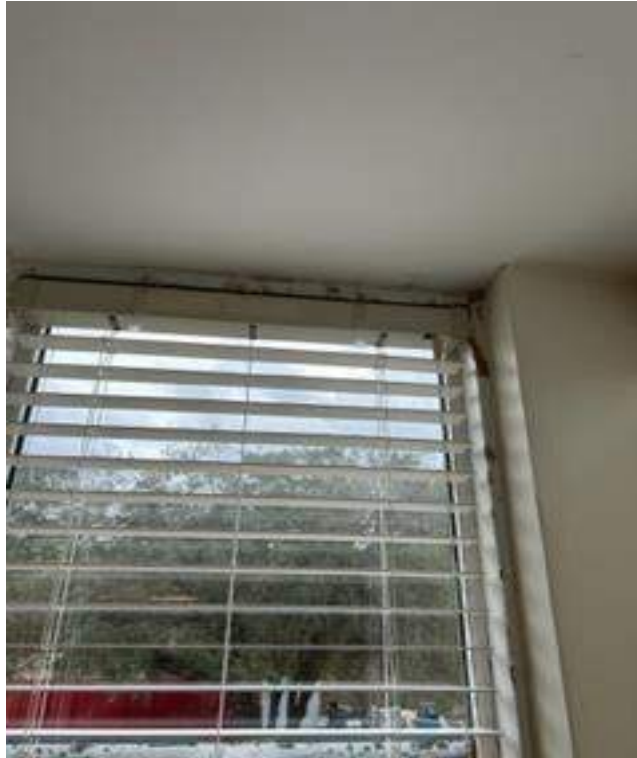
Visible water damage observed associated with window.

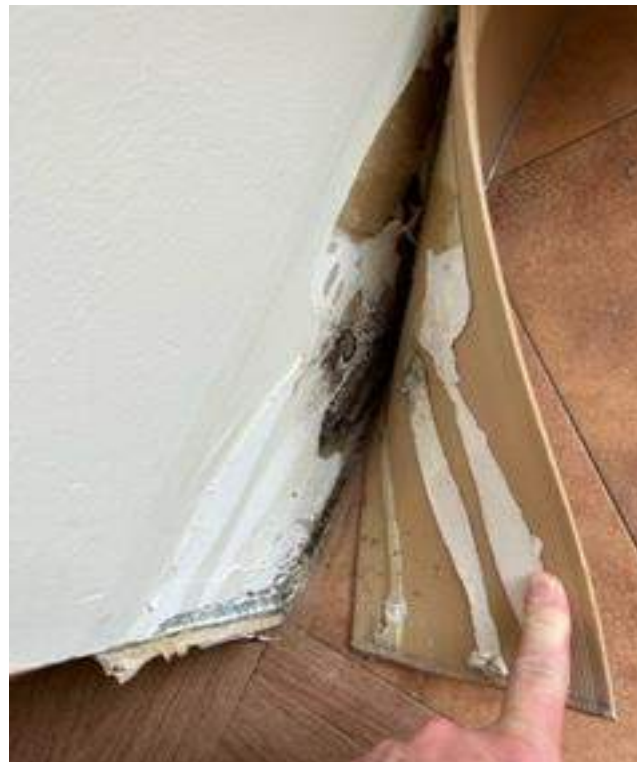
Typical of visible mold growth located behind vinyl cove base throughout the facility.

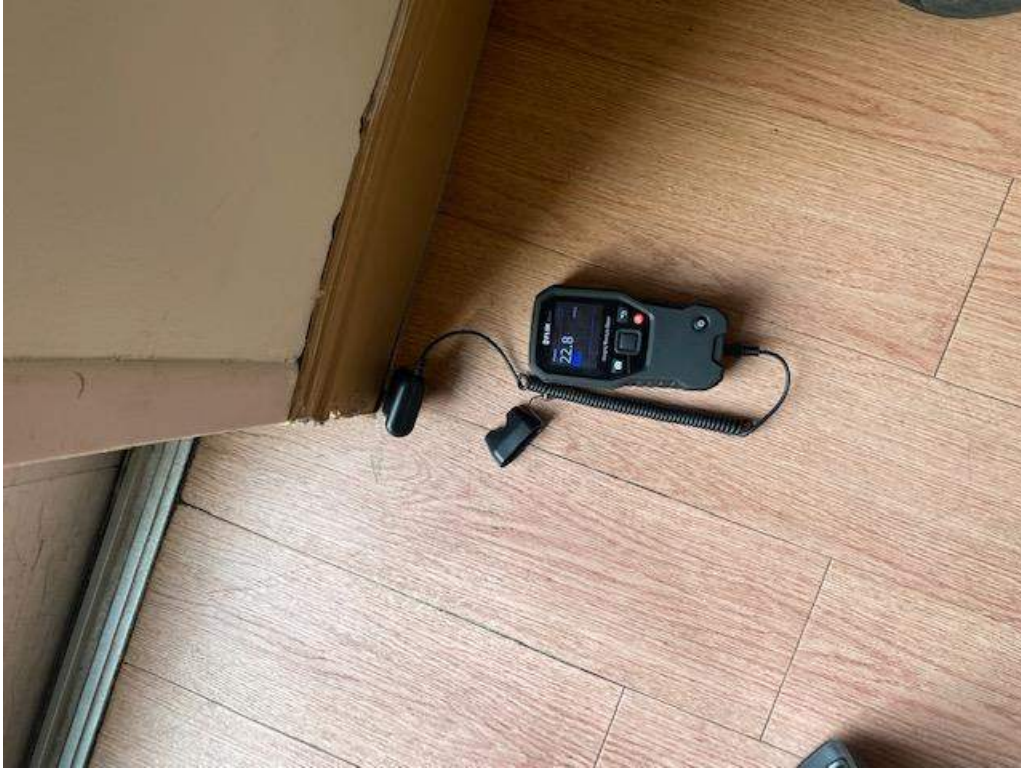
Water intrusion detected under flooring in Core Hall near door.

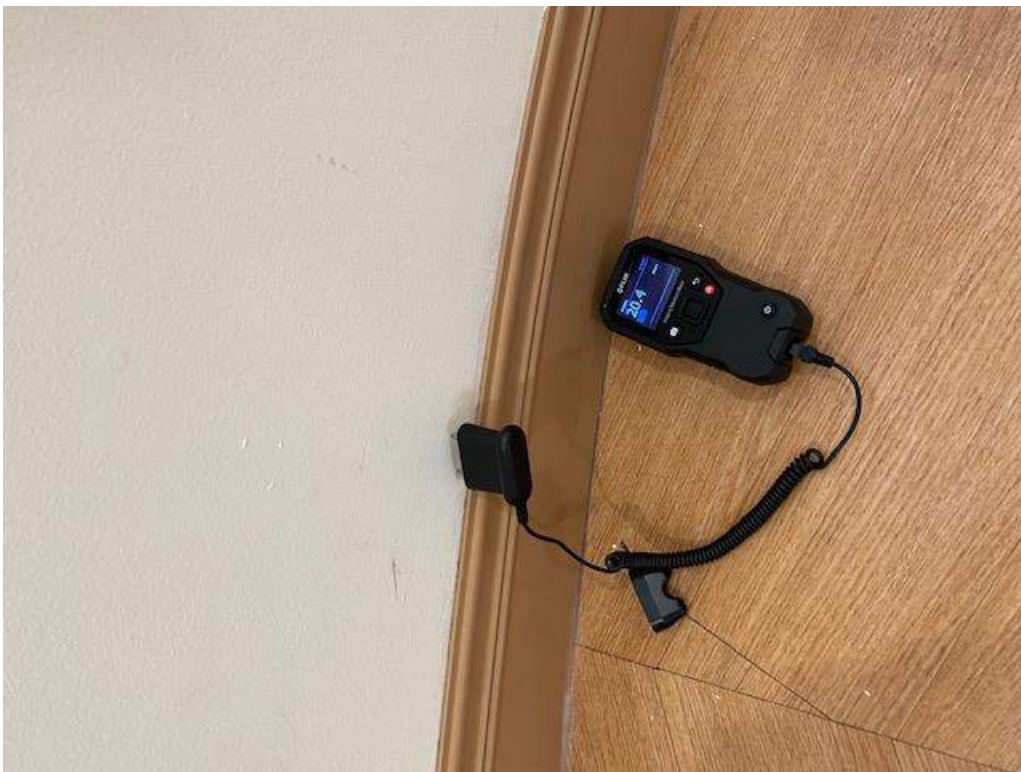
Water intrusion detected drywall in Core Hall near Bravo Wing.

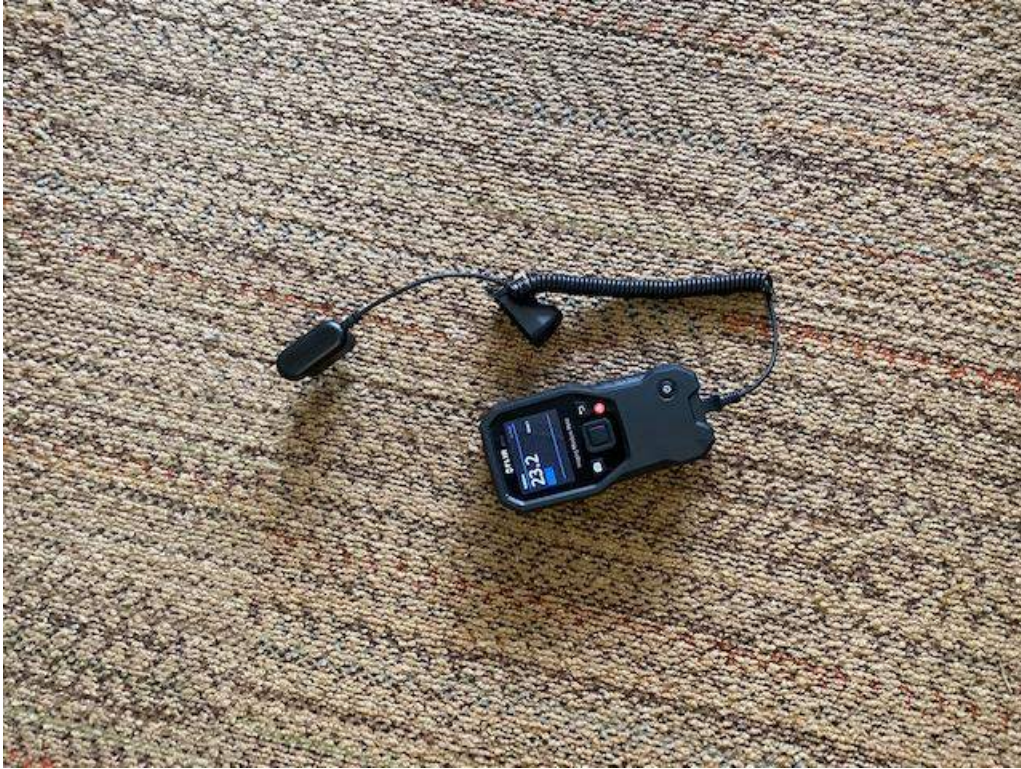
Water intrusion detected under flooring in Entry Hall near lobby.

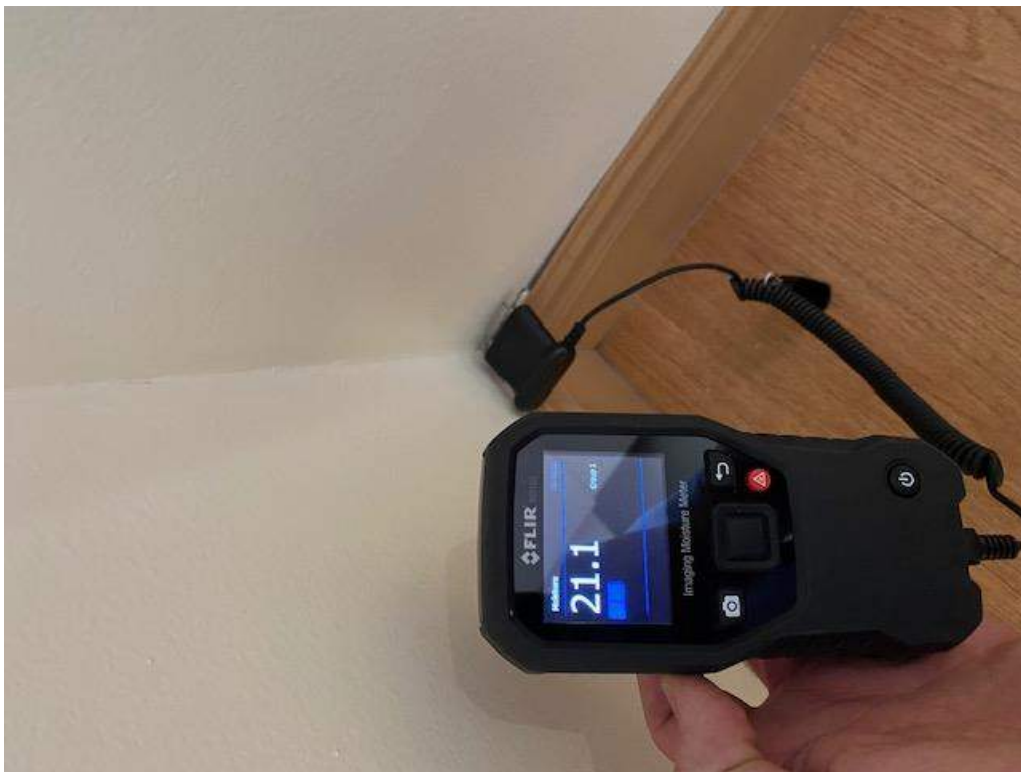
Water intrusion detected in drywall in Core Hall near kitchen.

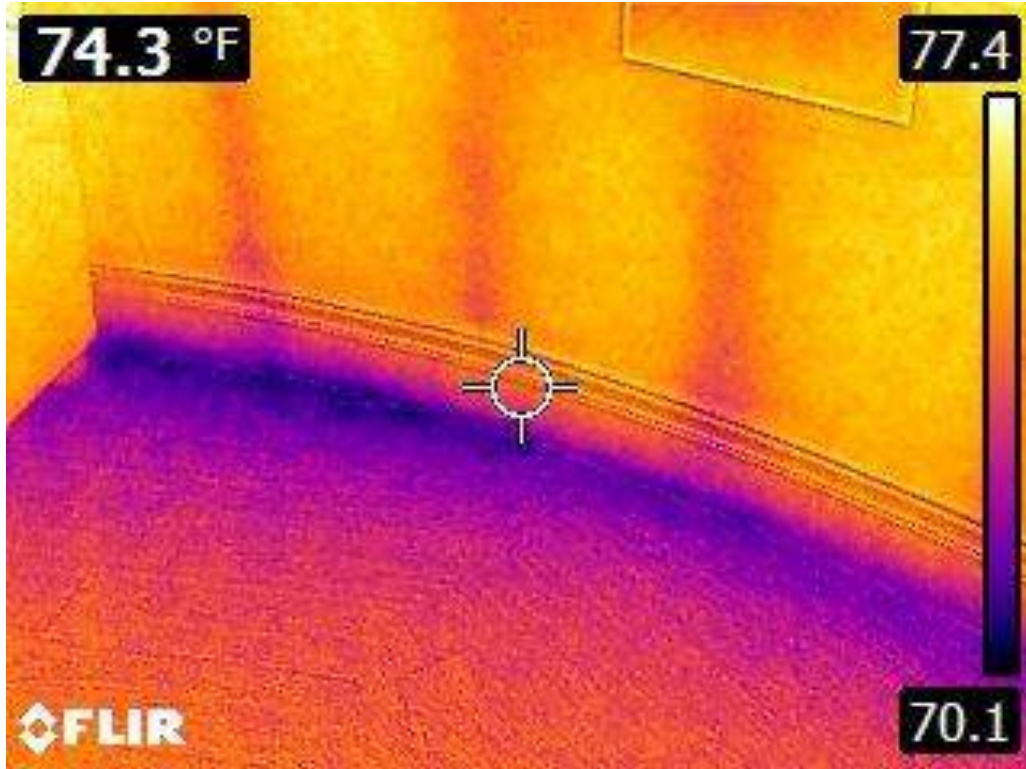
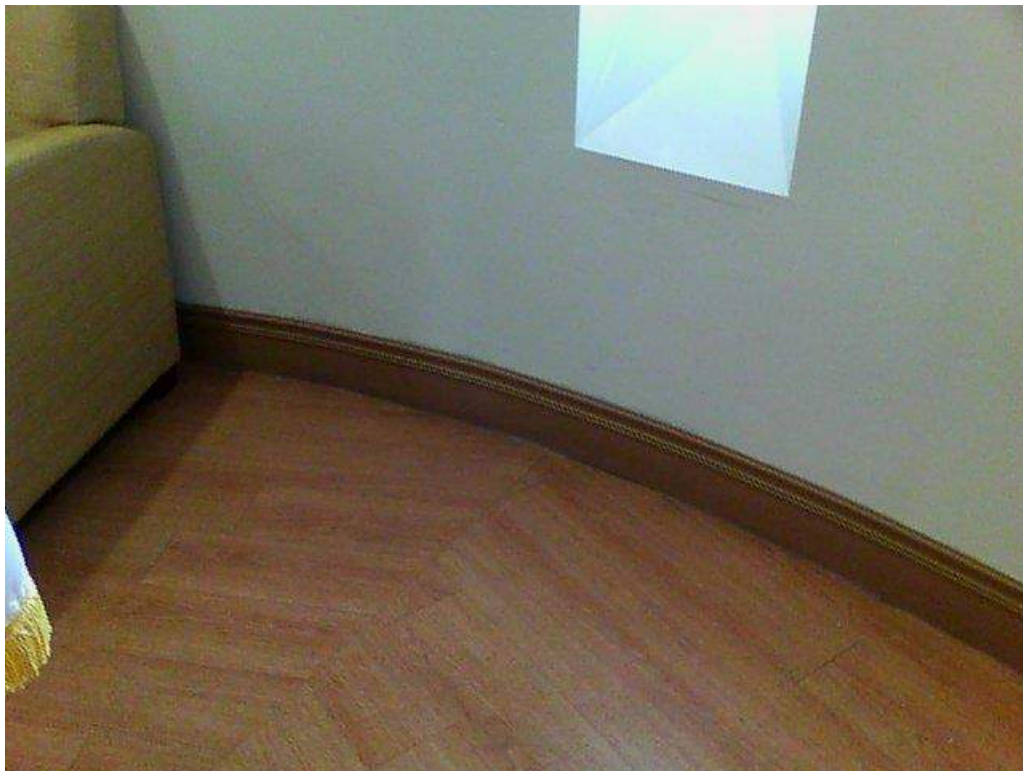
Photograph of image above, located in Core Hall near Bravo Wing.

Infrared image of drywall and flooring with indications of water intrusion.

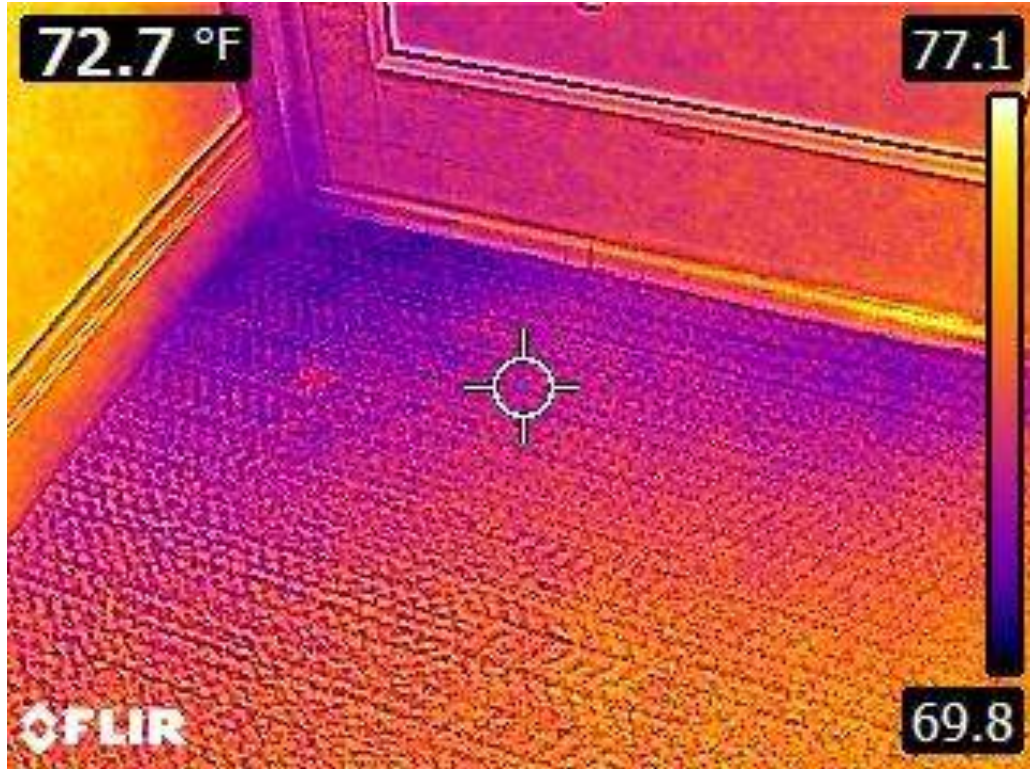
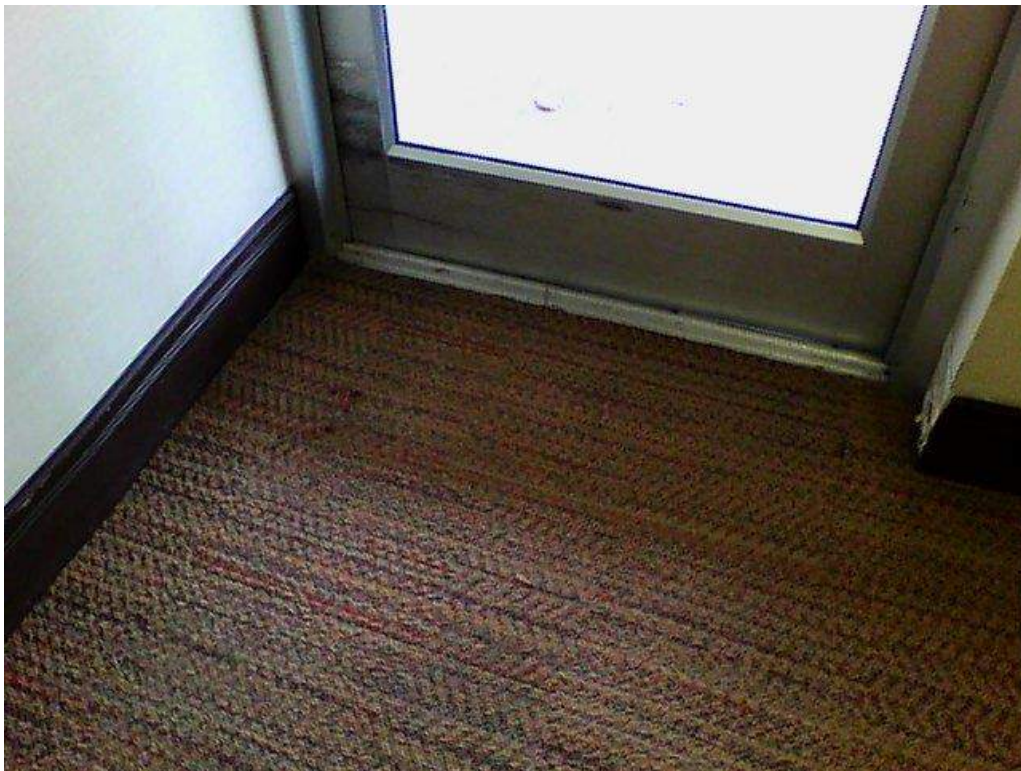
Photograph of image above, located in Entry Hall near Lobby.

Infrared image of drywall and flooring with indications of water intrusion.

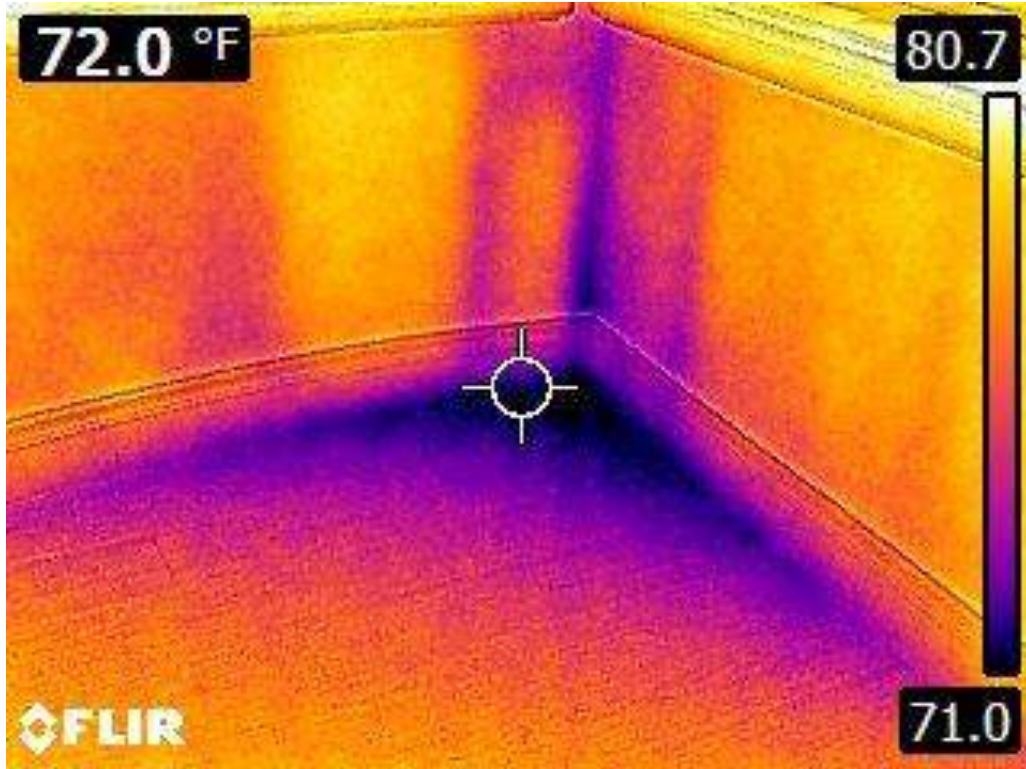
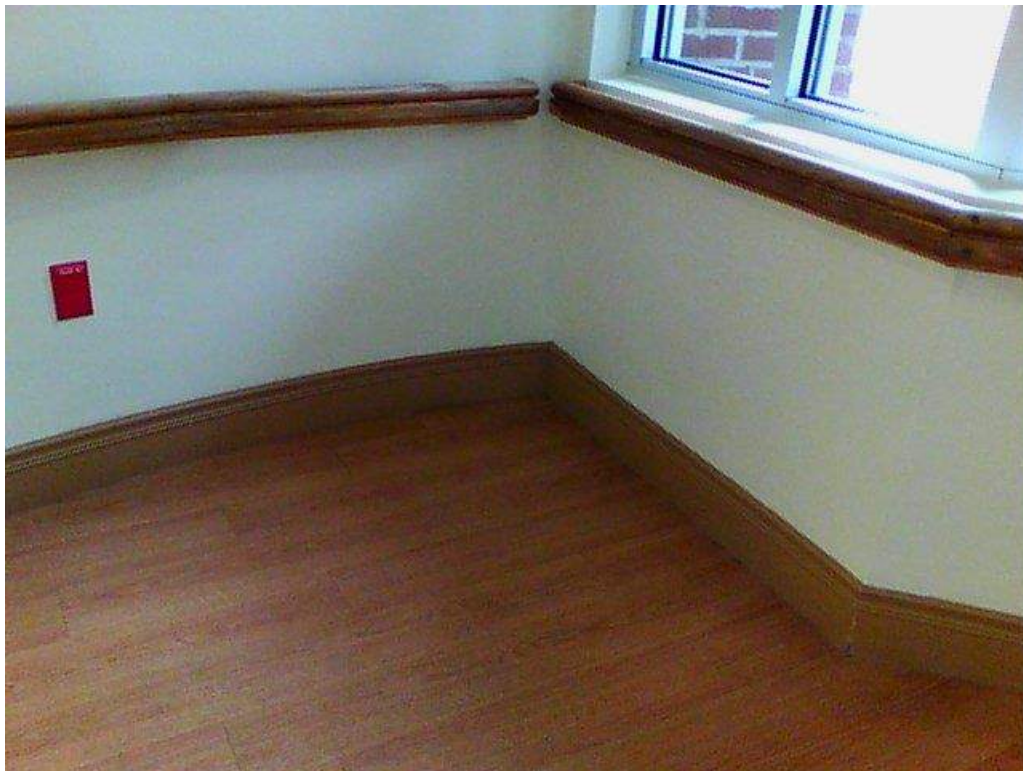
Photograph of image above, located in Core Hall near side entry.

Infrared image of drywall and flooring with indications of water intrusion.

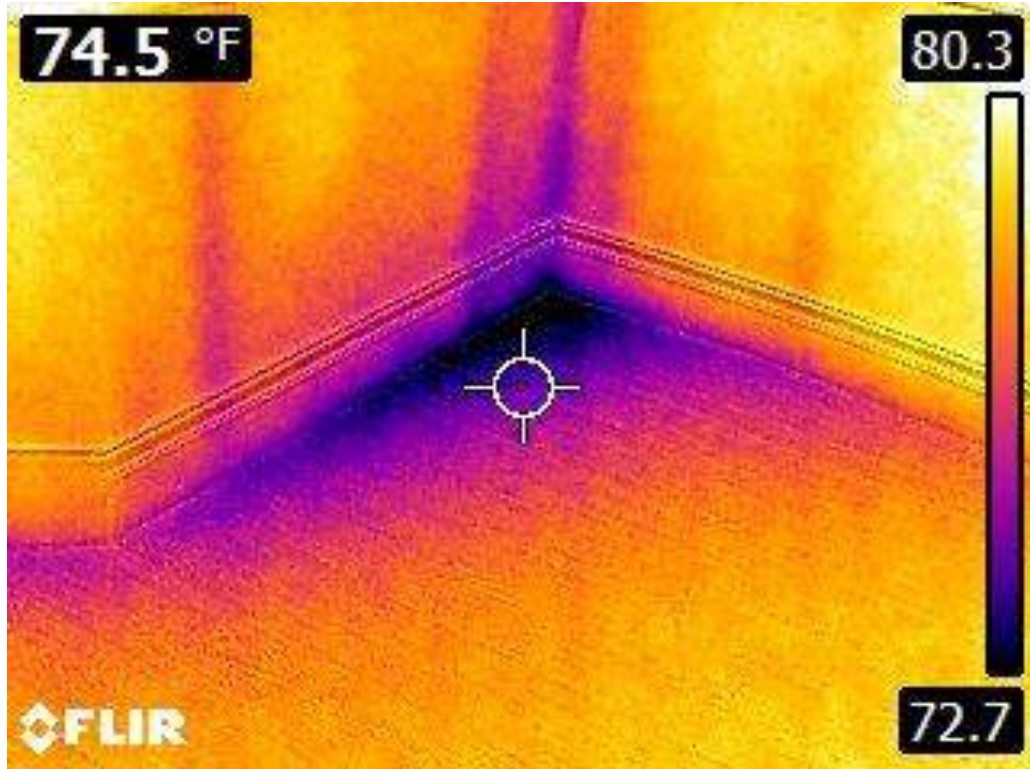
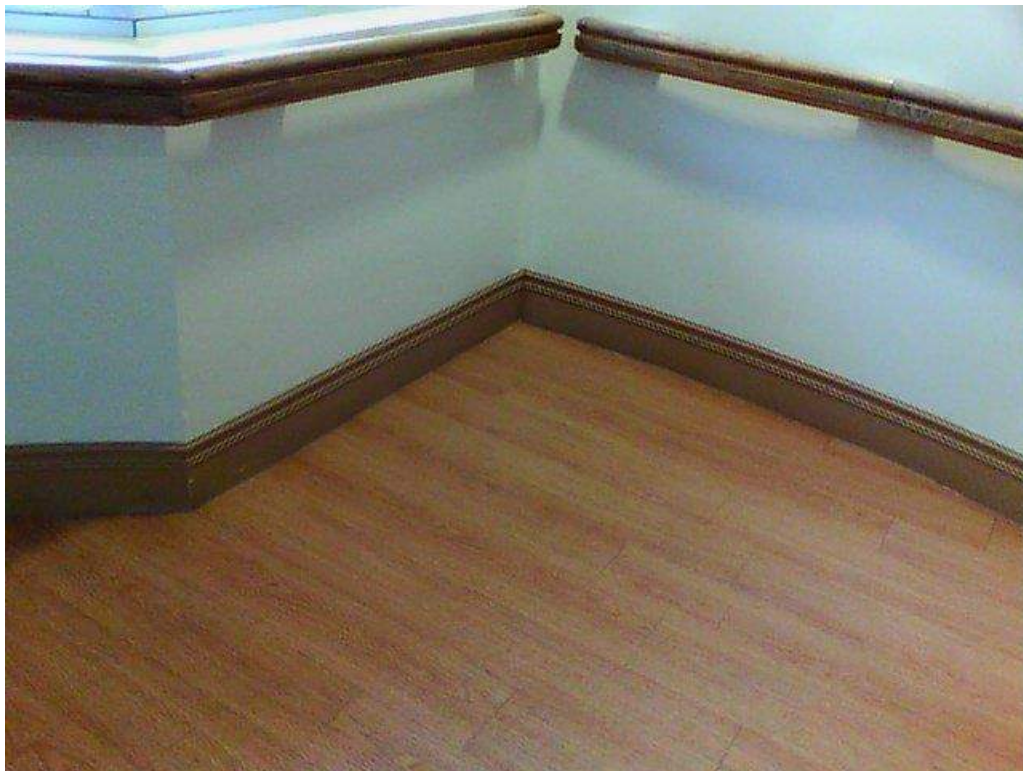
Photograph of image above, located in Core Hall under windows.

Infrared image of drywall and flooring with indications of water intrusion.

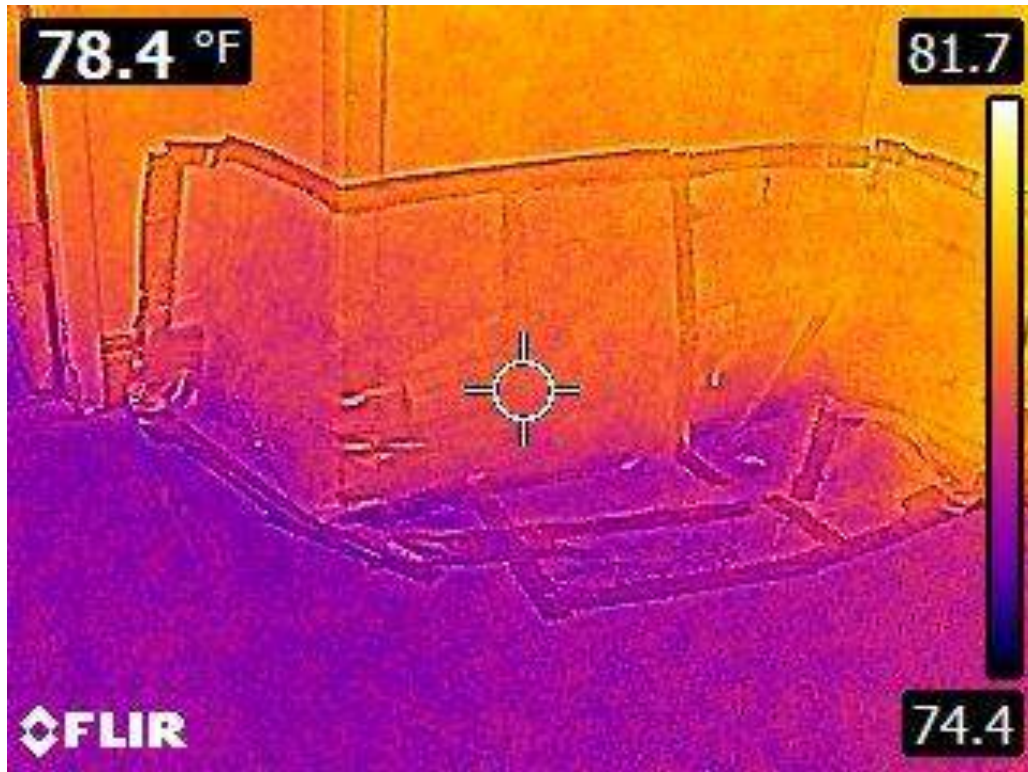
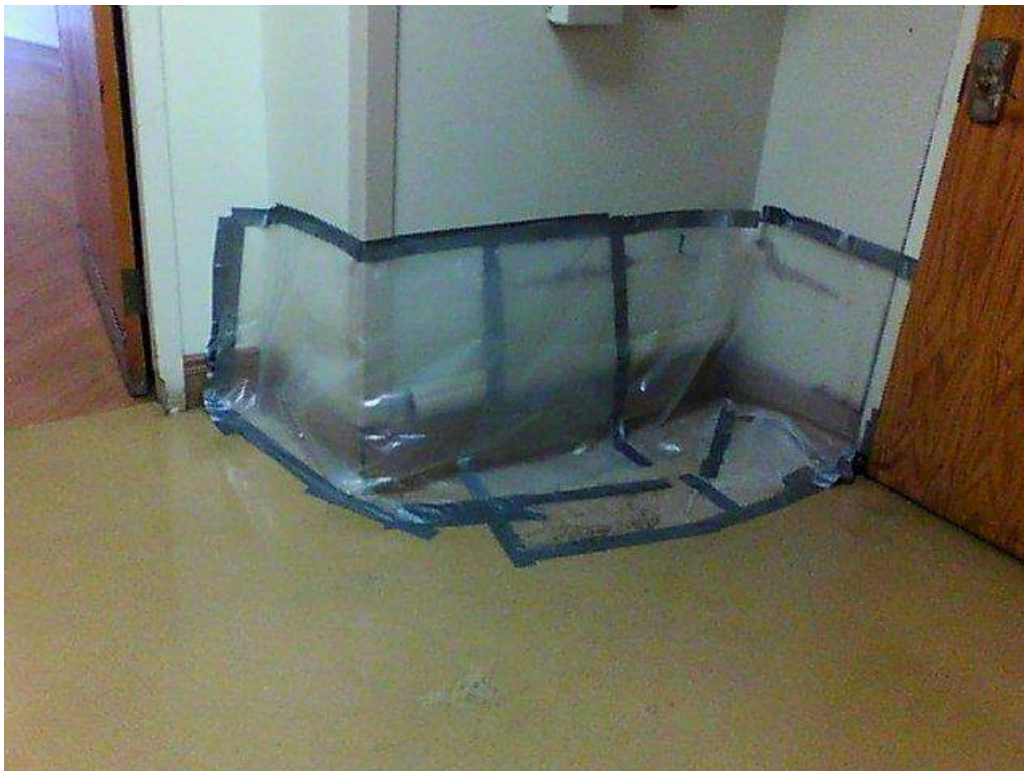
Photograph of image above, located in Core Hall near kitchen.

Infrared image of drywall and flooring with indications of water intrusion.

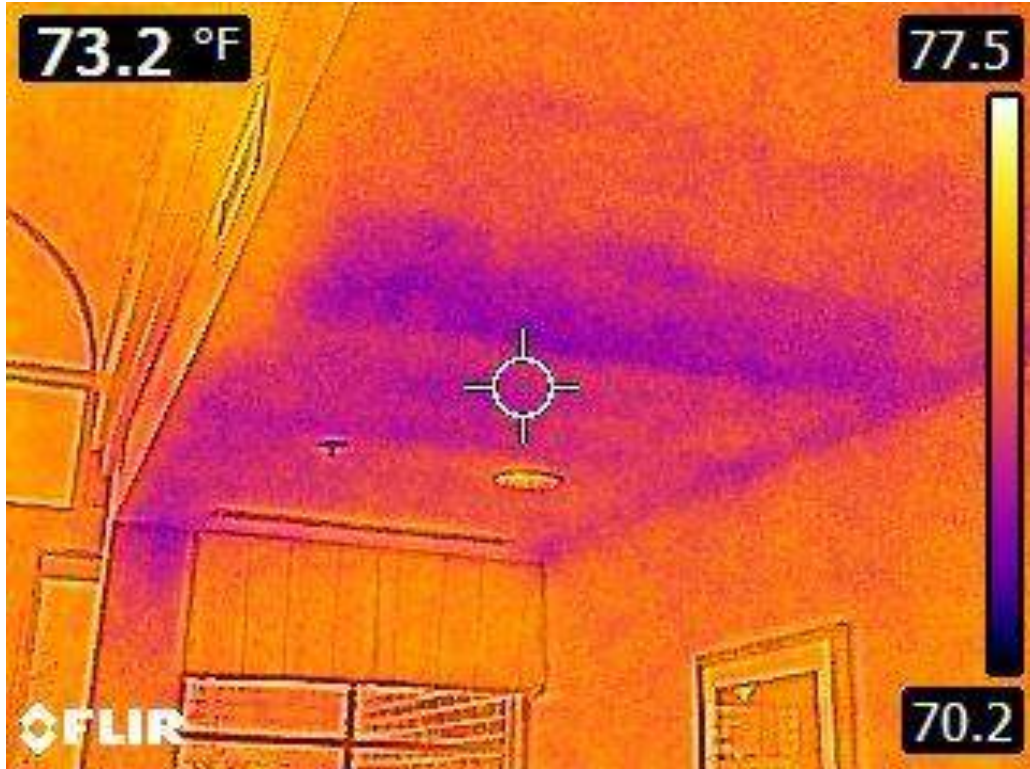
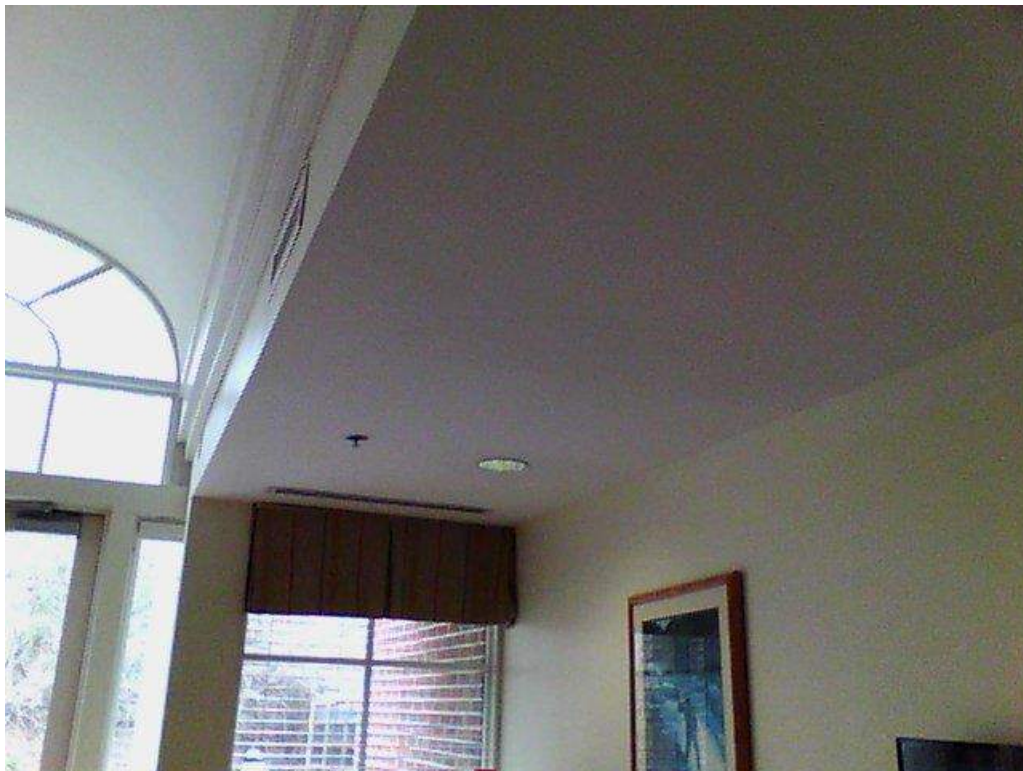
Photograph of image above, located in Alpha Wing.

Infrared image of drywall ceiling with indications of water intrusion.

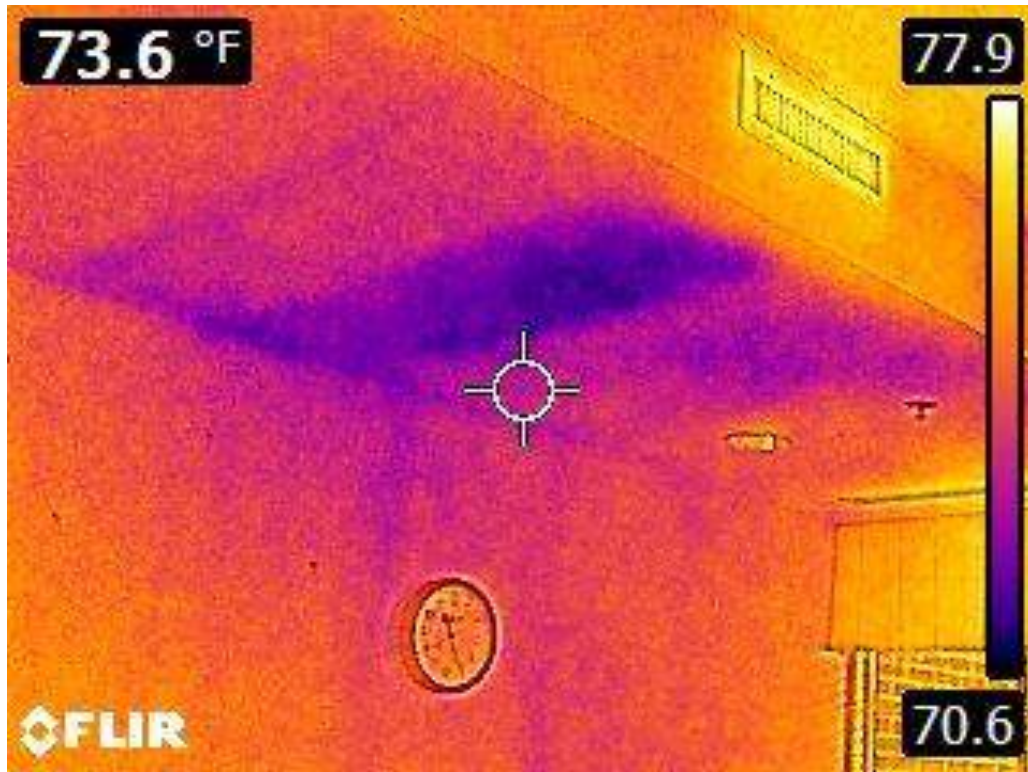
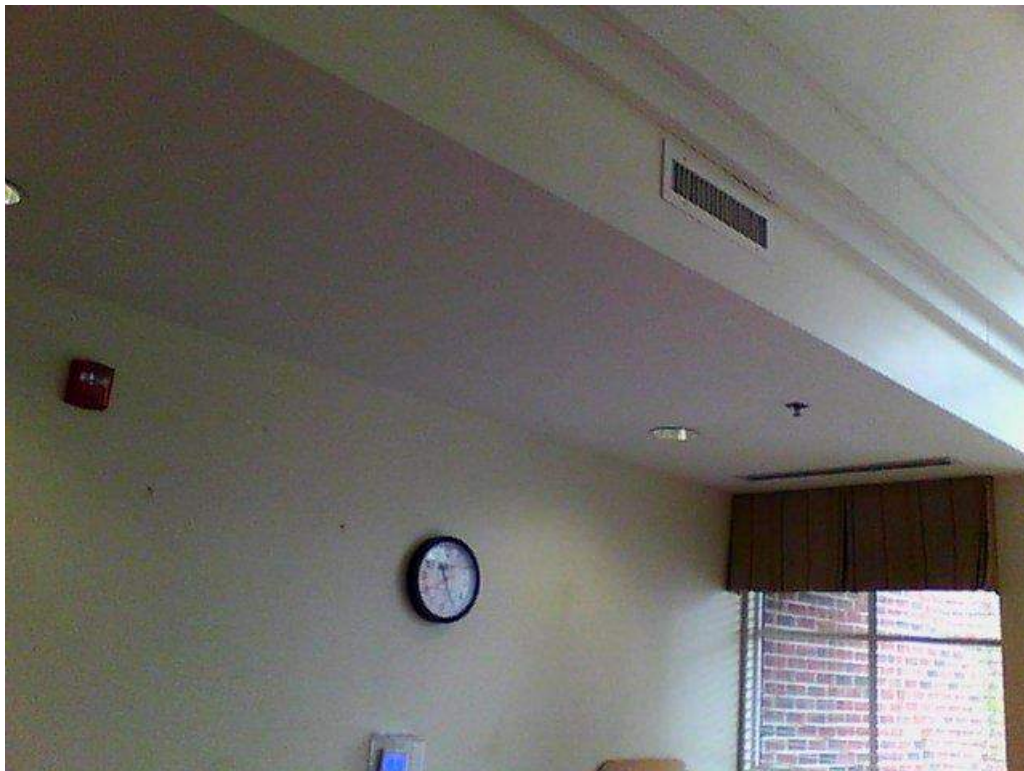
Photograph of image above, located in Alpha Wing.

Infrared image of drywall ceiling with indications of water intrusion.

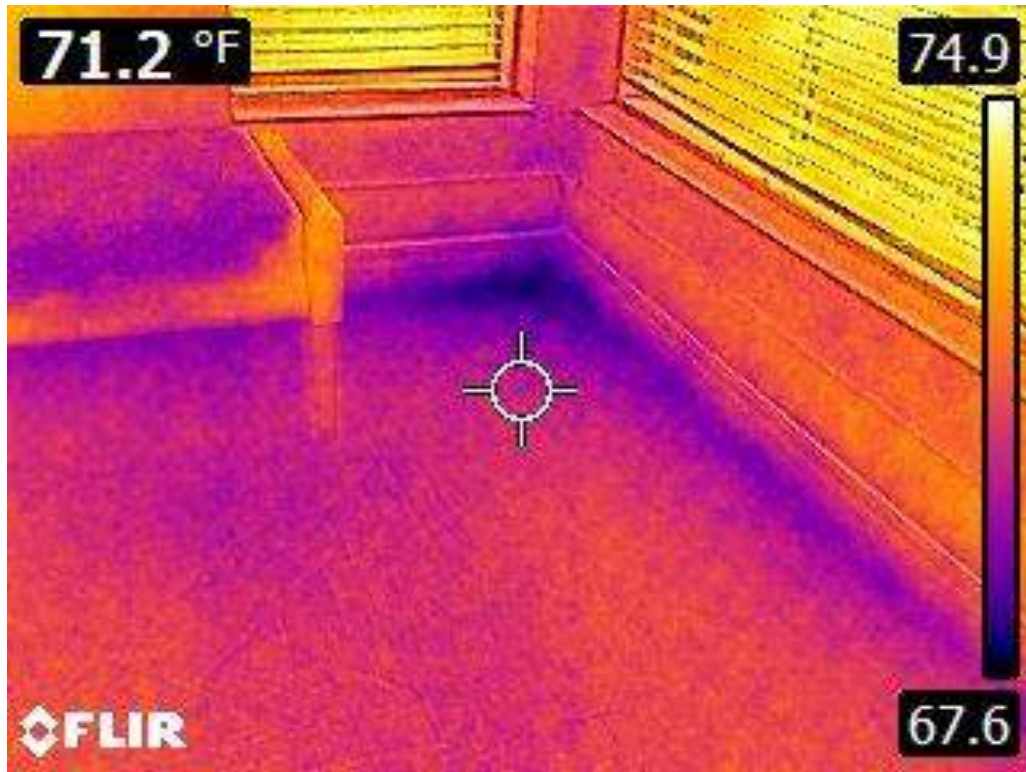
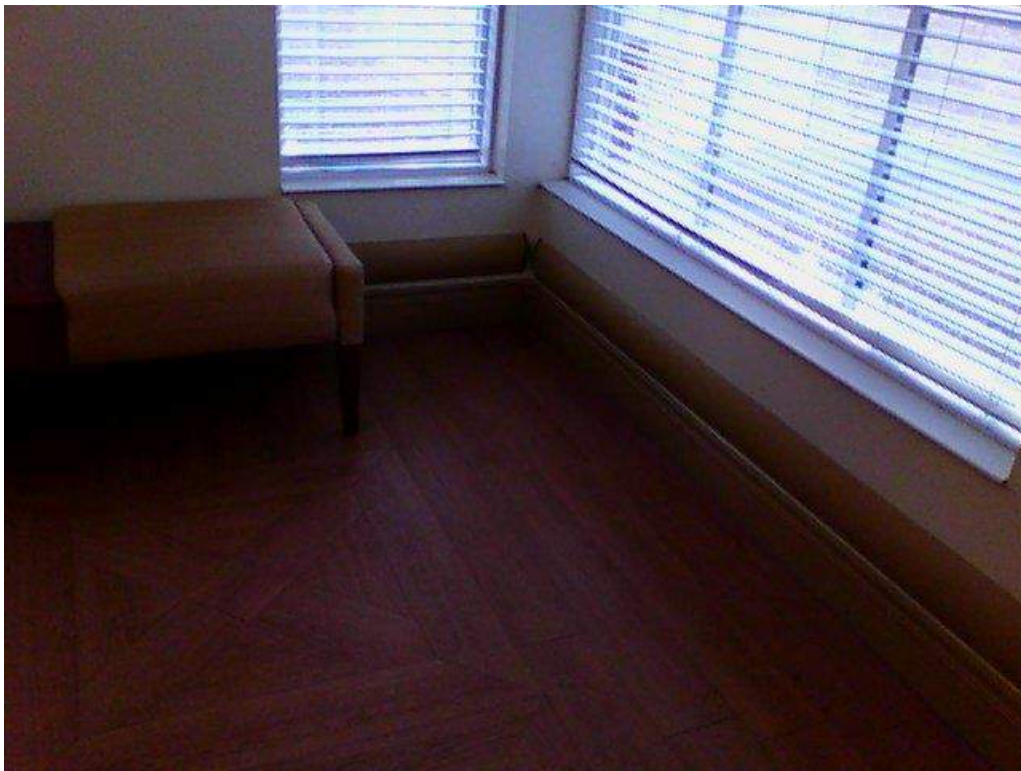
Photograph of image above, located in Alpha Wing.

Infrared image of drywall, flooring, and seat cushion with indications of water intrusion.
