Reference / Project: RAL1002.011 Fayetteville State Veterans Home Roof Repairs/Replacement
Amendment #03 Emergency Repair Design

Subject: Report of Existing Conditions for Owner's Immediate Response

RAL1002.011 Fayetteville State Veterans Homes - EMERGENCY LIFE SAFETY AND INFRASTRUCTURAL UPGRADES

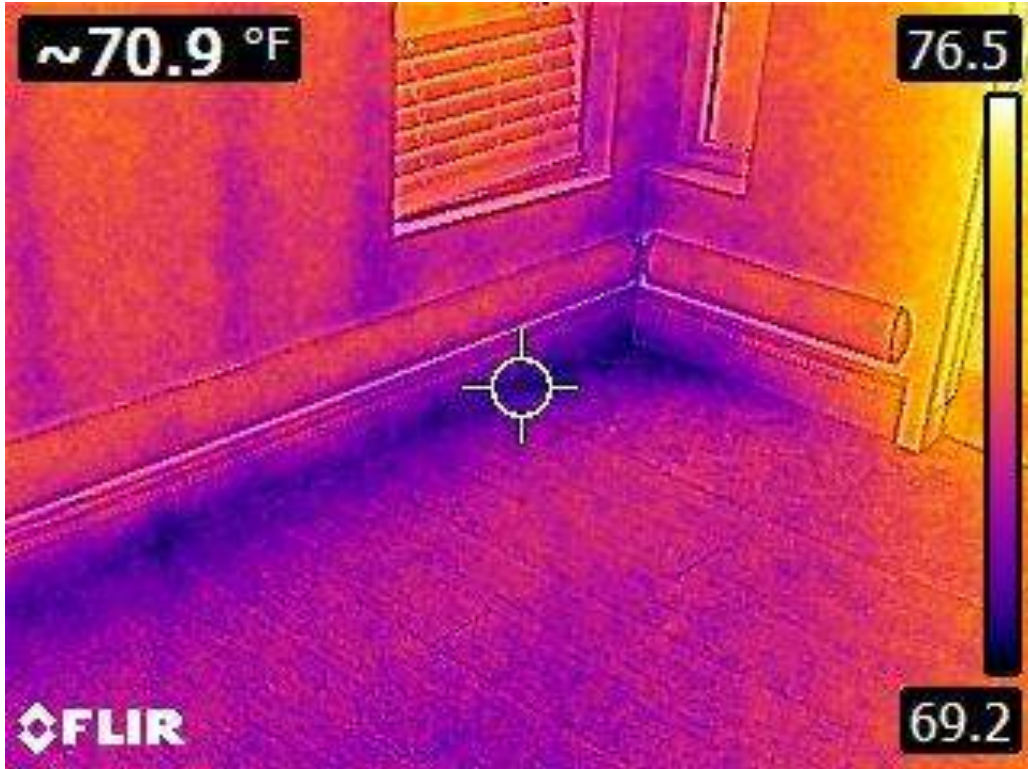
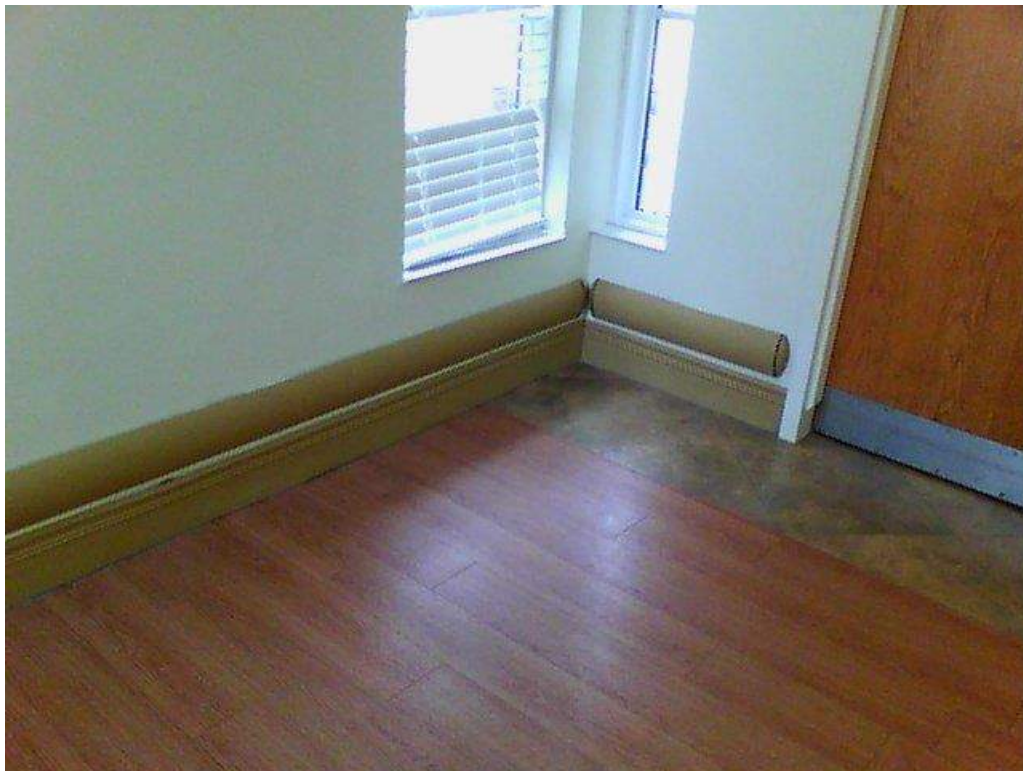
Photograph of image above, located in Bravo Wing.

Infrared image of drywall and flooring with indications of water intrusion.

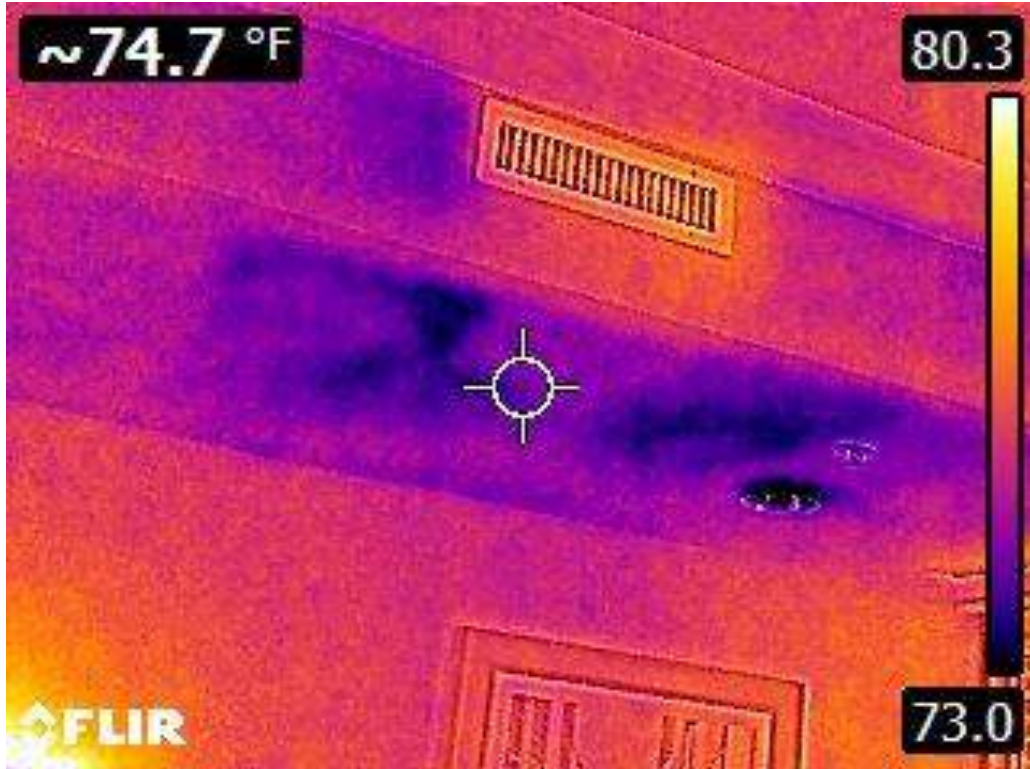
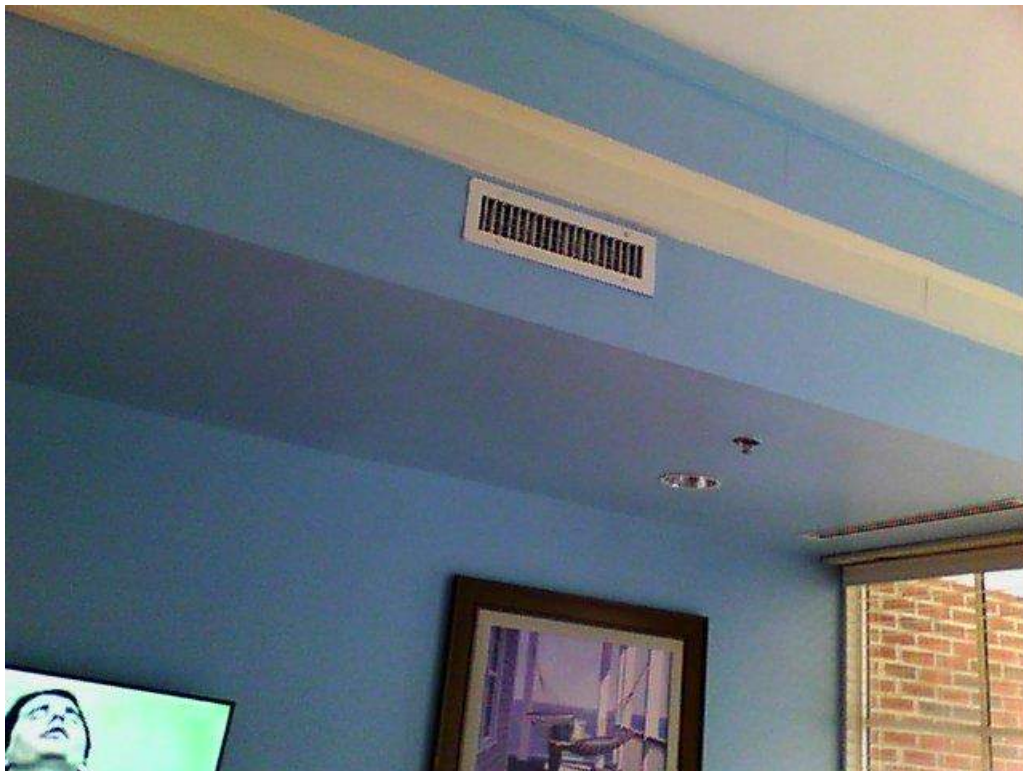
Photograph of image above, located in Bravo Wing.

Infrared image of drywall ceiling with indications of water intrusion.

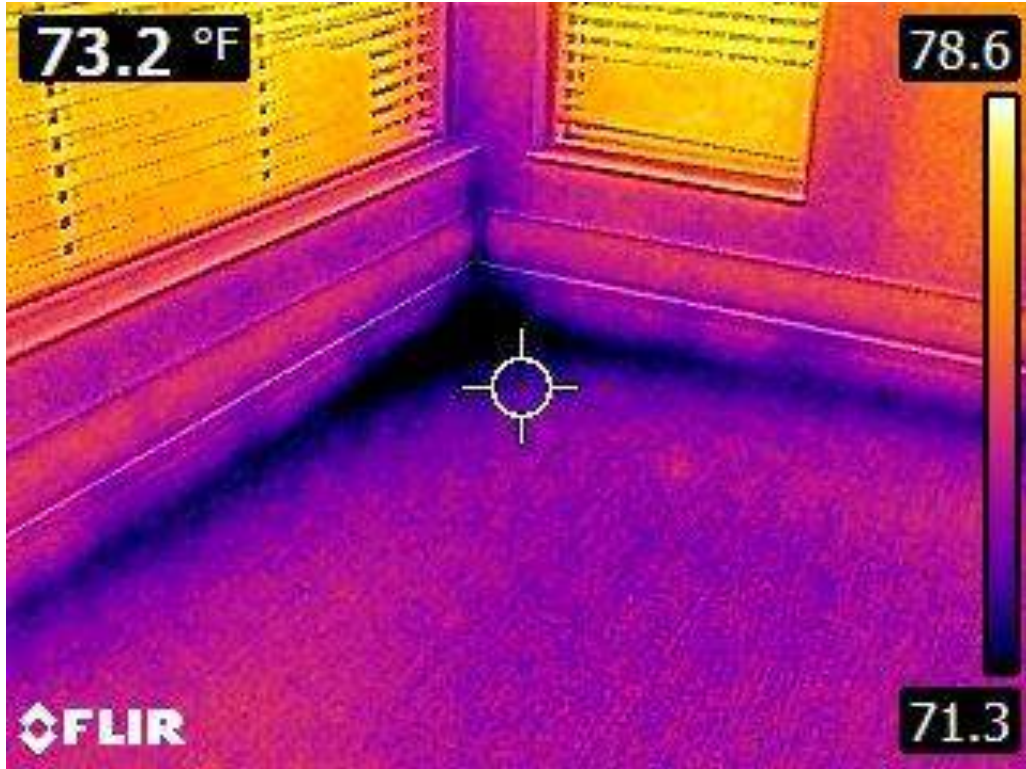
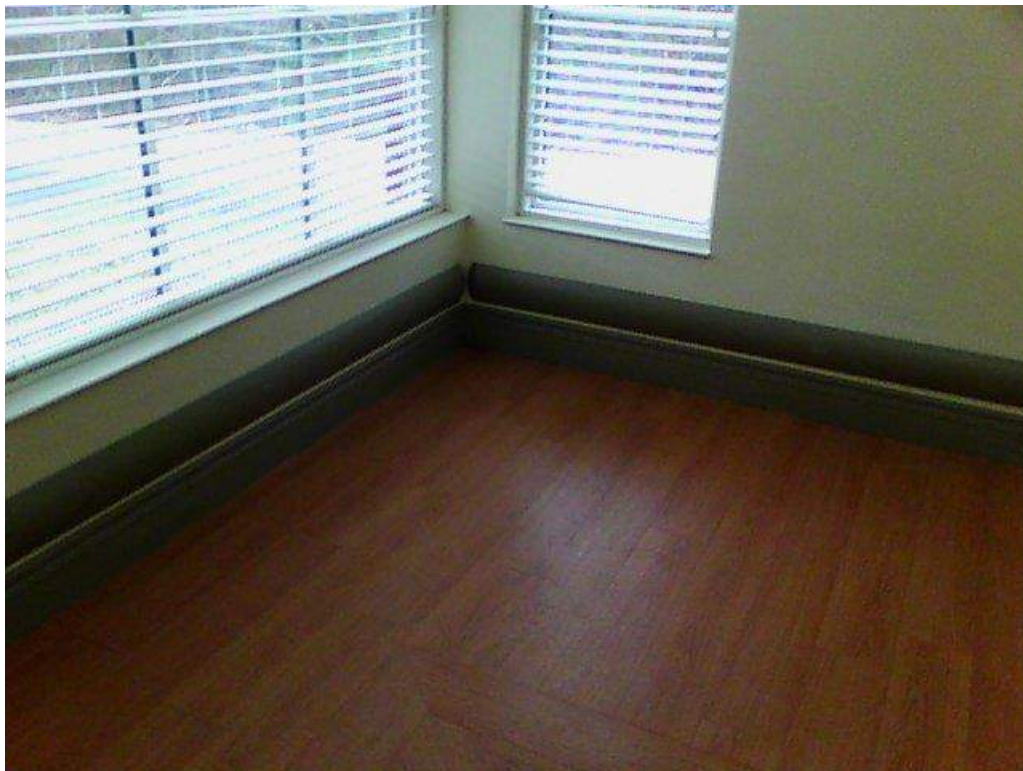
Photograph of image above, located in Charlie Wing.

Infrared image of drywall and flooring with indications of water intrusion.

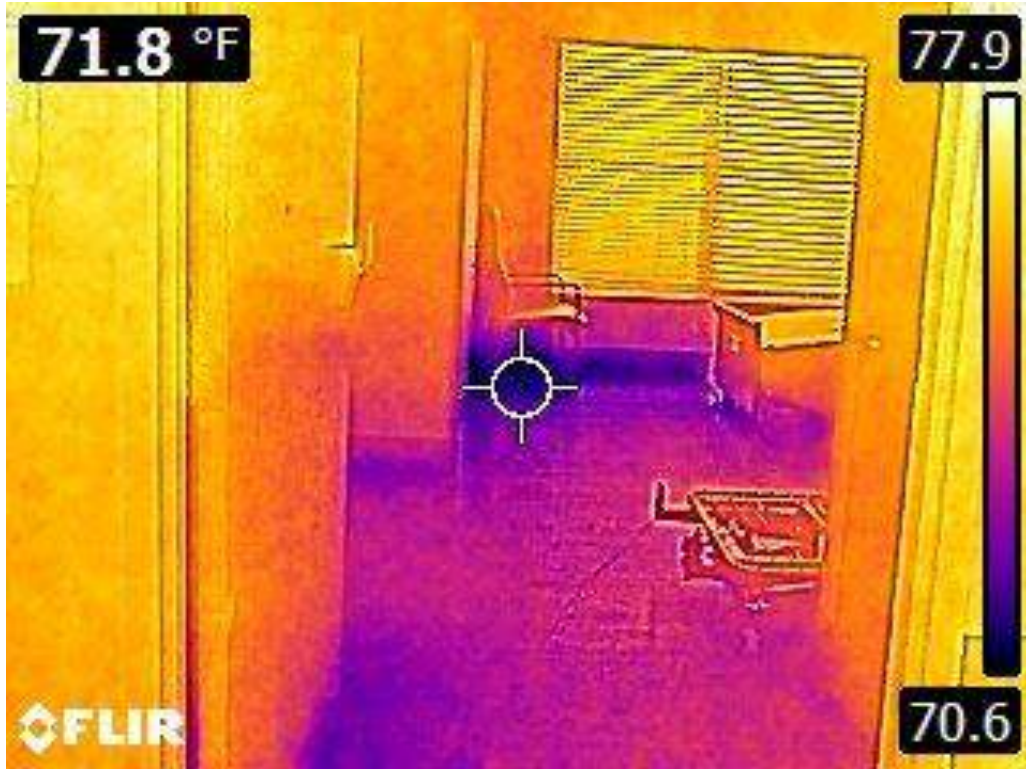
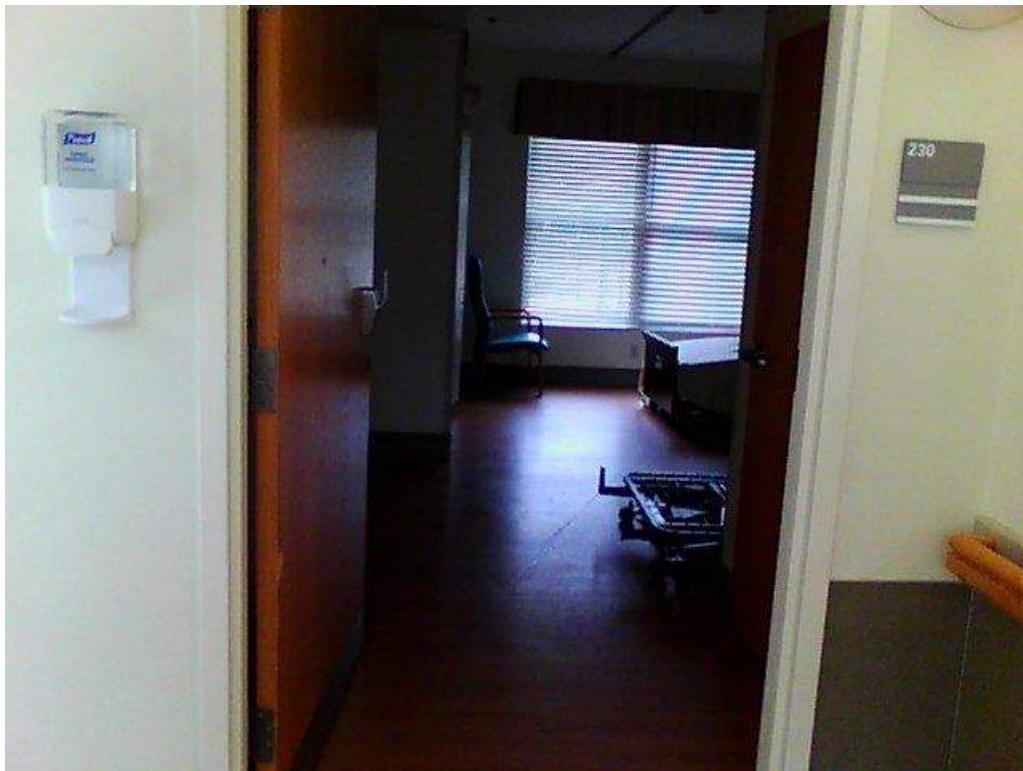
Photograph of image above, located in Charlie Wing.

Infrared image of drywall and flooring with indications of water intrusion.

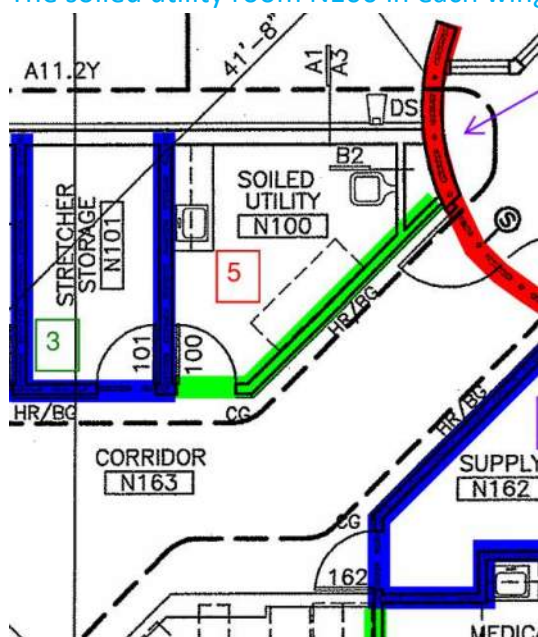
- 5) Incidental use area walls terminate at 2 layers of gypsum board attached to the bottom chord of the roof trusses. This gypsum board is noted as part of a 1 hour ceiling/roof assembly UL L542 and is an acceptable terminate for incidental room separation walls.
