# Joint Legislative Oversight Committee on General Government

# DMVA Fayetteville State Veterans Home

# DMVA Fayetteville SVH - FCAP Assessment

# NCDOA On-Site Assessment

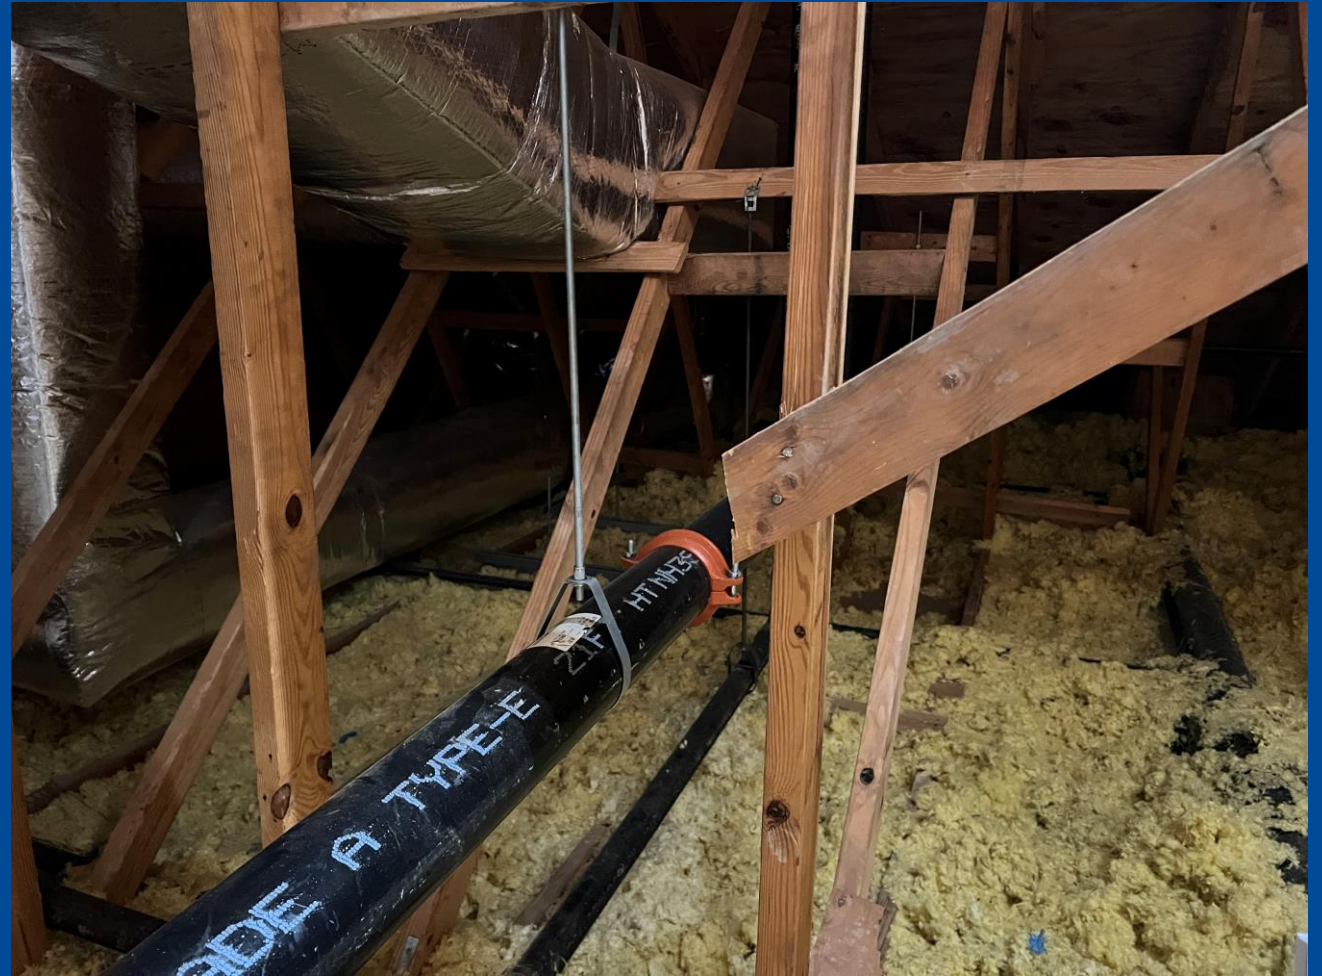
# FCAP Repair Recommendations (Structural)

- Various structural deficiencies were observed
  - Misaligned base truss top chord and other Truss issues
  - Truss deterioration/decay (water infiltration and improper attic ventilation)
  - Cut bracing (sprinkler system install)
  - Extensive water damage to roof sheathing
- Repair is required.

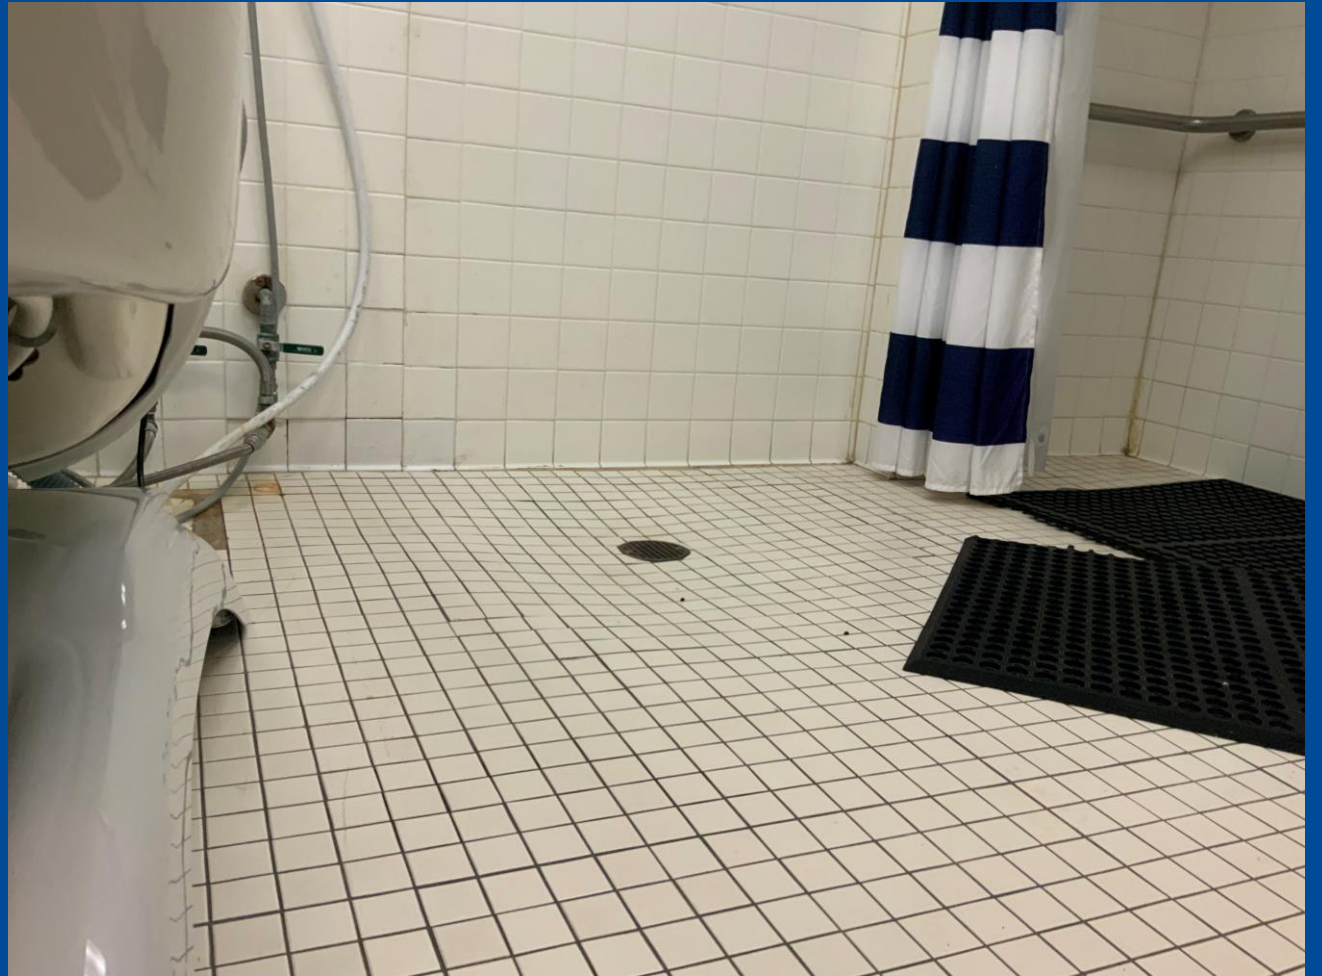
# FCAP Repair Recommendations (Plumbing)

- Wastewater system has reported issues but is concealed below the concrete slab on grade.
- A system investigation, including video scope inspection, by an industry specialist is recommended.

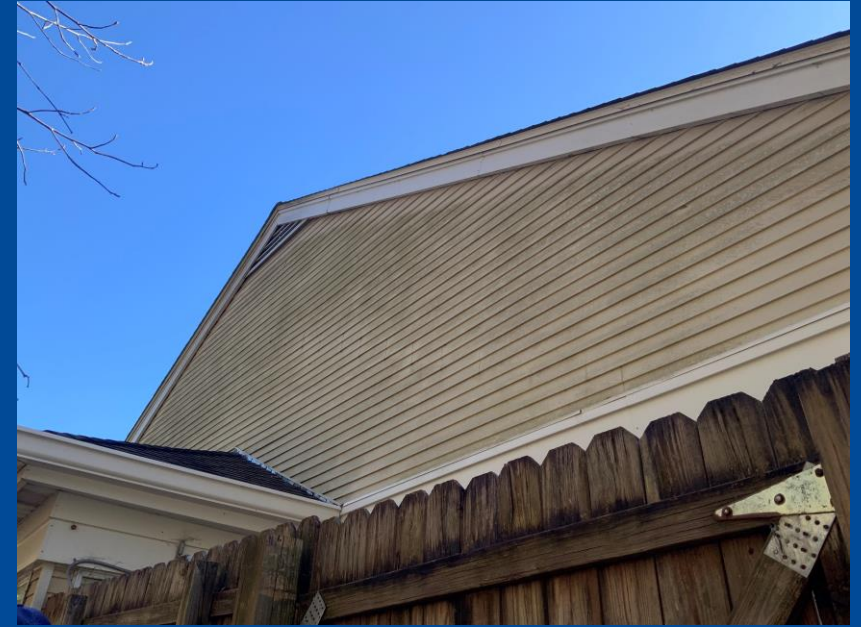
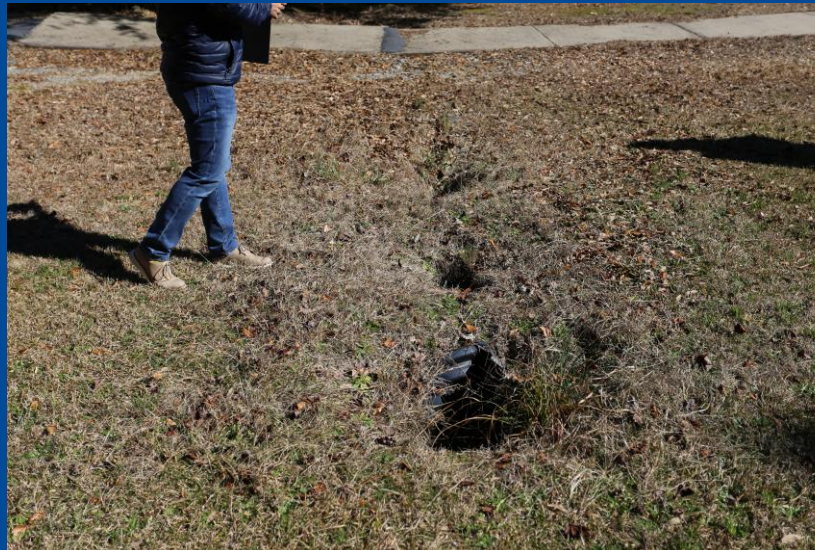
# Deferred Maintenance

- This facility was built with issues and located in a questionable area.
- Serious surface and sub-surface water issues result in saturated ground, standing water, and moisture infiltration.
- Poor drainage of surface water away from building.
- Lack of Exterior maintenance.
- Evidence of crushed drainage pipe(s).
