Neuse River Riparian Buffer
Case Study

Alexander Family Property
US70/Yeargan Road
Garner, NC

1/14/2014

Art Alexander

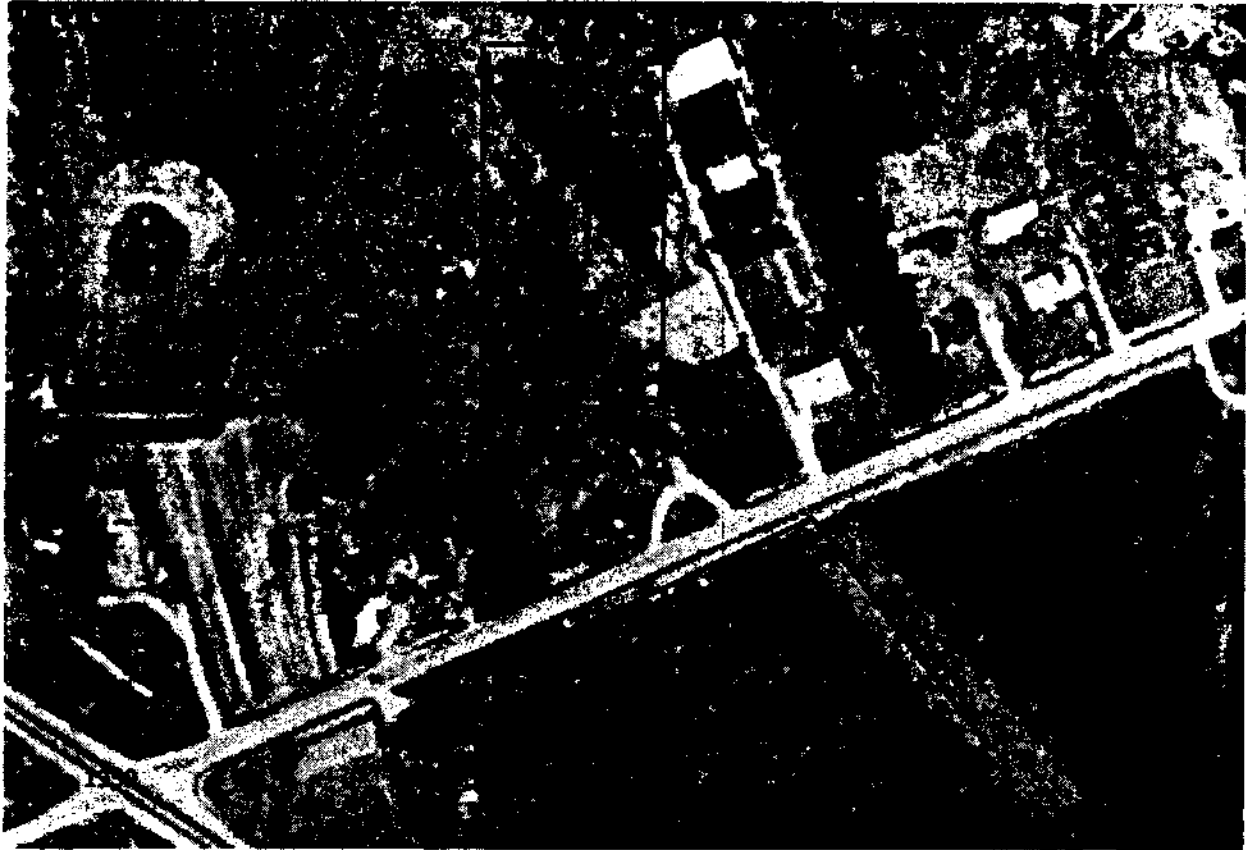
1959 Aerial Image of Area Upslope from Ditch on Our Property

There is no visual evidence of any water channel upslope of our property--neither ditch nor stream.

By comparison, note the clear evidence of the ephemeral stream channel in the power line on the lower right edge of the photograph. Proof that this resolution is sufficient to see surface stream features if they existed.

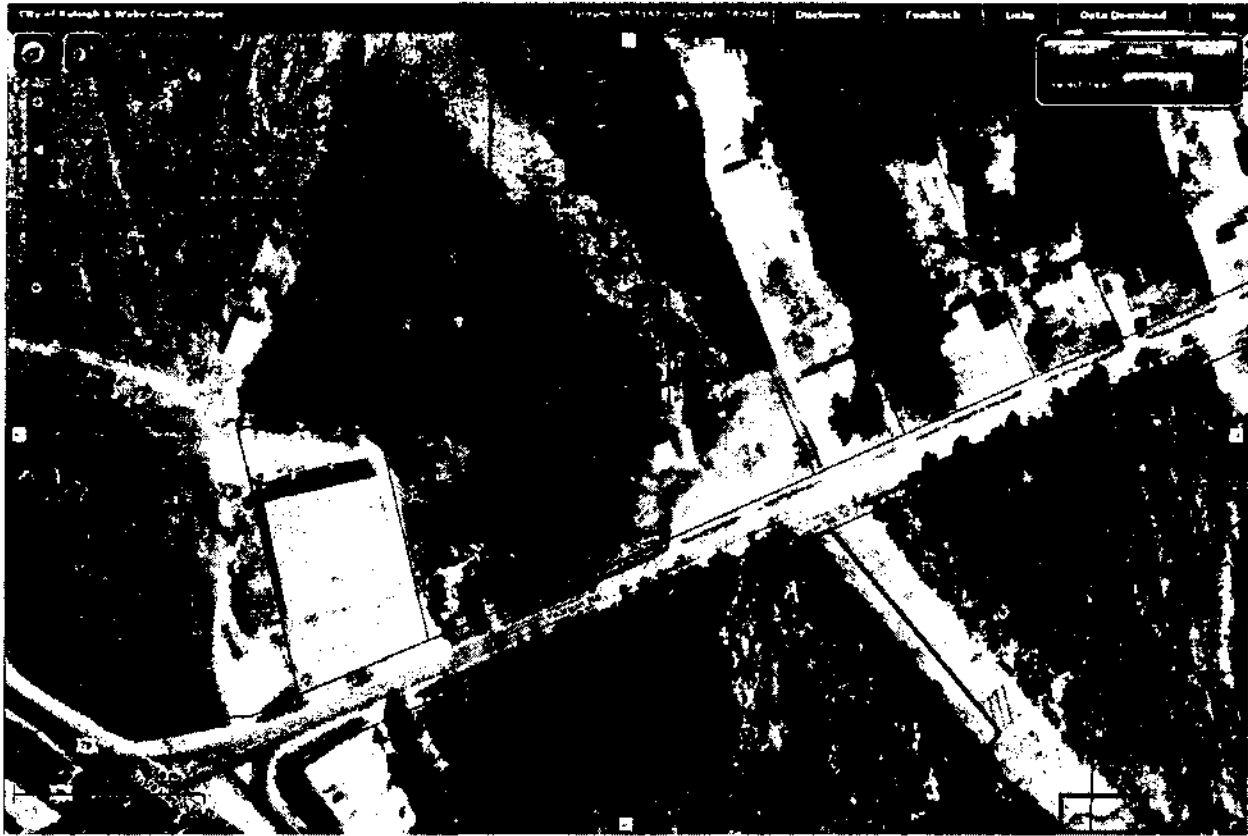
1981 Aerial Image of Area Upslope from Ditch on Our Property

22 years later, still no evidence of any water channel upslope of our property.

The ephemeral stream channel in the power line on the lower right edge of the photograph is still evident in the same location as on the 1959 photo.

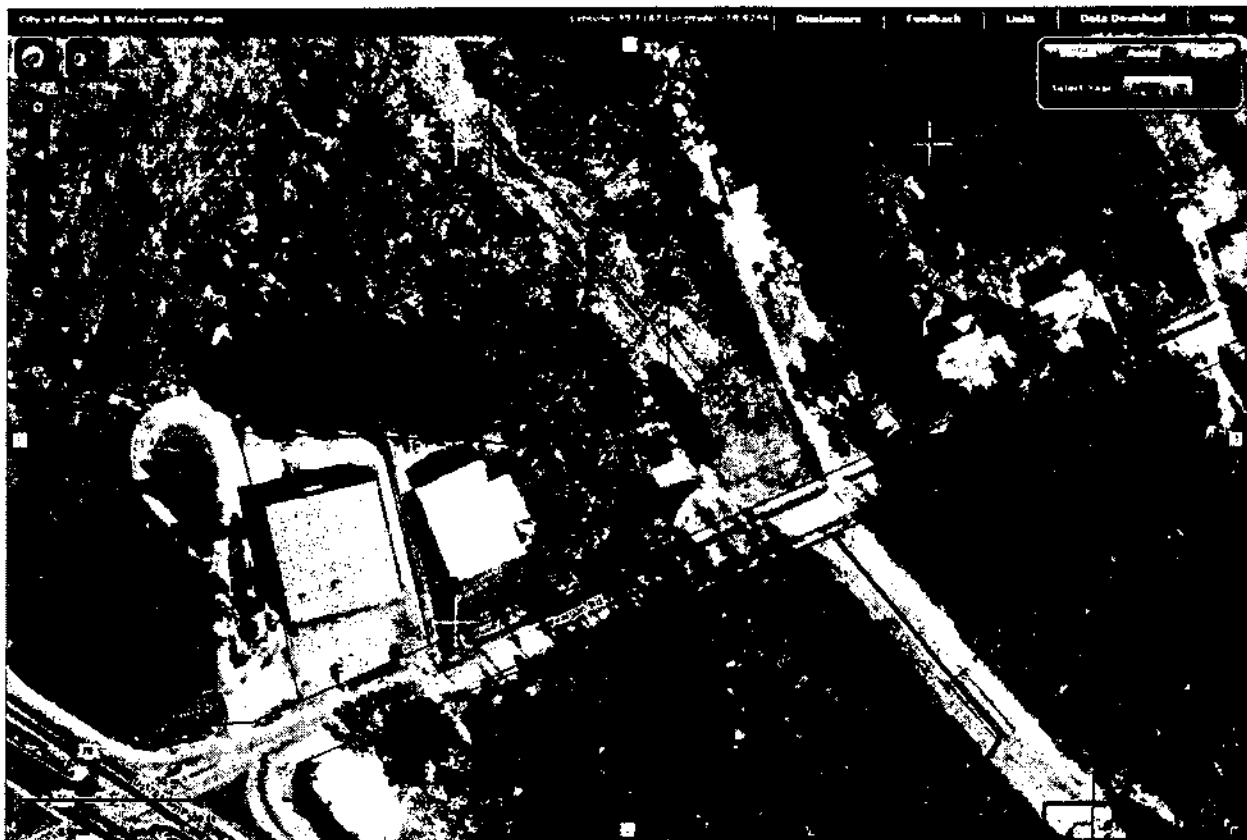
1988 Aerial Image of Area Upslope from Ditch on Our Property

In 1988 there is clear evidence of a ditch having been dug since the 1981 photo was taken.

Note the relatively straight nature of the cut, lack of sinuosity.

A close-up view of the original aerial photo will reveal further evidence of spoil piles excavated from ditch.

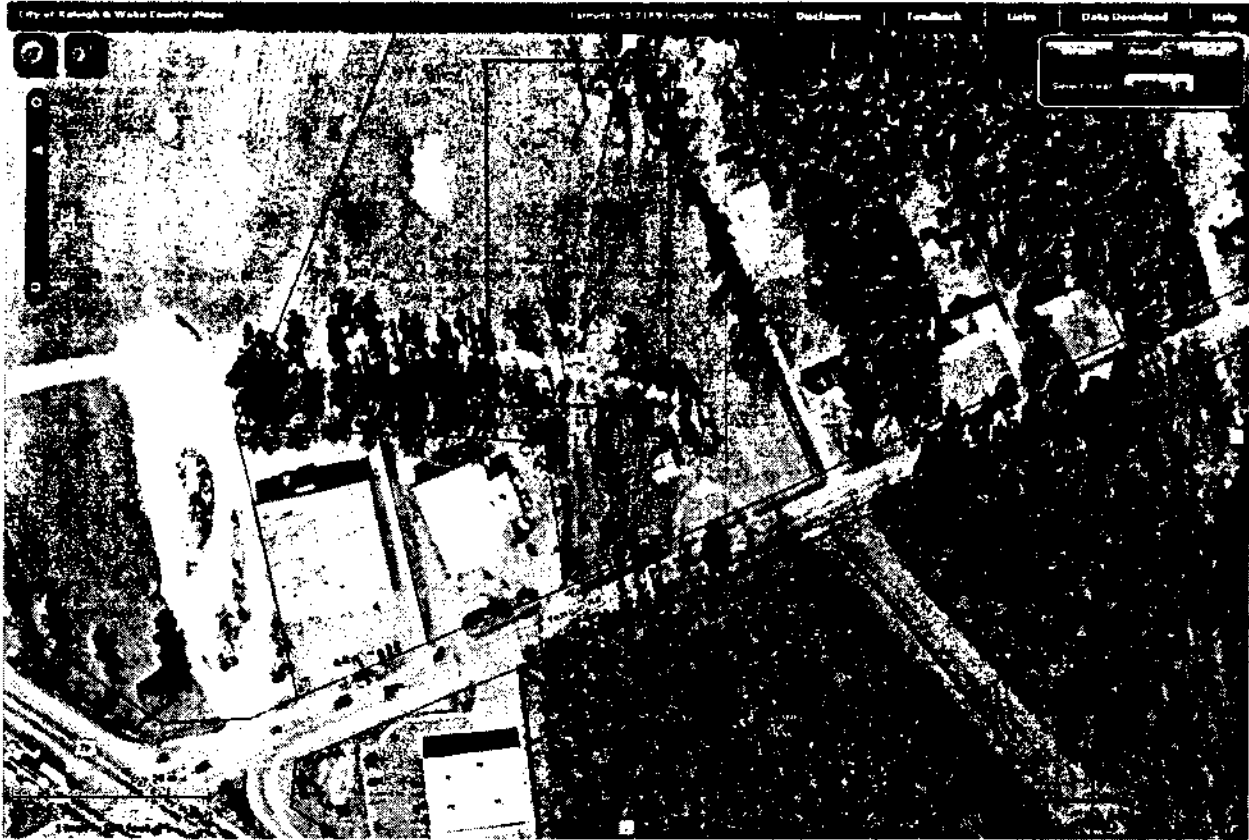
1999 Aerial Image of Area Upslope from Ditch on Our Property

Improved clarity of photograph emphasizes the straight cut and lack of sinuosity of the ditch. A close-up of the original aerial photo would reveal better clarity of spoil piles excavated from ditch.

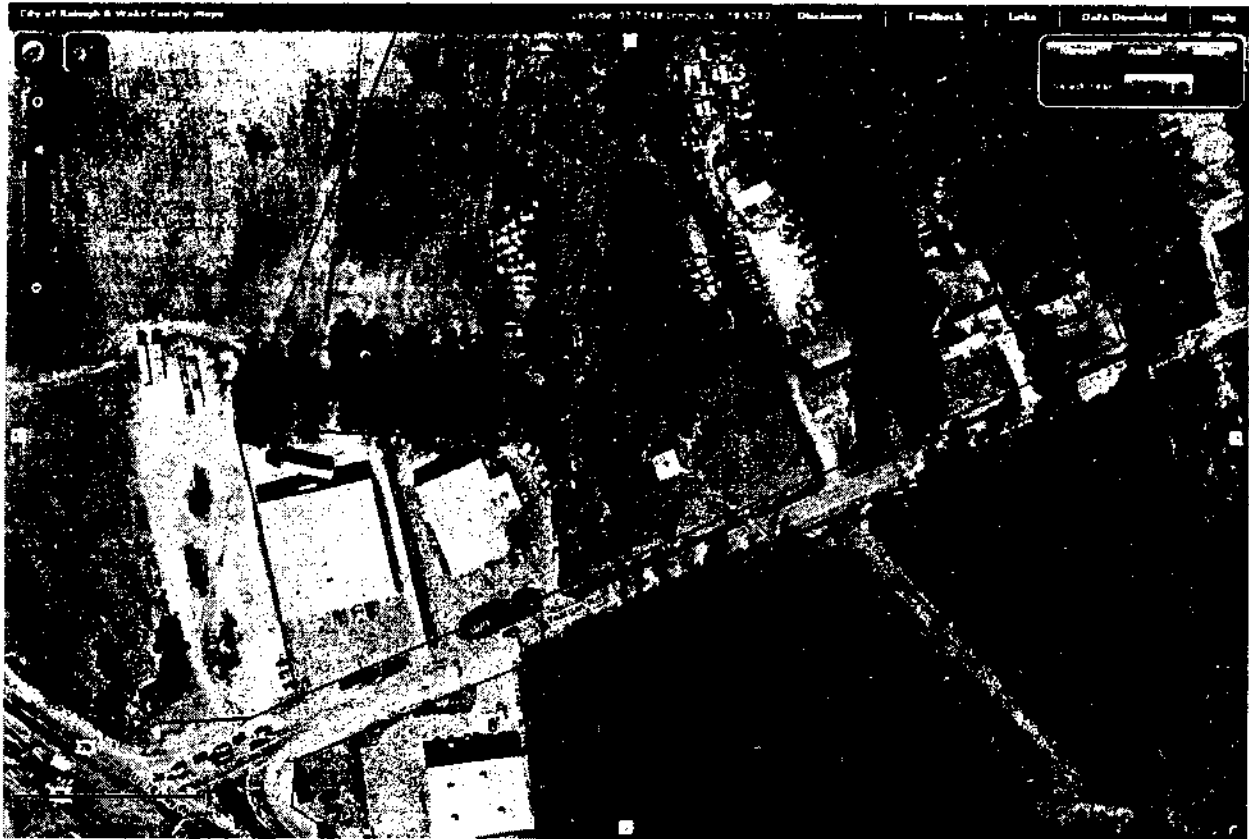
2005 Aerial Image of Area Upslope from Ditch on Our Property

This version provides an even better view of the well-formed, straight cut. No doubt about it here.

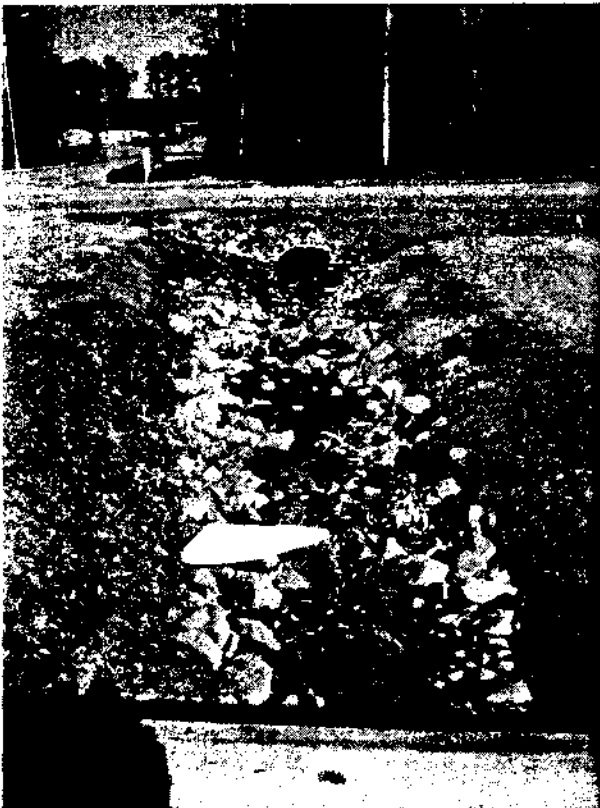
This is a close up shot of the ditch as it crosses the Raynor property north of our property. The width of the ditch here is approximately 18"-20".

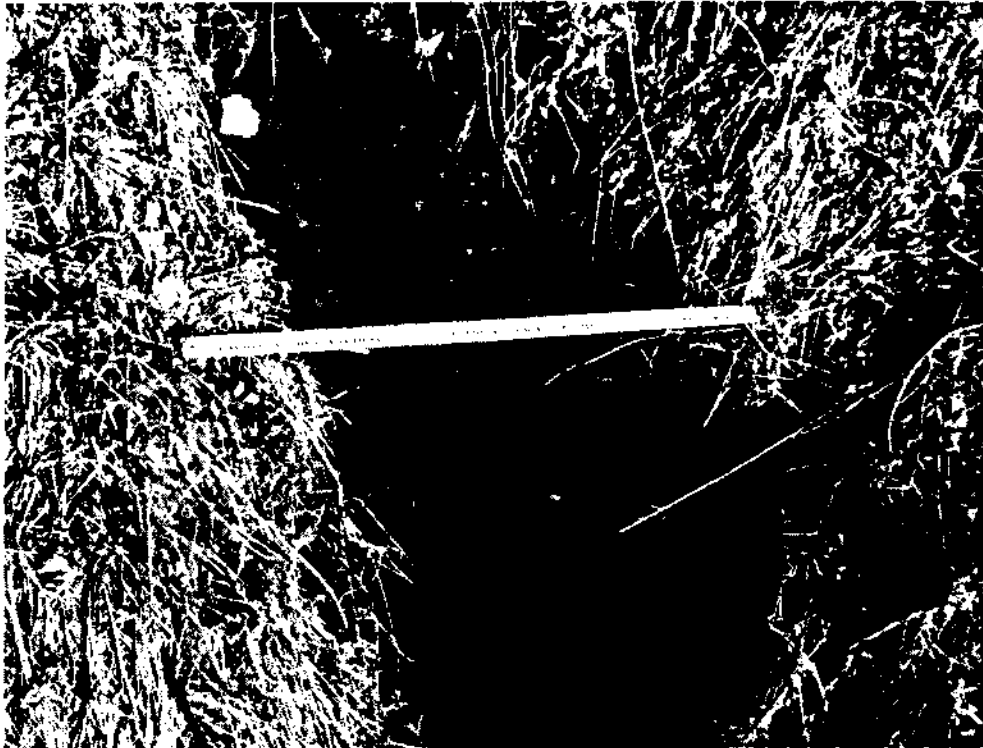
This is a picture of the ditch farther downslope on the Raynor property, just before it flows into the pipe underneath Yeargan Road.

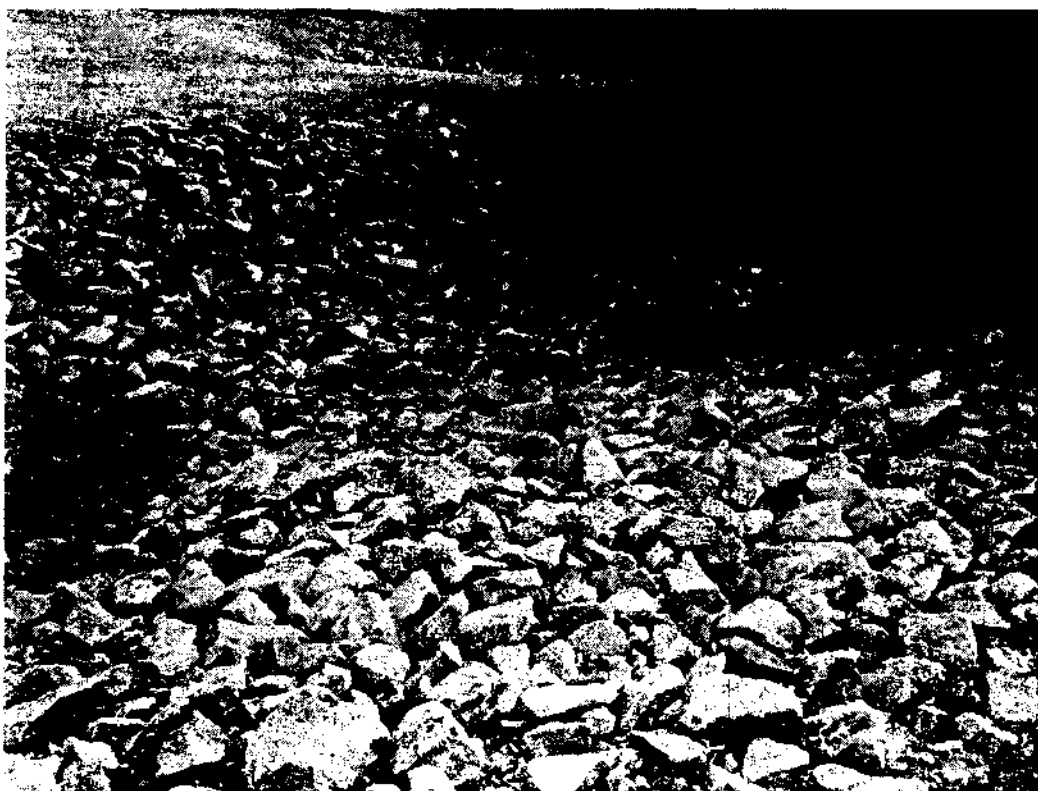
Although the spoil piles don't show up as well in a photo as onsite, you are still able to see the mounds in these and the following photo.

The mounds are clearly visible, but there are some things you cannot see in the photo. Beyond the mounds there are still traces of the surface flow patterns where the overflow ran from the termination point of the original ditch, over the land to the low lying area to the south.
