Neuse River Riparian Buffer
Case Study

Alexander Family Property
US70/Yeargan Road
Garner, NC

1/14/2014

Art Alexander

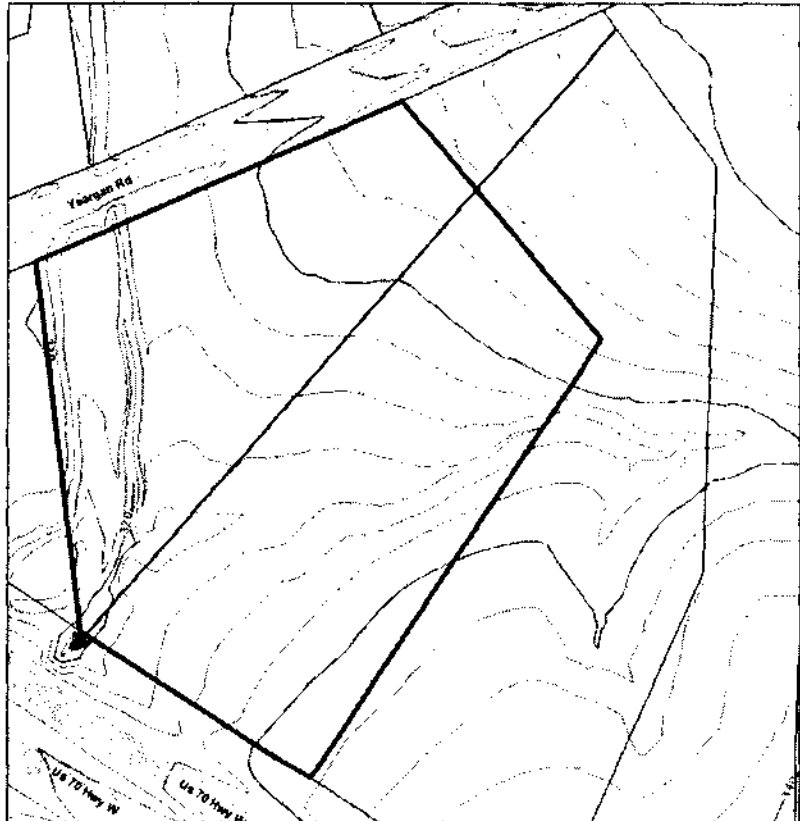
This is the ditch on Granddaddy's property that I remember from playing in those woods as a boy. It was approximately 3 feet wide and 18 inches deep. It intersected with the ditch that ran along the south shoulder of Loop Road, then ran straight back into the woods on the property where it stopped abruptly. (See red arrows)

Rainwater runoff from Loop Road was the primary source of water into this ditch. It was a dry bed most of the year.

Since the path of the ditch cut across the natural slope, there was no natural path for the excess water to follow. It overflowed, across the surface of the surrounding forest floor, slowly seeping into the low lying areas. There it sat until it was absorbed by the soil or until it eventually found its way into the ephemeral stream farther south on the property.

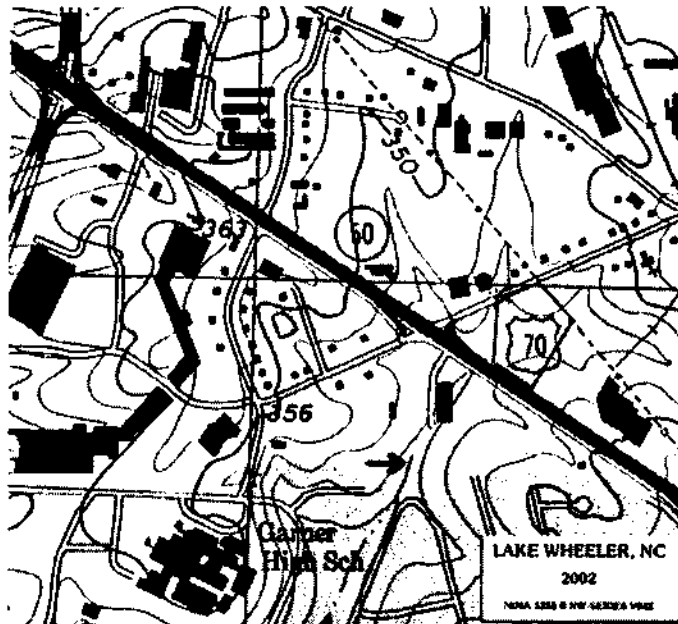
2002 USGS Map Lake Wheeler Quadrangle (this was the "current" map at the time of our property evaluation)

No stream on our property.

The stream begins south of US70, after flowing *under* Garner TV & Appliance building.

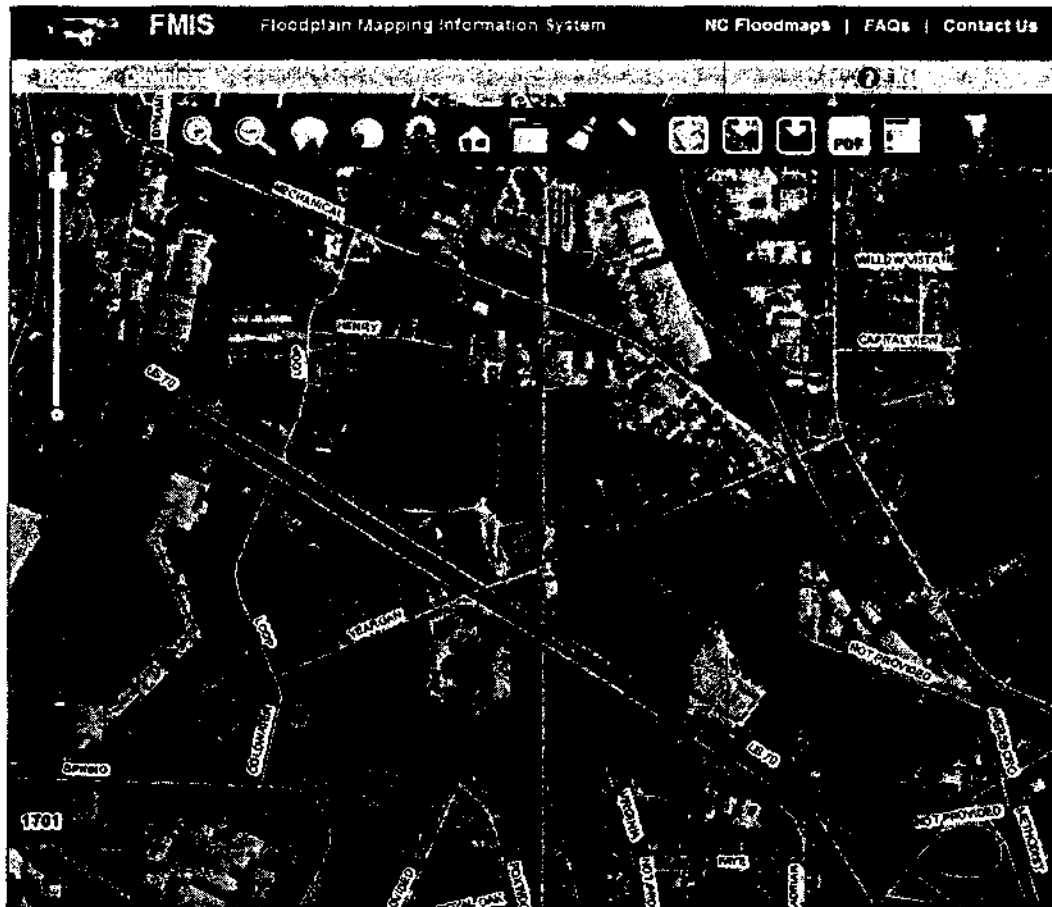
Light Detection and Ranging (LiDAR) the North Carolina Floodplain Mapping Information System.

The LiDAR based map of the NCFMIS places the stream origin south of US70, near the point where it flows out from underneath the Garner TV & Appliance building—virtually the same point as on the 2002 USGS Map.

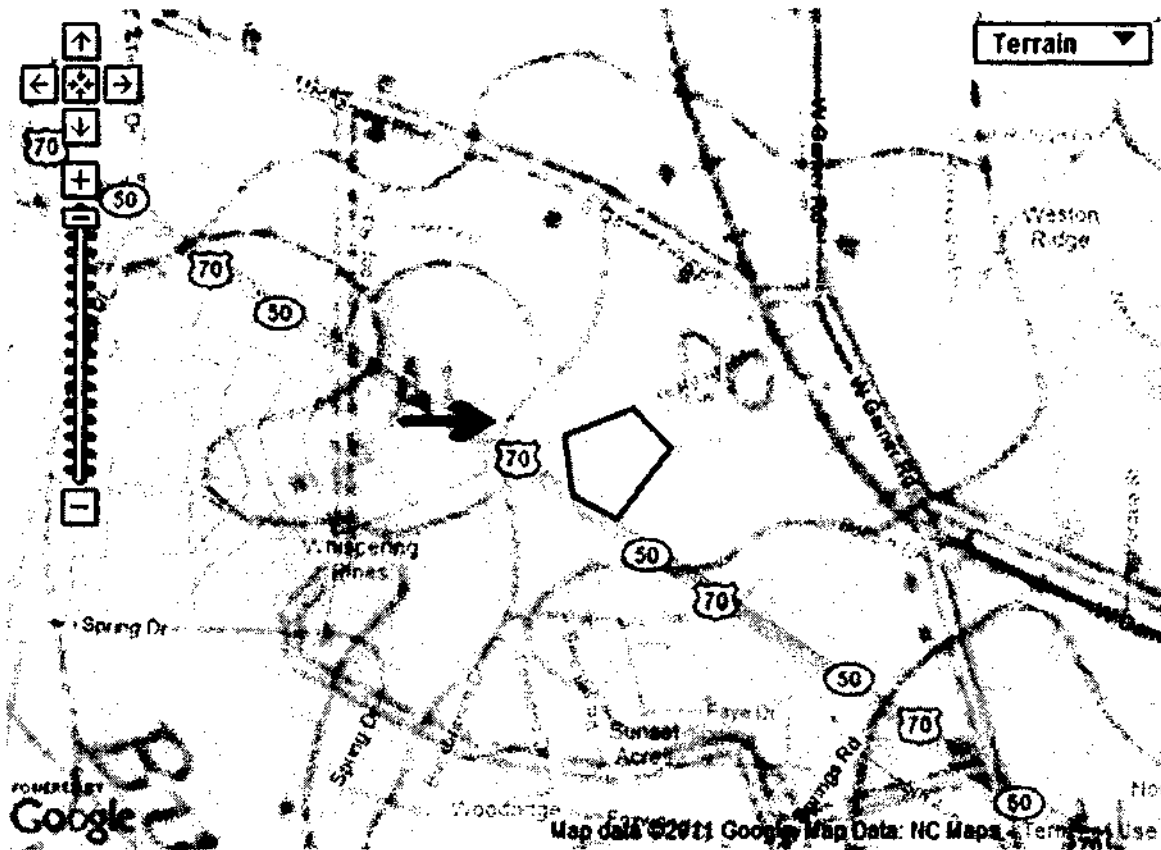
Notice that there is only one stream feature on this map. It crosses the US 70/Yeargan Road intersection west of the intersection.

Our property lies east of this intersection. **This original stream location does not cross our property.**

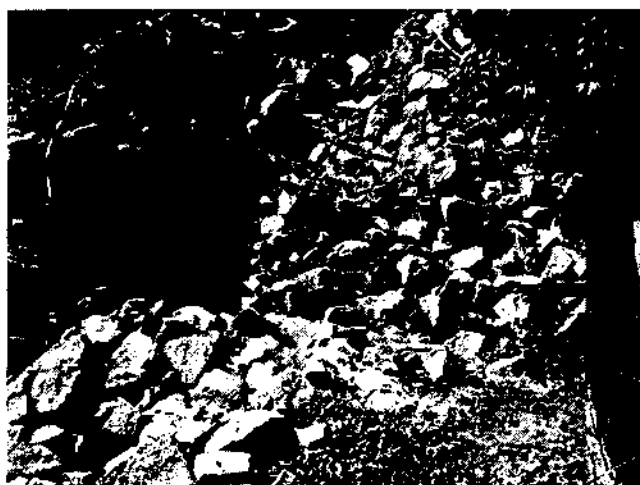
Before we move on, take a quick second look at the ditch and pipe on the Raynor property north of Yeargan Road, compared to the ditch immediately across the road on our property.
