1. Report No. ATRC-99-11		2. Government Accession No.		3. Recipient's Catalog No.	
4. Title and Subtitle Survey of Tire Debris on Metropolitan Phoenix Highways				5. Report Date November 1999

11. Contract or Grant No.	
12. Sponsoring Agency Name and Address ARIZONA DEPARTMENT OF TRANSPORTATION 206 S. 17TH AVENUE PHOENIX, ARIZONA 85007 Project Manager: John Semmens				13. Type of Report & Period Covered

14. Sponsoring Agency Code	
15. Supplementary Notes Prepared in cooperation with the Governor's Office of Highway Safety					
16. Abstract <p>This report was prepared in order to evaluate the impacts that tire debris on state highways produces in Arizona and the Phoenix metropolitan area. Estimates of debris collected in metro Phoenix were reported along with an analysis of the safety implications that roadway debris and tire defects have for Arizona motorists. In order to assess the causes of tire debris in metropolitan Phoenix, a sample of tires and tire fragments was taken at several ADOT maintenance yards in the metro area. These fragments were classified according to type of vehicle, retread or original tire, and probable cause of failure.</p> <p>The study revealed that, relat

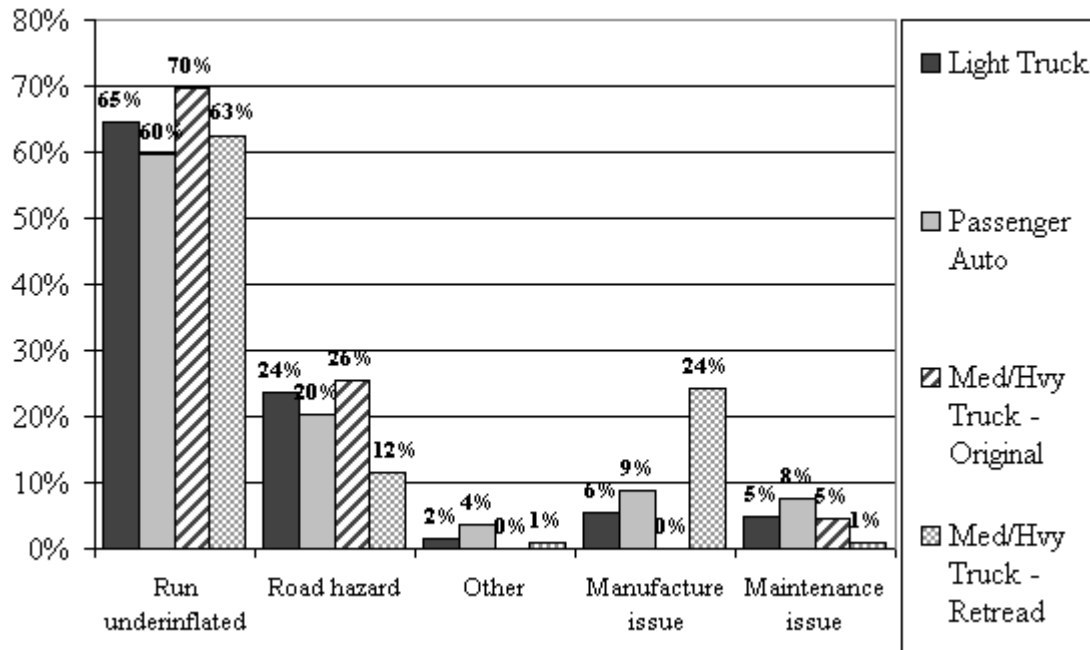
Figure 17: Cause of Tire Failure by Type of Tire

The percentage distributions of causes of failure by tire type are shown in Figure 17. As indicated in the chart, under-inflation was not only the most common cause of failure, but also the most *consistently* distributed among tire types. Failures caused by running tires under-inflated ranged from 60 percent (passenger autos) to 70 percent (large truck - original) of all failures in each subcategory. Other causes of failure exhibited greater variation. "Road hazards" were the cause of failure for 20 percent to 26 percent of passenger auto, light truck and original medium truck tires, but represented only 12 percent of retread failures. In contrast, "Manufacturer issues" were more highly represented in the sample of retread tires (24 percent) than in any other tire category. Medium/heavy truck retreads had the lowest percentage of failures due to "Maintenance issues" and "Other/unidentified" causes (2 percent combined), while passenger auto tires had the highest percentage of failures (12 percent combined) due to these causes.

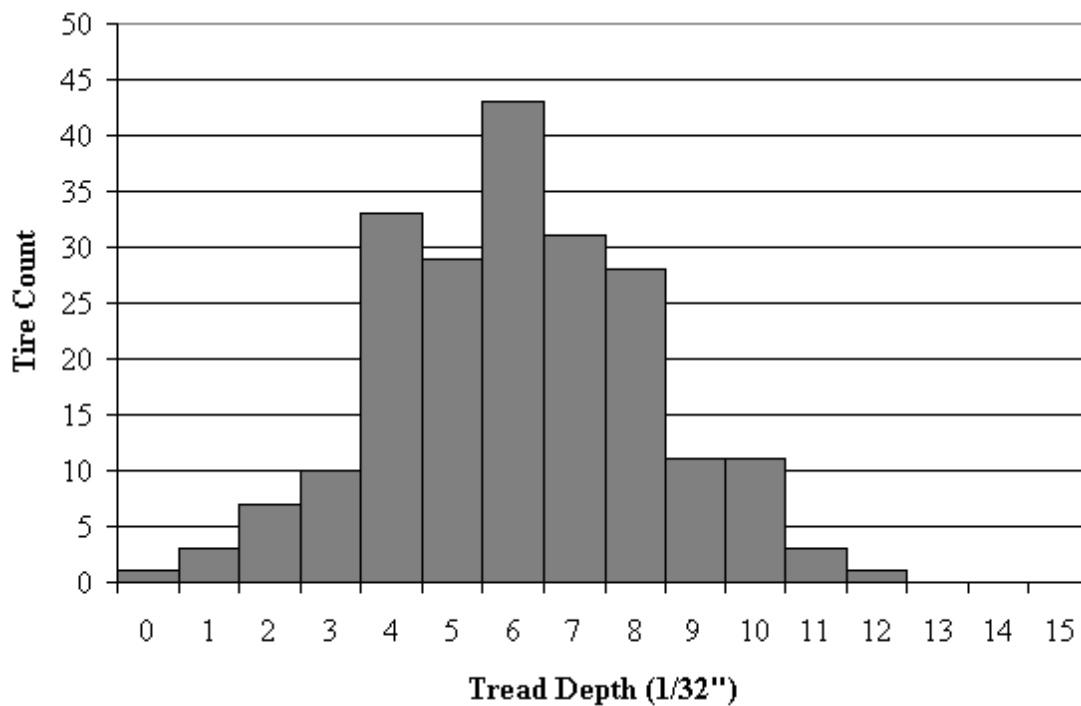
Figure 18: Distribution of Tread Depth - Passenger Auto Tires

Figures 18 to 21 on the following pages provide frequencies of tread depth by tire type. With the exception of medium/heavy truck original tires, all distributions were basically normal. The distribution of medium/heavy truck retreads exhibits some positive skewness.
