Reference / Project: RAL1002.011 Fayetteville State Veterans Home Roof Repairs/Replacement
Amendment #03 Emergency Repair Design

Subject: Report of Existing Conditions for Owner's Immediate Response

RAL1002.011 Fayetteville State Veterans Homes - EMERGENCY LIFE SAFETY AND INFRASTRUCTURAL UPGRADES

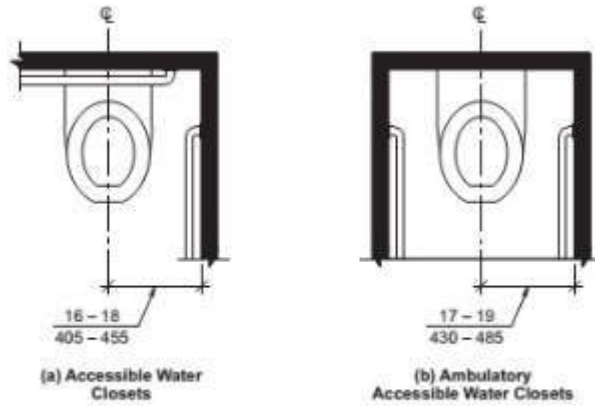
FIG. 604.2 WATER CLOSET LOCATION

- 1) Toilet centerline must be between 16 and 18 inches from the adjacent wall. **Non-compliant condition found in congregate rooms A110, A152, B152, C152. Recommend removal and reinstallation at compliant distance off wall.**

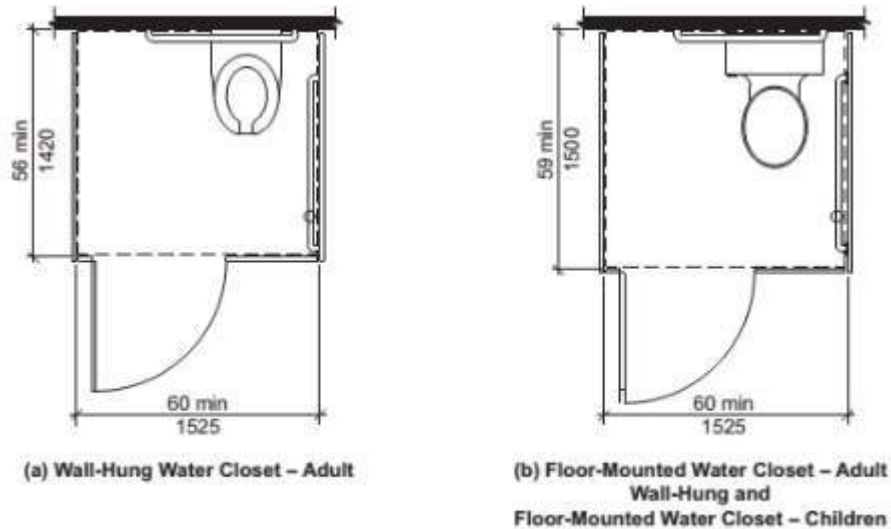
FIG. 604.9.2 WHEELCHAIR ACCESSIBLE TOILET COMPARTMENTS

- 2) Clear floor space of 60" wide by 56" deep. Non-compliant condition found in congregate rooms A110, A152, B110, B152, C152. These locations are deficient in the width by fractions of an inch. This is due to the tile installed over the gypsum board coupled with an offset in the rear wall creating an alcove that is slightly too narrow. Recommend furring out the wall to remove the alcove offset so required clearances can be achieved.

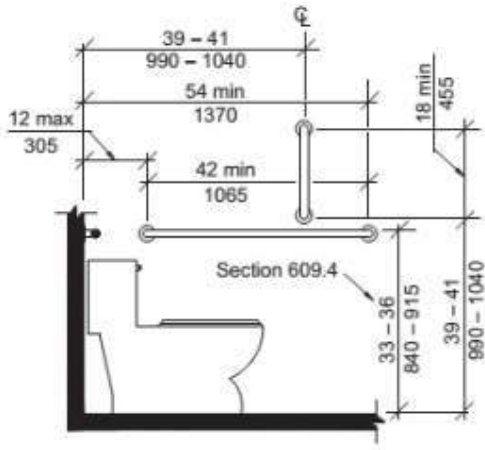
FIG. 604.5.1 SIDE WALL GRAB BAR FOR WATER CLOSET

- 3) Vertical grab bar 18" high and 2 horizontal grab bars 36" on the rear wall and 42" on the side wall. Vertical grab bars are missing at all locations. Recommend installation of additional grab bars for compliance.

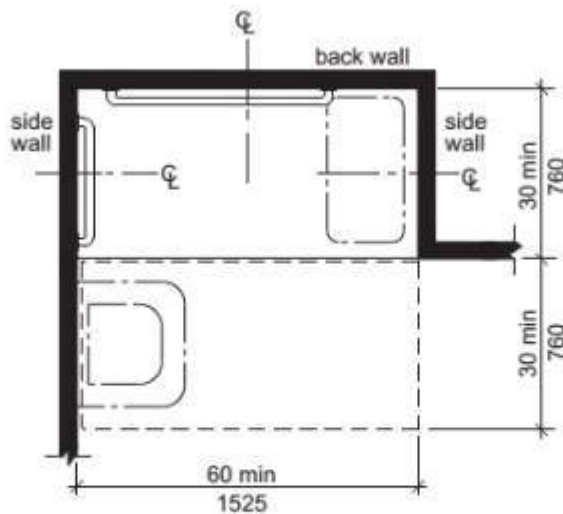
FIG. 608.2.2 STANDARD ROLL-IN-TYPE SHOWER COMPARTMENT SIZE AND CLEARANCE

- 1) Size: min. 60" wide by min. 30" deep. . Non-compliant condition found in congregate rooms A110, A152, C152. 60" minimum width is not being met. Recommend demolition and reconstruction of compartment wing wall to compliant location..
- 2) Clearance: min. 60" wide by min. 30" deep. No deficiencies noted.

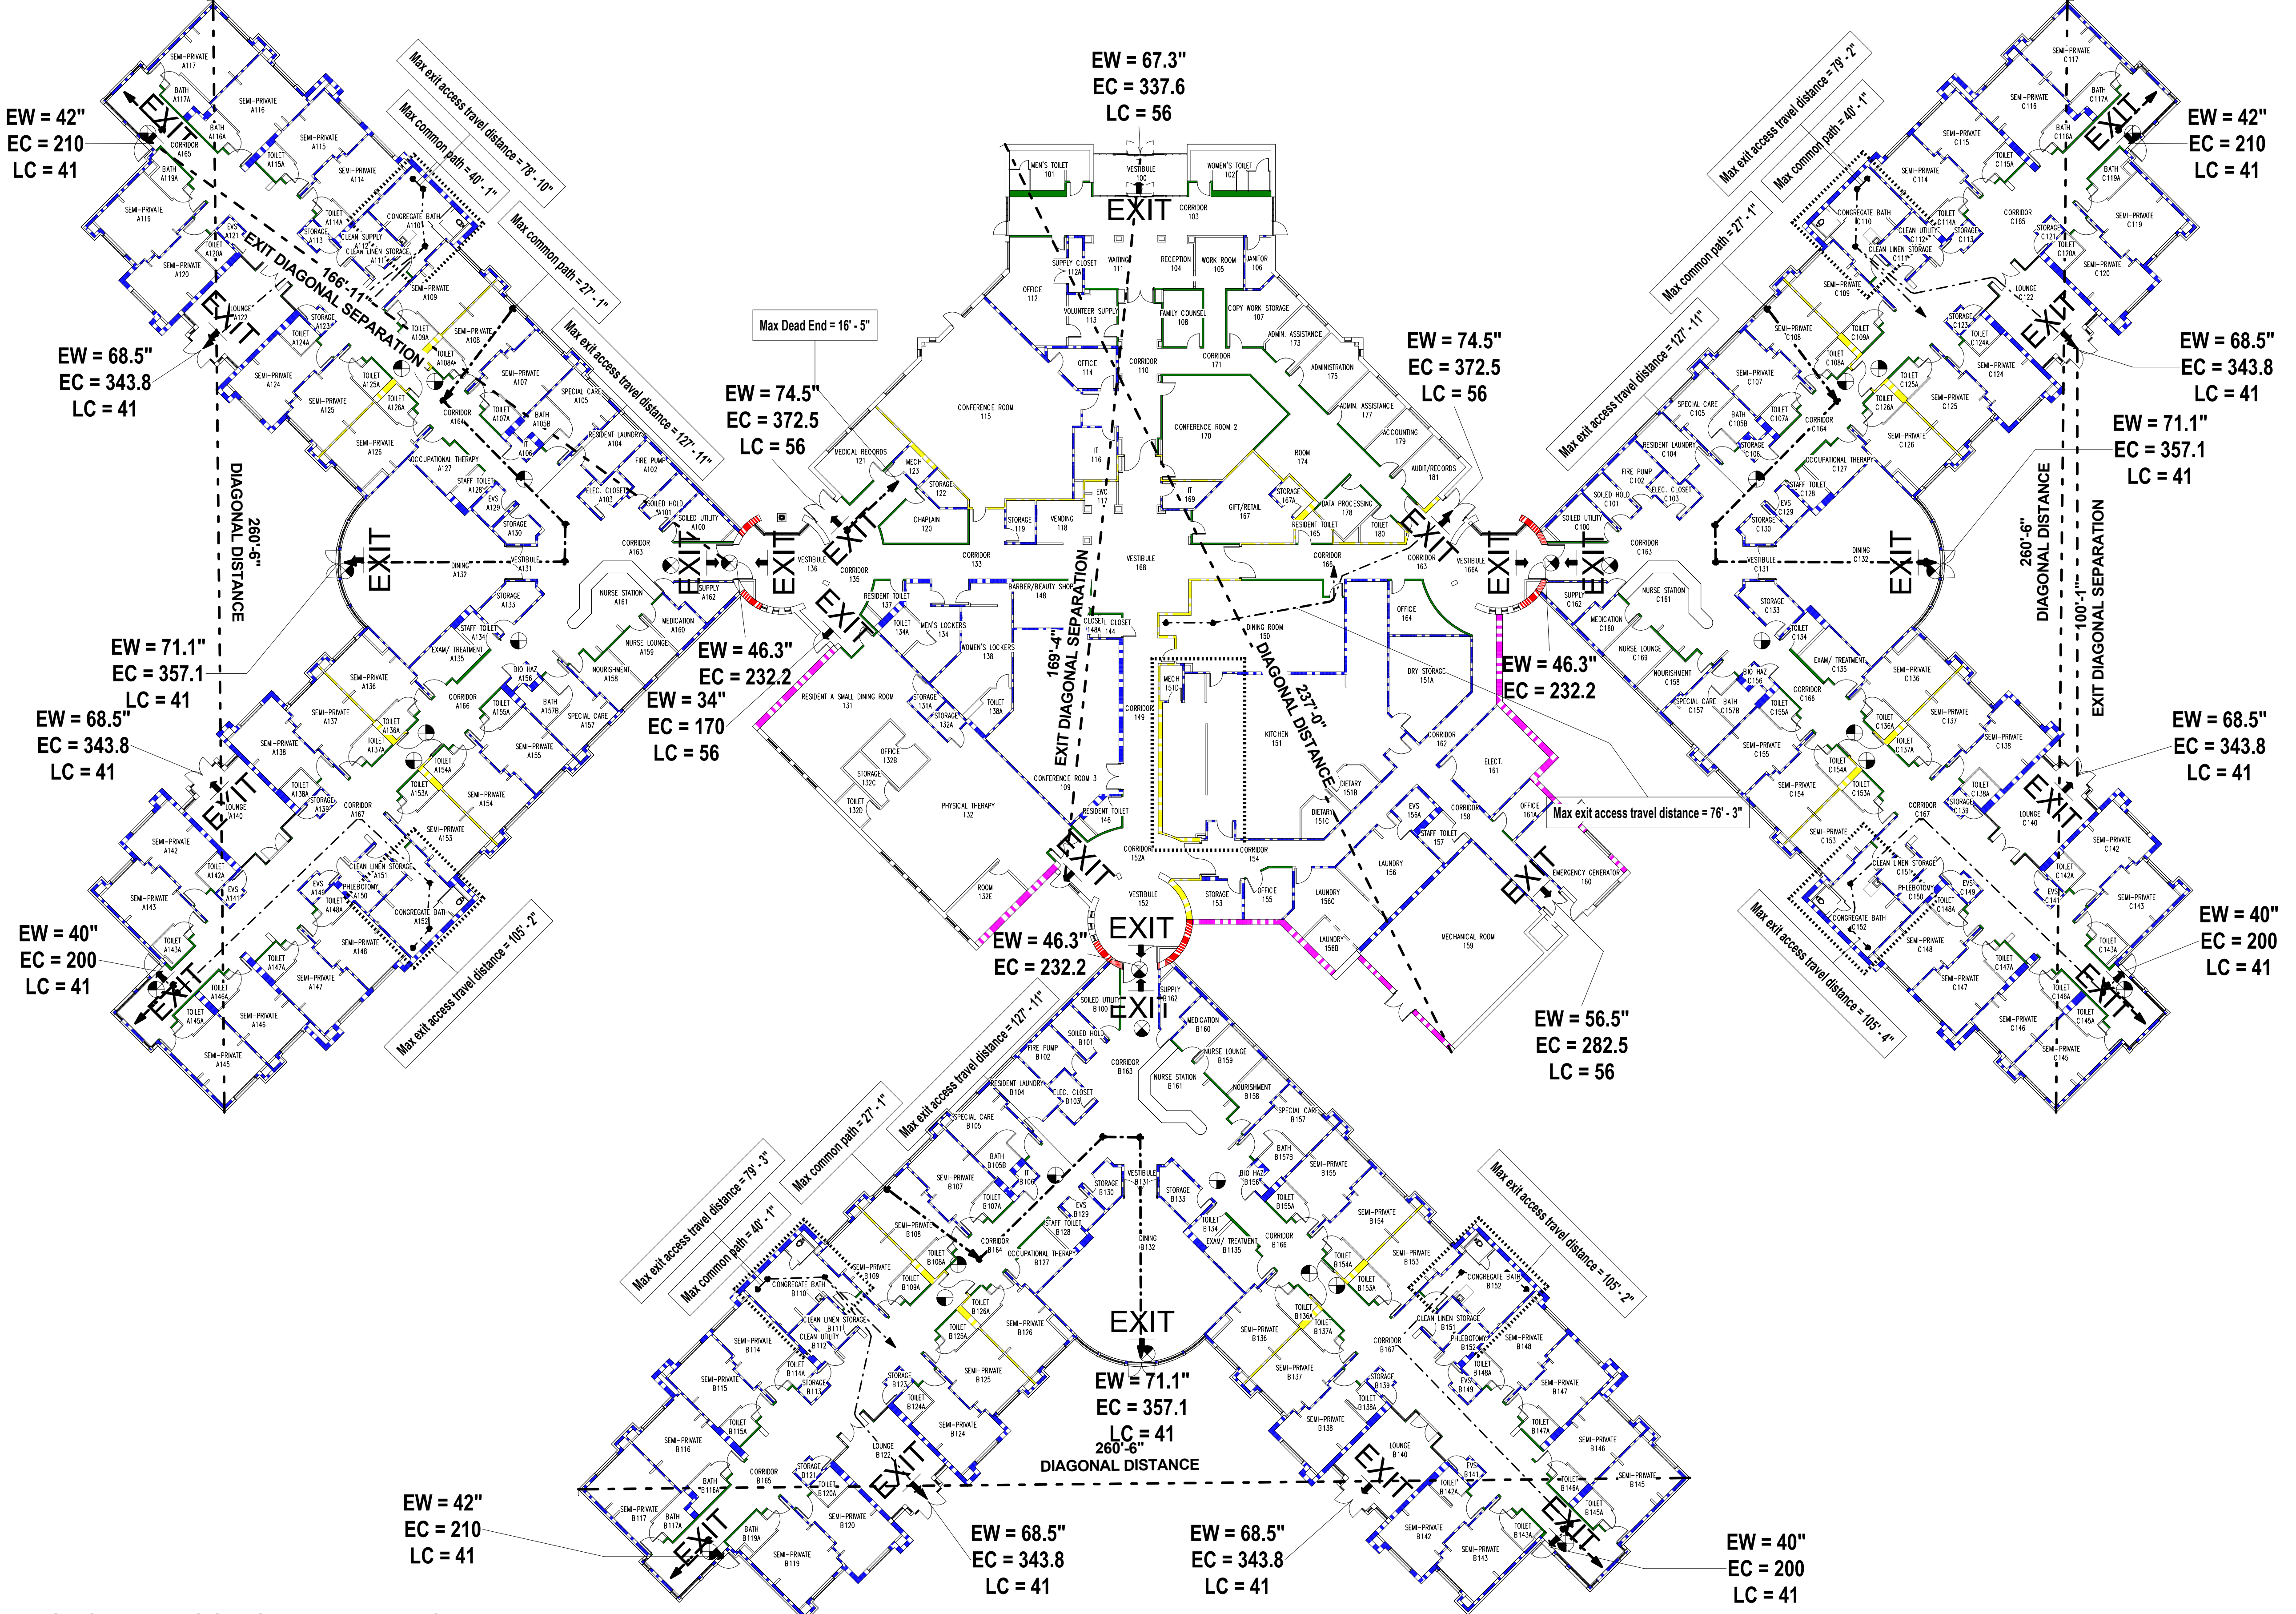
THIS PLAN INDICATES EXISTING WALL RATINGS AS DETERMINED BY SELECTIVE SPOT VERIFICATION.

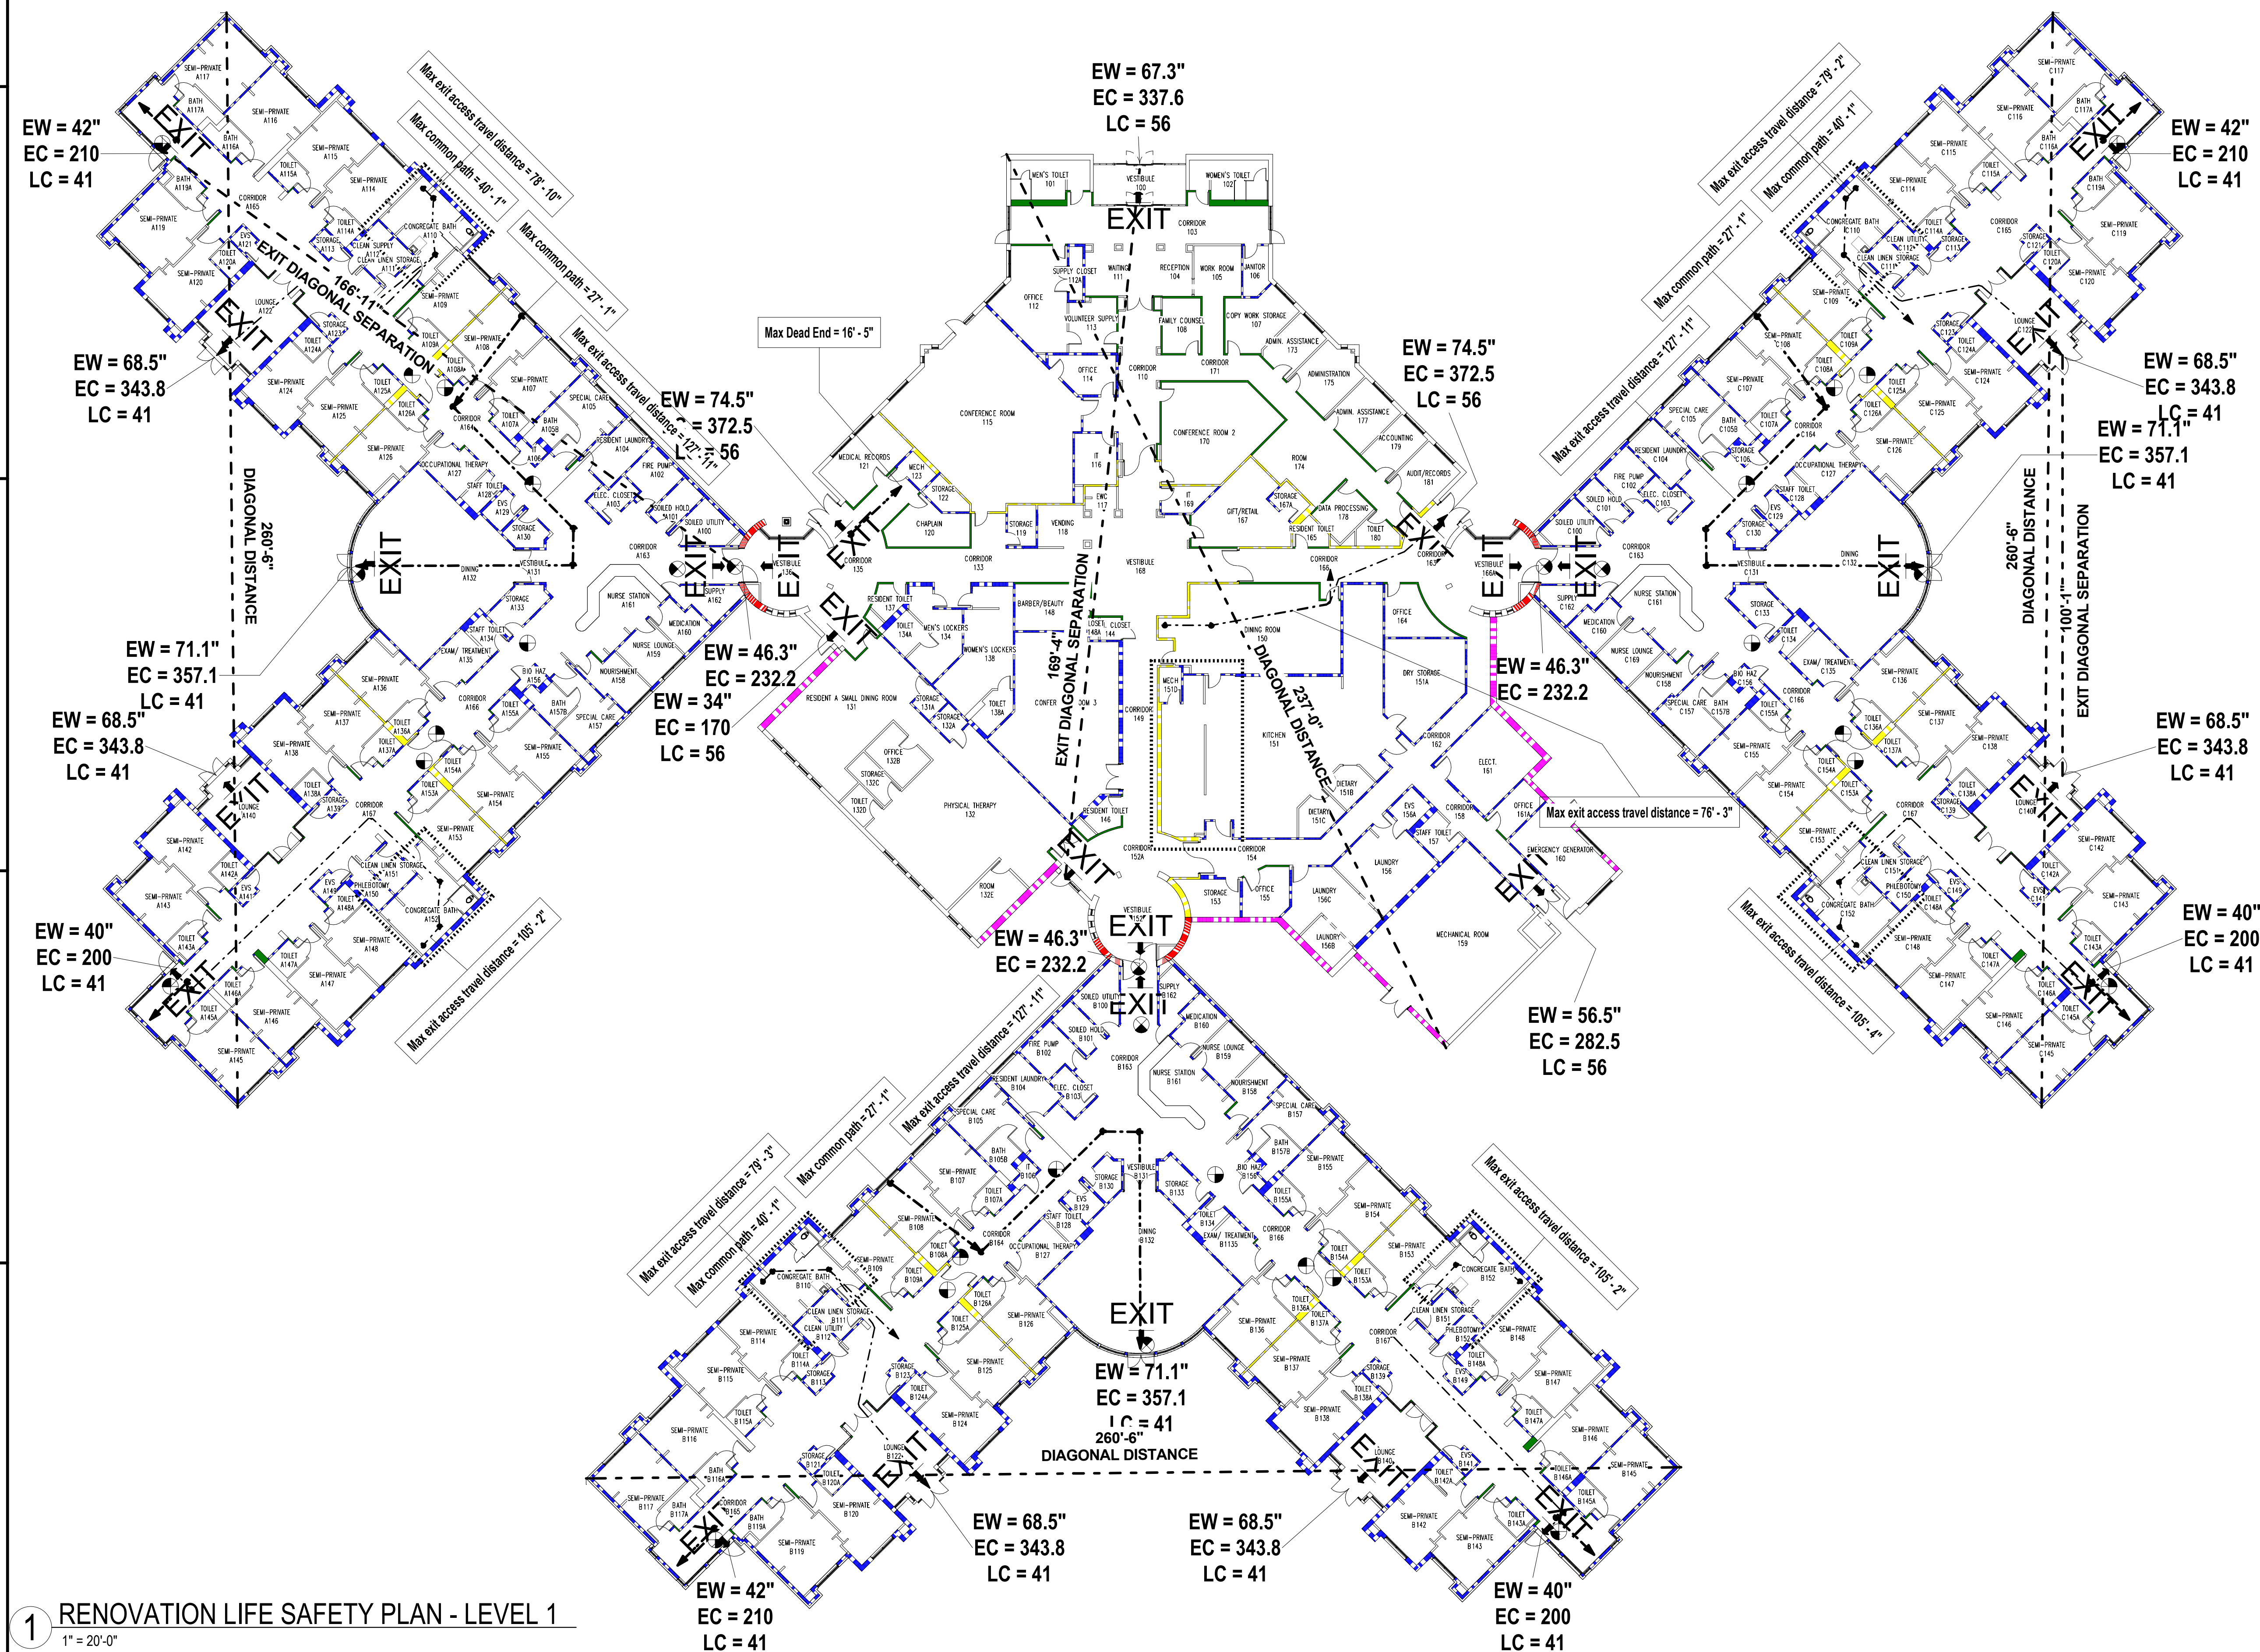
THIS PLAN INDICATES REQUIRED WALL RATINGS FOR LIFE SAFETY COMPLIANCE. THERE ARE MULTIPLE SMALL STORAGE ROOMS NOT REQUIRED TO BE FIRE RATED, BUT THOSE HAVE BEEN LEFT AS IS UNLESS THE OWNER REQUEST THE WALLS BE DOWNGRADED.
